### **Marine Dive Survey Report**

**Underwater archaeological inspections  
Arklow Waste Water Marine Outfall  
Arklow, Co. Wicklow  
17D0078, 17R0197**

09 July 2018

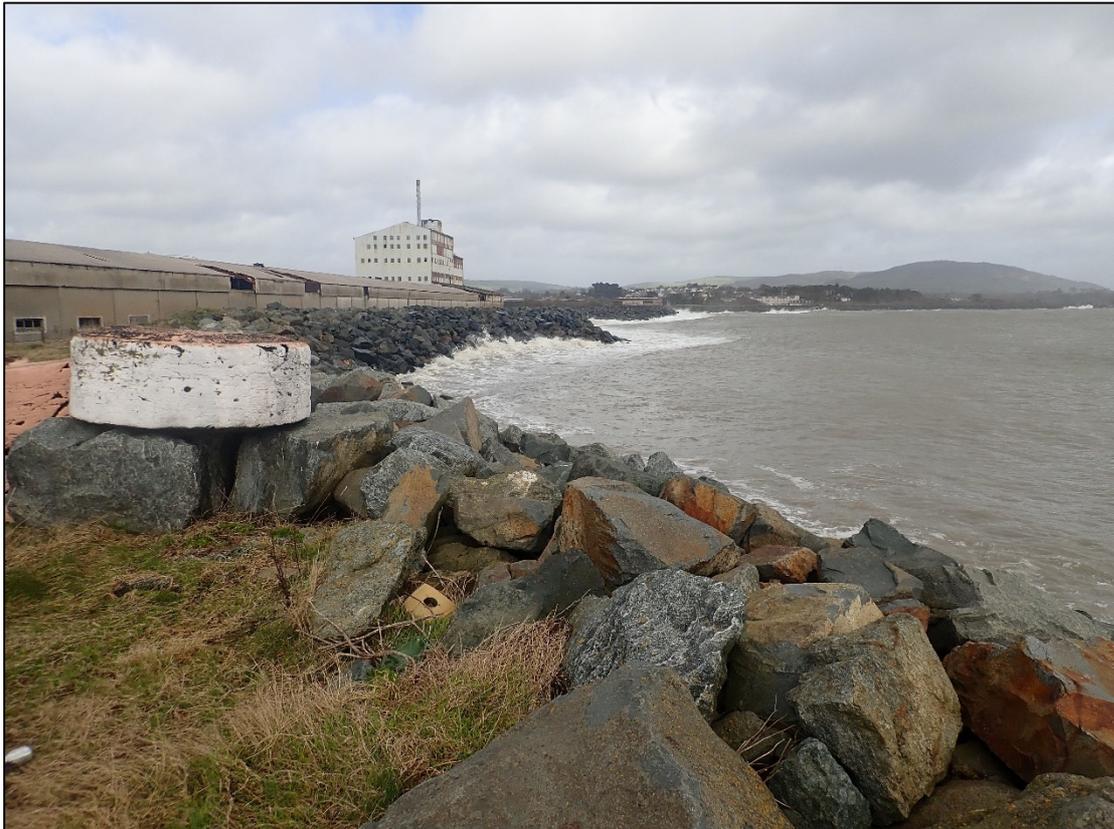
**Plate 1:** View looking north from Arklow Harbour at the rock-armoured foreshore from which the marine outfalls will extend.

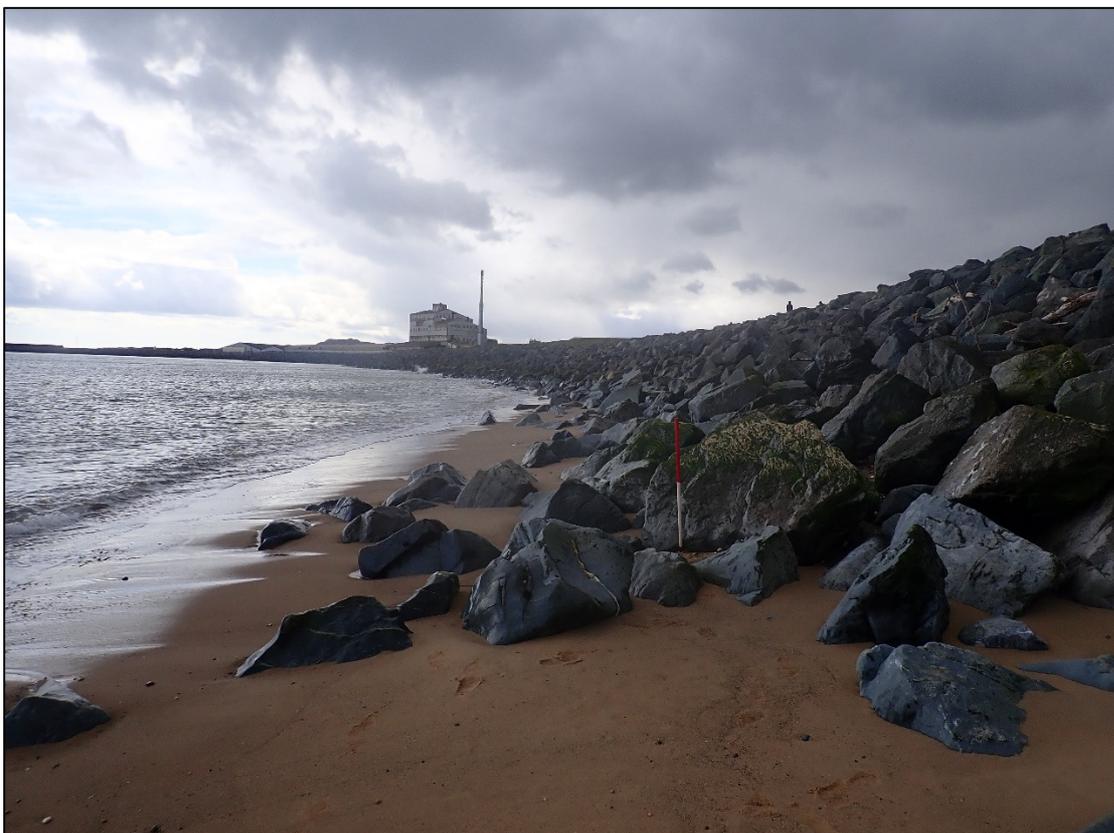
**Plate 2:** View looking south along toe of the rock-armoured foreshore at Low Water.

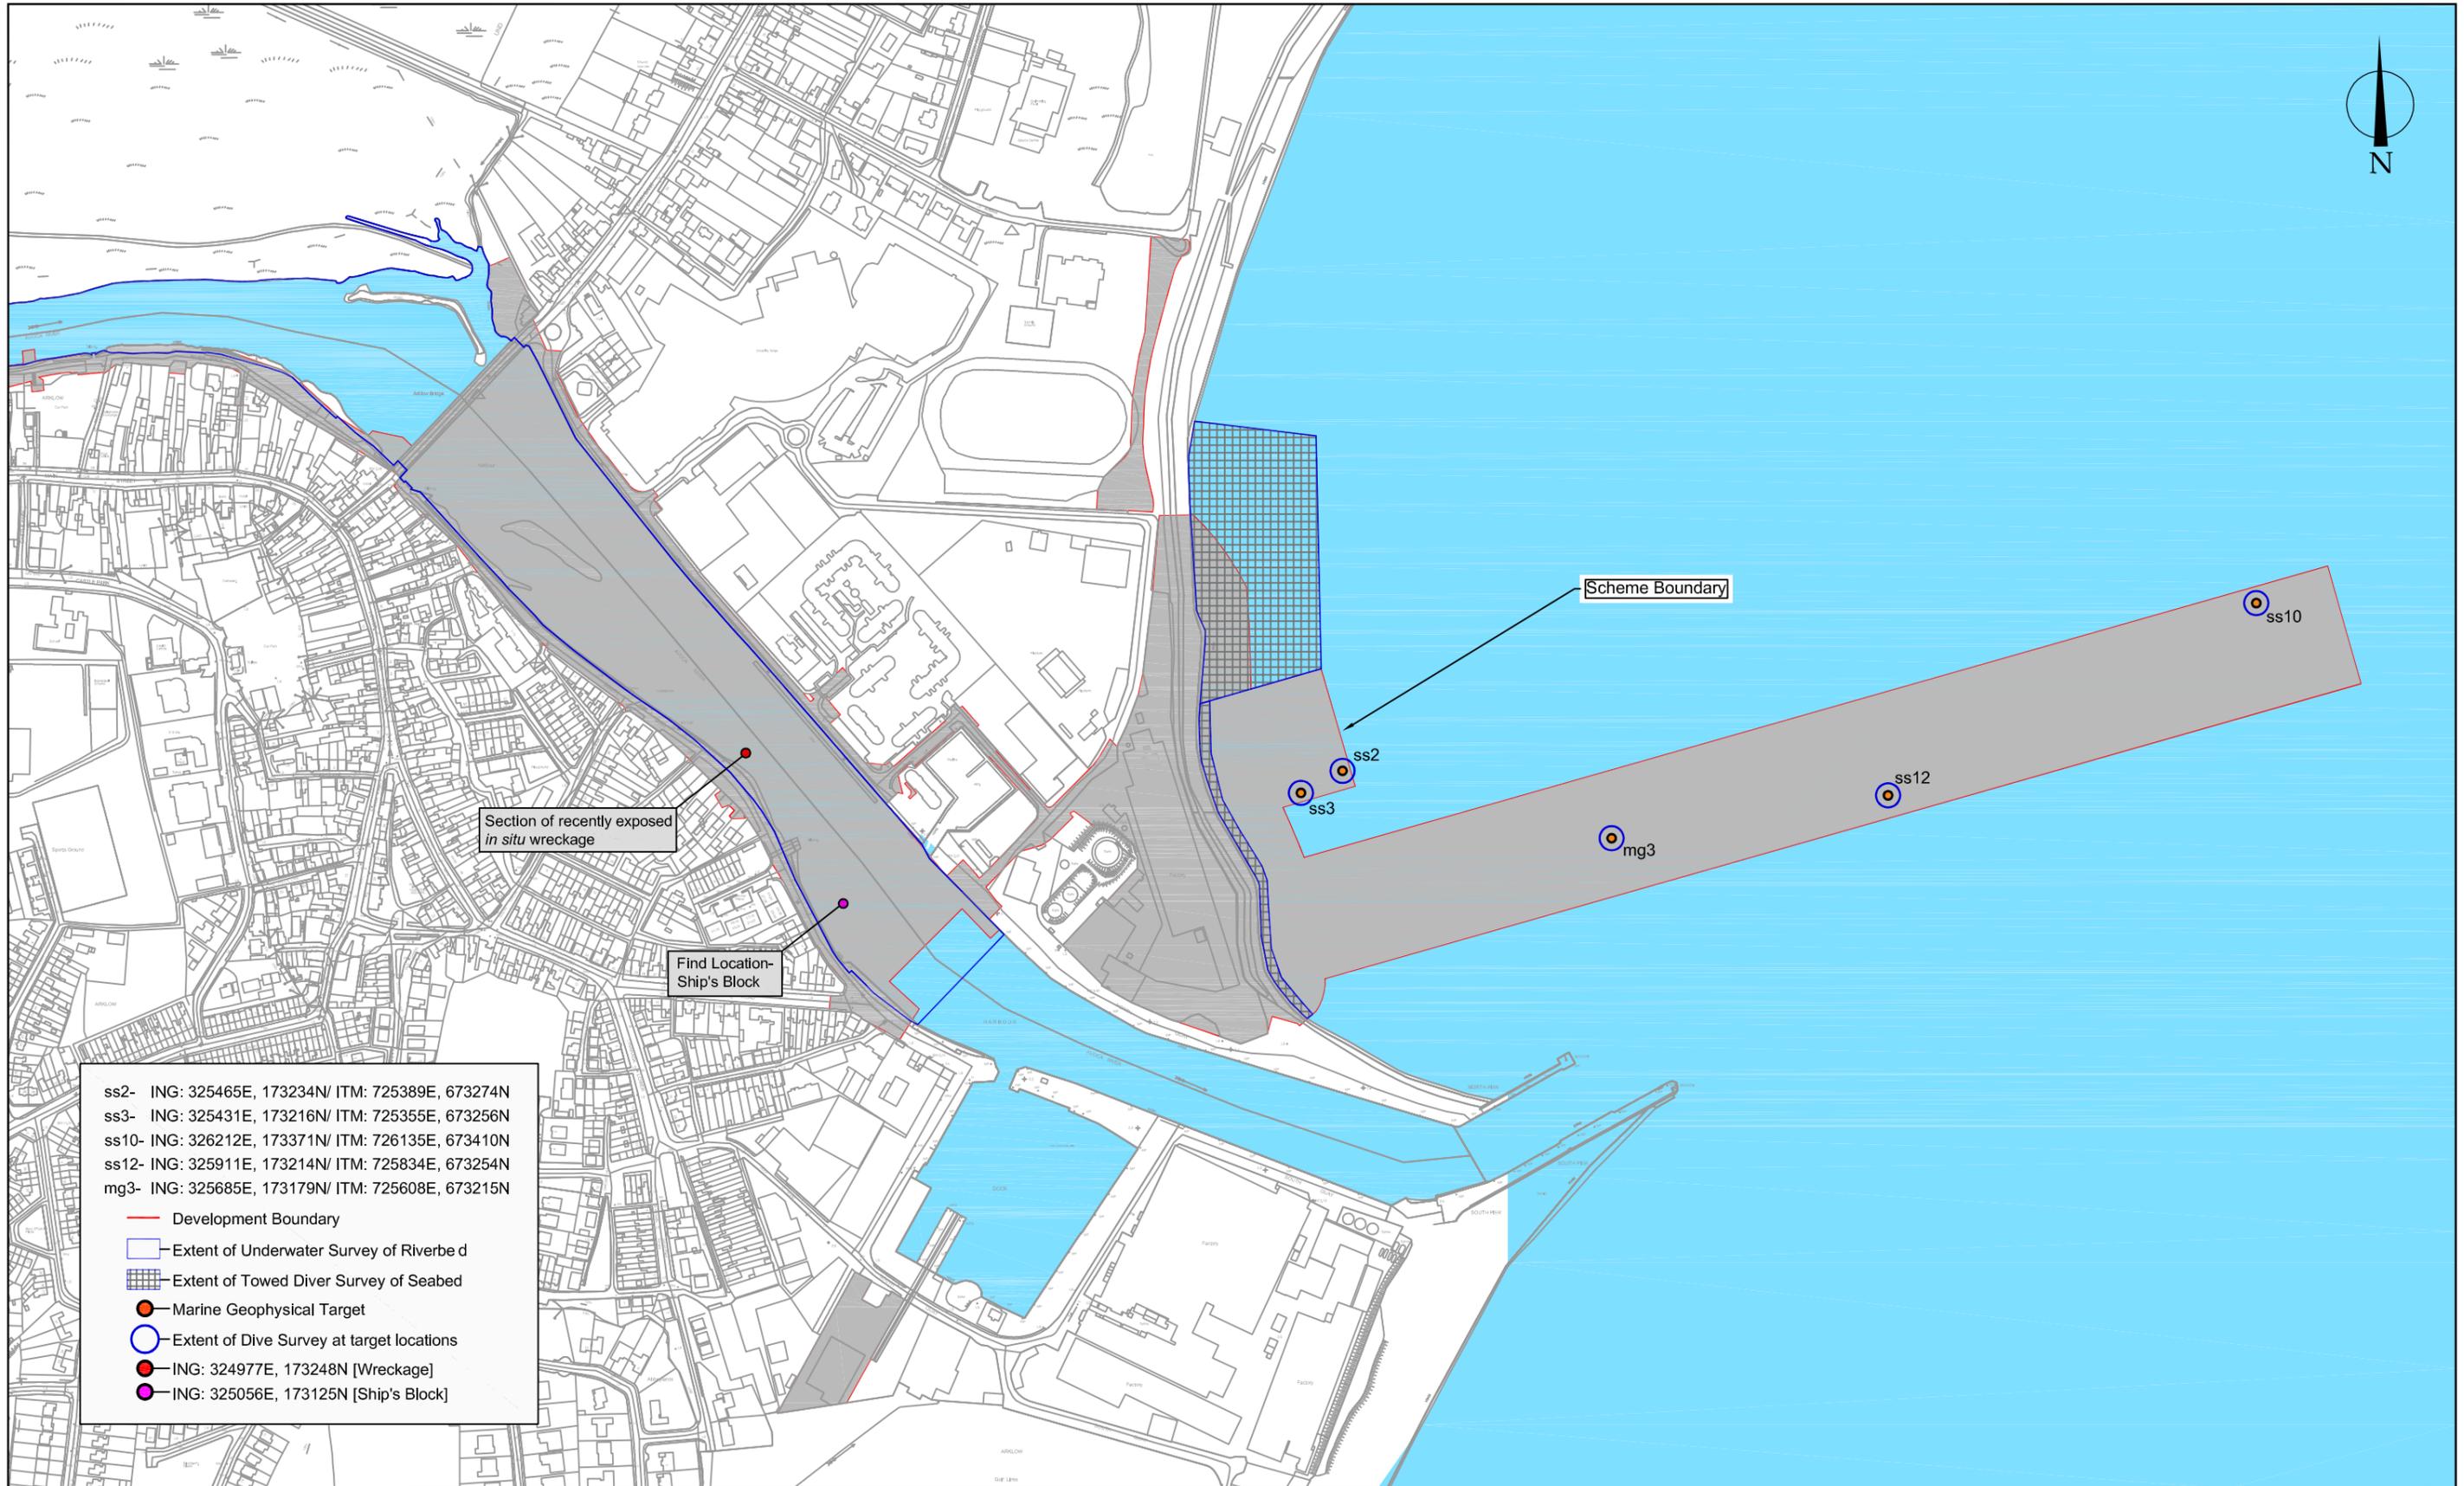
Side-scan sonar anomaly ss2, as indicated in Table 1, was considered in the geophysical survey report to be two conjoined tyres. The dive inspection identified a length of scrap metal in this location and determined that it was piece of an I-beam.

Anomaly ss3 was formerly considered to be a small rock. Dive inspection determined it was a modern metal stake, measuring 180-200mm high, and 40mm in diameter.

Anomaly ss10 was thought to be rock but dive inspection observed it to be a man-made box steel piece, much of which is buried in the surface sand. It lies 8-1-m away from the charted downline.

Anomaly ss12 was also thought to be rock. Dive inspection did not observe any particular object here but did record a dynamic seabed with sand undulations measuring between 1m and 5m in width. The object may well be buried by same.

Magnetometer anomaly mg3 was inspected because it lies on the route of the longer proposed outfall. A length of wire/steel cable was identified in this location.

There are two new observations to highlight within the main channel of the Avoca downstream of Arklow Bridge (Figure 5). A ship's block constructed of wood was noted within the channel at a location upstream of the harbour, at ING 325056E 173125N, while a section of ship or boat wreckage was located a little upstream at ING 324977E 173248N, next to an existing foul outfall. The section of wreckage is an archaeological constraint and will need to be resolved in advance of works proceeding at this location.

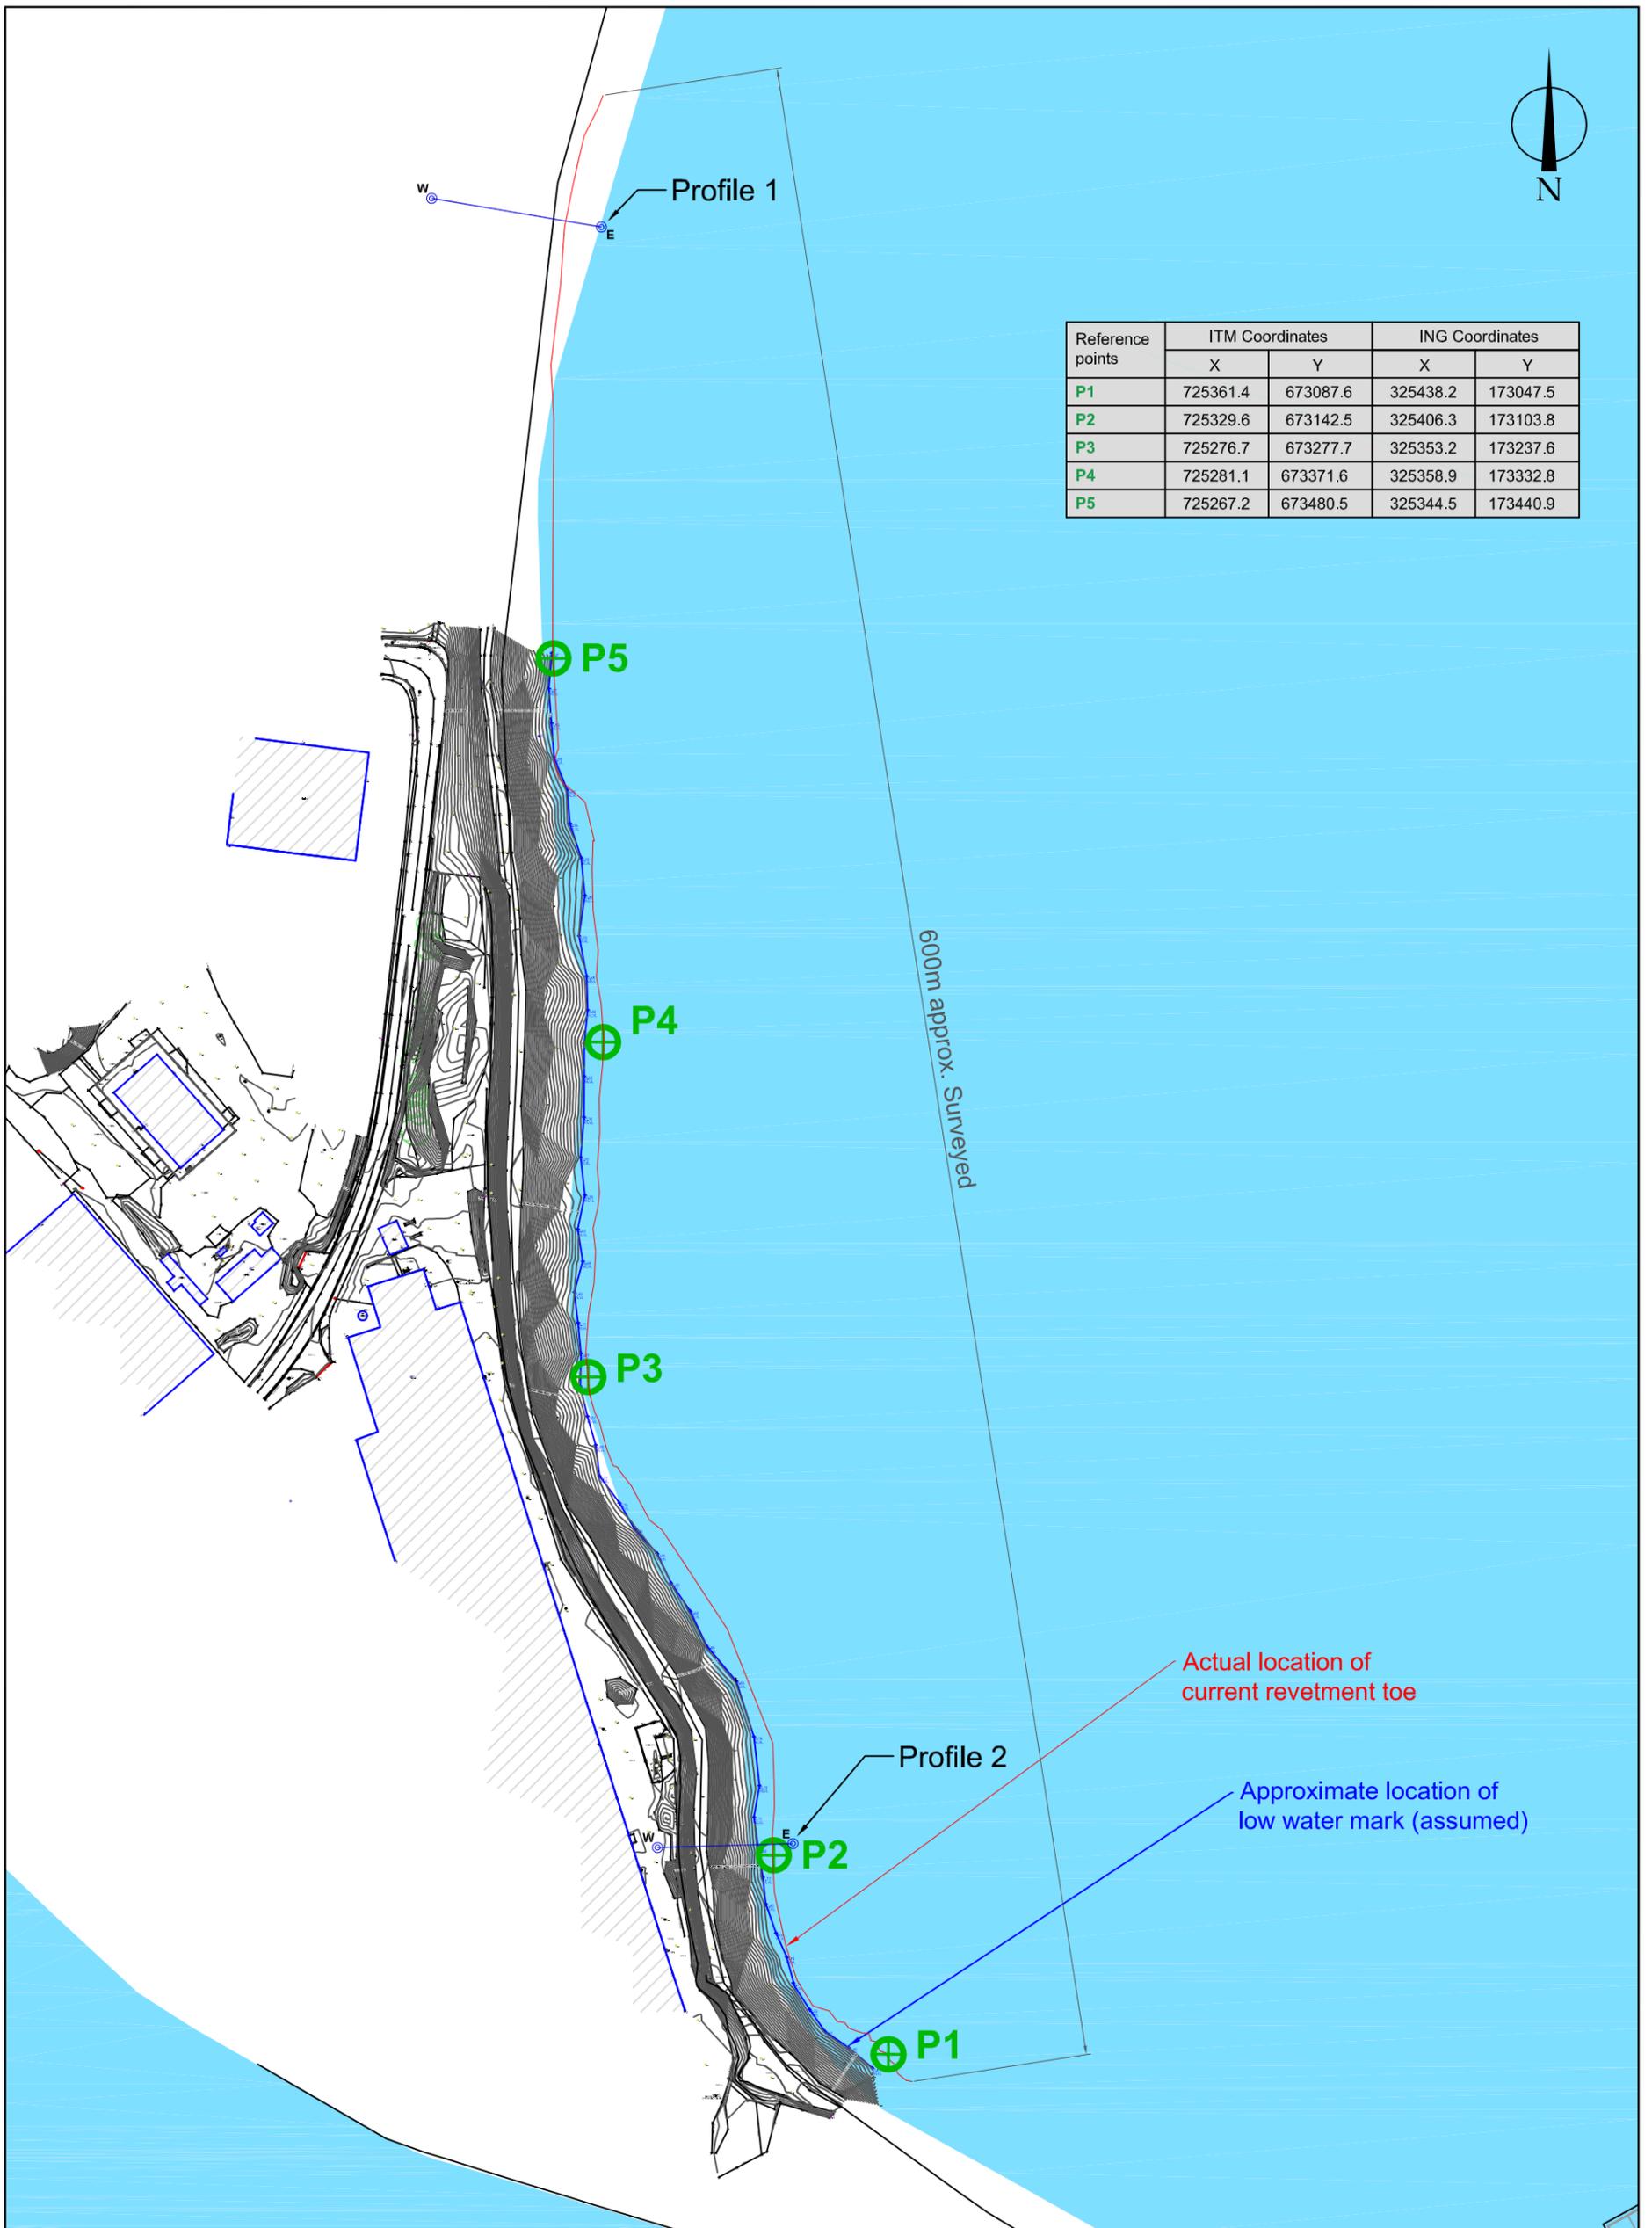
**Title**  
Figure 6- DGPS Survey undertaken along toe of Rock Armour.

The rock armour that extends north from the harbour and along the shoreline in front of the former industrial complex is a substantial feature that is constructed to combat aggressive easterlies and south-easterly storms. It is tightly fashioned, with little evidence of creep or displacement. The natural topography to its east/seaward side is defined by flat sand, which runs up directly to the rock armour and buries its full toe.

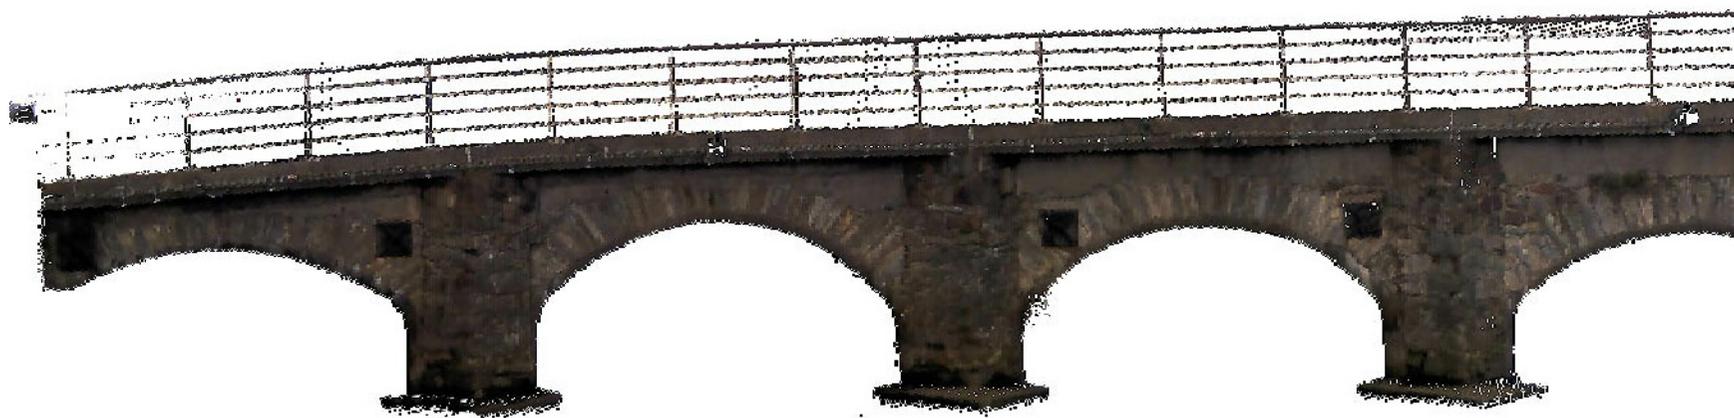
**Title**  
Figure 8- Laser-scan imagery of southernmost arches of Arklow Bridge; taken on its downstream side.

Arklow Bridge was surveyed in detail and a comprehensive record of its elements is being compiled. Figure 8 presents a laser-scan image of the bridge's downstream elevation at its southernmost arches. In addition, the structural levels under the waterline were recorded using a Total Station and it is anticipated that this will provide a comprehensive and metrically accurate record of the standing structure.
