Annual Environmental Report

Edgeworthstown

D0098-01

BIOLOGICAL WATER QUALITY ASSESSMENT OF THE RIVER BLACK, EDGEWORTHSTOWN, CO. LONGFORD (2023)

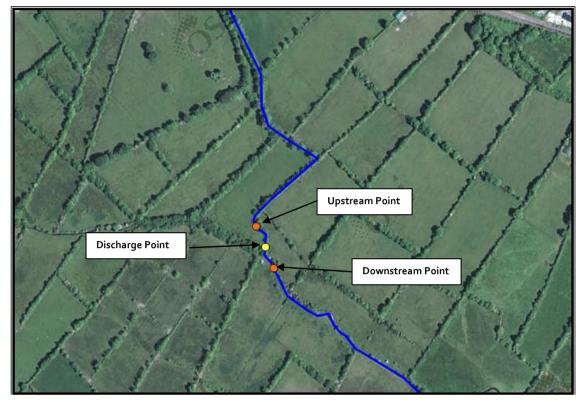
Figure 1 – Location of Sampling Points on the River Black

Biological water quality assessment was carried out at two separate locations on the River Black, both upstream and downstream of the effluent discharge point. These locations are summarised in Table 1 and illustrated in Figure 1.
