# Annual Environmental Report

2023

Kilmuckridge

D0161-01

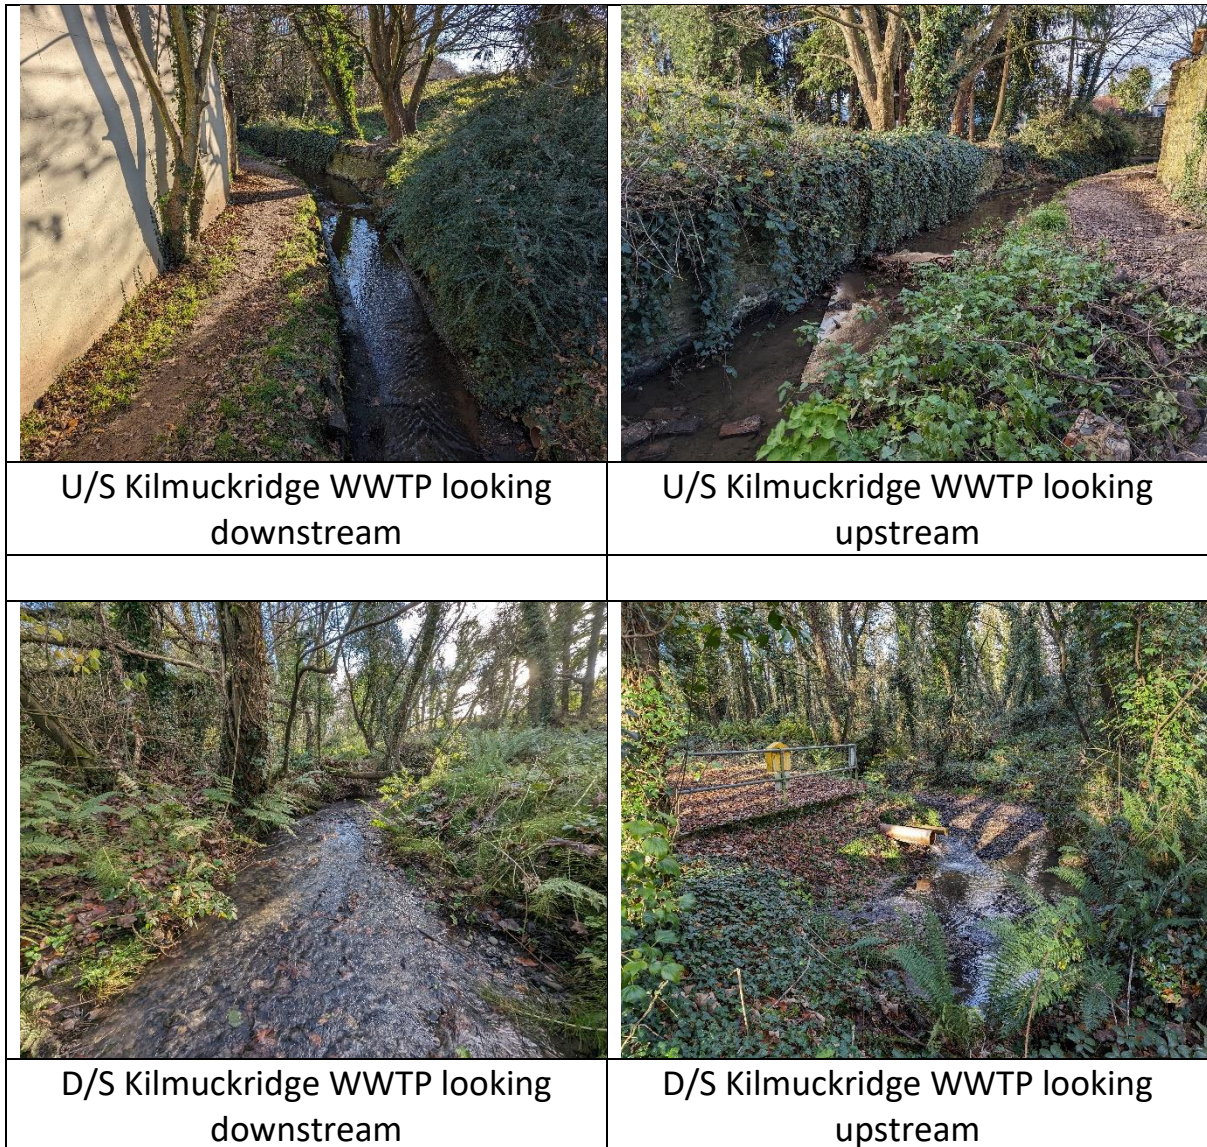
**Figure 2. Upstream (U/S) and downstream (D/S) of Kilmuckridge WWTP.**

Figure 2 shows photographs taken at Site 1 and Site 2 upstream and downstream of the Kilmuckridge WWTP on 5 December 2023, taken when sampling.

The upstream site was dominated by *Asellus* and Tubificidae were numerous. Both are highly tolerant of organic pollution. The presence of the red ‘blood worm’ *Chironomus* also indicates very poor conditions. The SSRS score of 1.6 is very low and the Q-Value assigned was Q2 – indicating Bad Status upstream of the WWTP discharge. The site downstream of the WWTP discharge once again had excessive numbers of *Gammarus* with numerous blackfly larvae Simuliidae and *Baetis rhodani*. The score was higher than the upstream site at an SSRS of 2.4 and a Q-value of Q2-3. This further emphasises the very poor condition of the stream in the village of Kilmuckridge upstream of the WWTP. As indicated in the 2022 report on Kilmuckridge, this does not necessarily mean that the WWTP has little impact on the stream.

The Litter More River was once again in very poor condition in Kilmuckridge village upstream of the Kilmuckridge WWTP discharge. The pollution source may be agricultural or industrial – investigative assessment is needed to source the cause. Downstream of the WWTP discharge the stream was in better condition than at the upstream site although still in poor condition. It is difficult to assess the extent of the impact of the WWTP due to the stream’s bad status upstream. On the day of sampling a maintenance team were repairing a set of gears in the WWTP’s oxidation ditch. The plant hadn’t been working properly for the past few days.
