Greater Dublin Drainage Project Addendum

**Environmental Impact Assessment Report Addendum:
Volume 3A Part B of 6**

Appendix A9.1 Marine Habitat Assessment Survey Report

Uisce Éireann

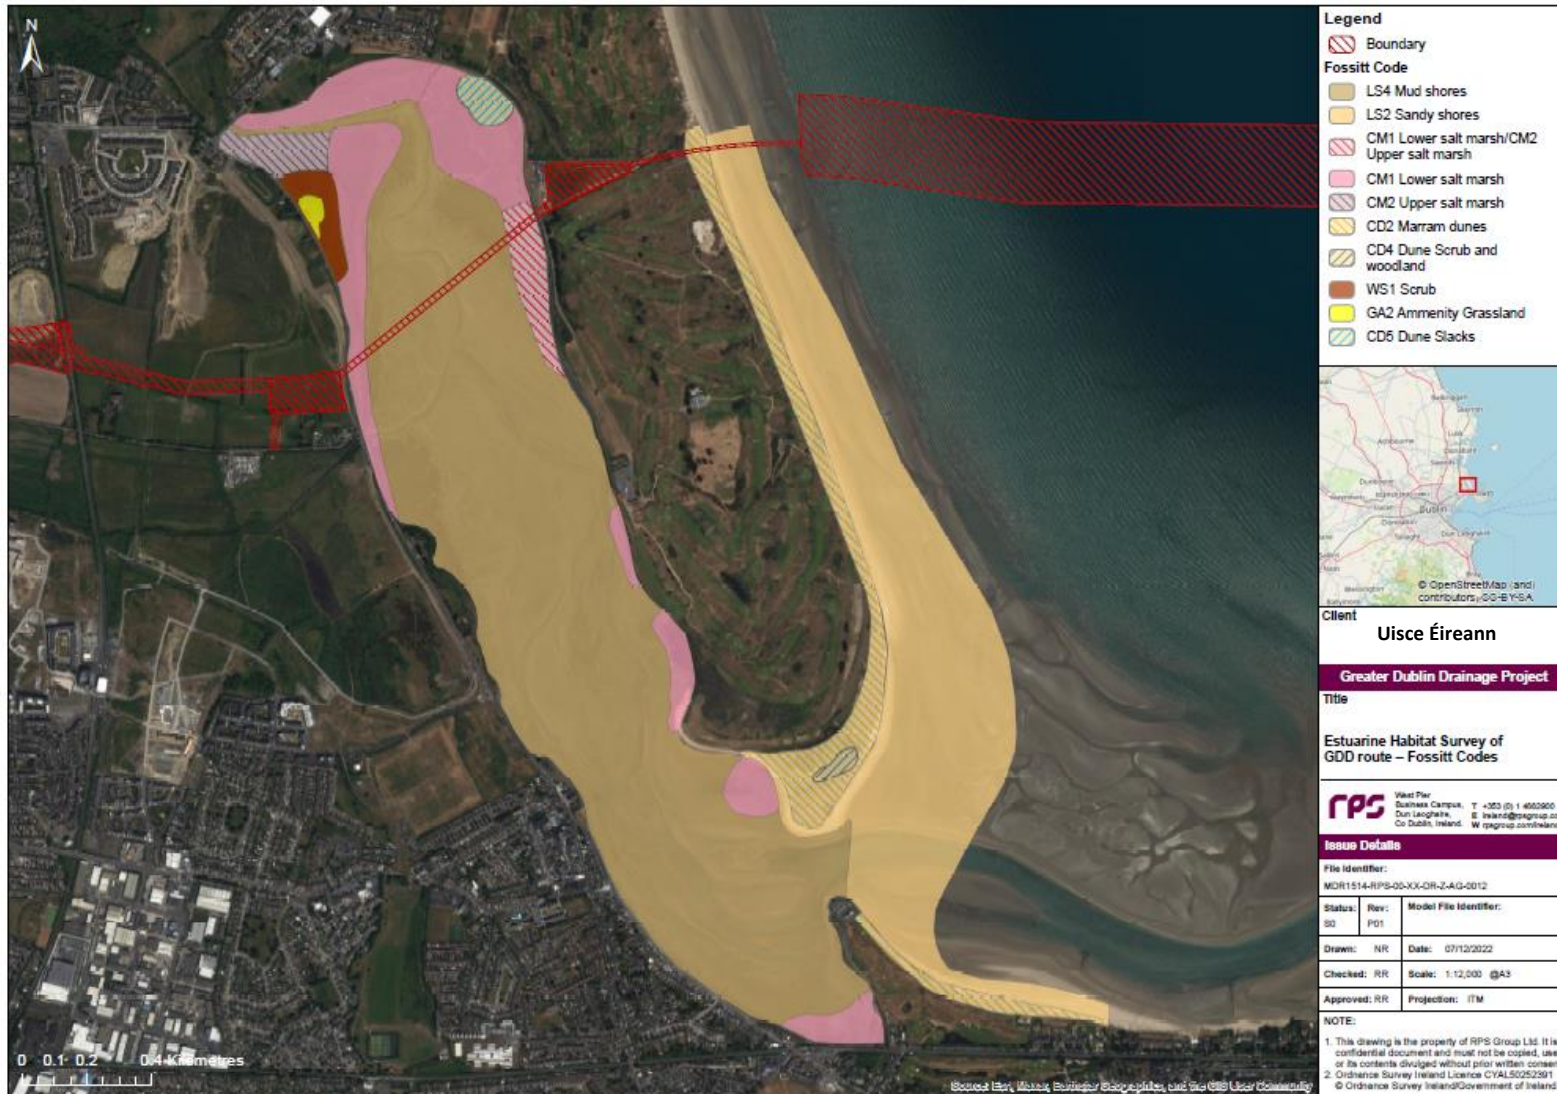
Figure 5.1: Habitat Map of the Fossitt Habitats of Baldoyle Estuary (Based on 2022 Update Survey)

This Section should be read with reference to Figure 5.1 Habitat Map of the Fossitt Habitats of Baldoyle Estuary, Figure 5.2 Habitat Map of Annex I habitats of Baldoyle Estuary, and Figure 5.3 Habitat Map of Annex I Habitats of Baldoyle Estuary prepared by McCorry and Ryle (McCorry and Ryle 2009), and review notes from 2013 revisit survey (Appendix A9.1 of the 2018 EIA submission).

The previous study reported a wider extent of Atlantic salt meadow directly above the proposed outfall pipeline route (marine section), which in the 2022 survey was dominated by *Spartina* swards and only extended into Atlantic salt meadow at the uppermost section of the marsh. Overall, the extent of Mediterranean salt meadow remained broadly unchanged since the previous survey. Some of the species recorded in the previous survey, such as common scurvy grass (*Cochlearia officinalis*) and sea pink (*Armeria maritima*) were not encountered in the 2022 survey.

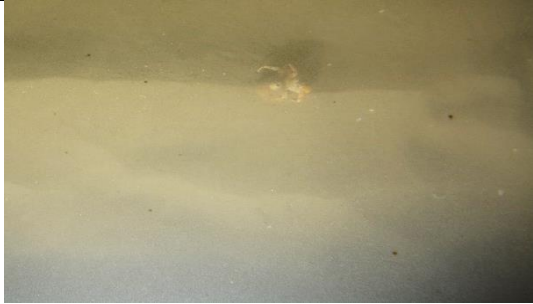
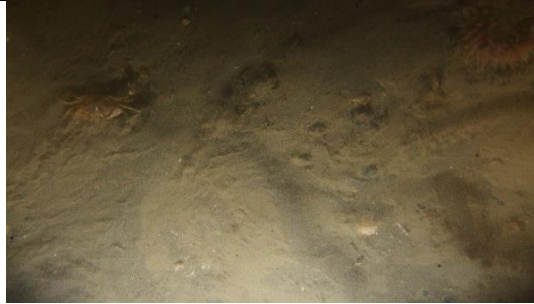
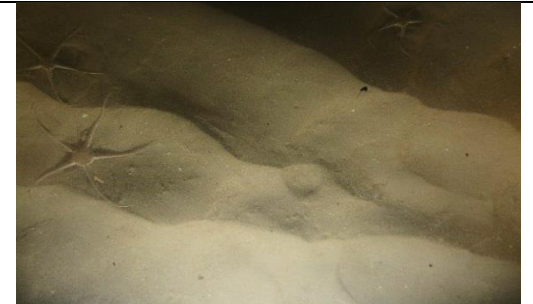
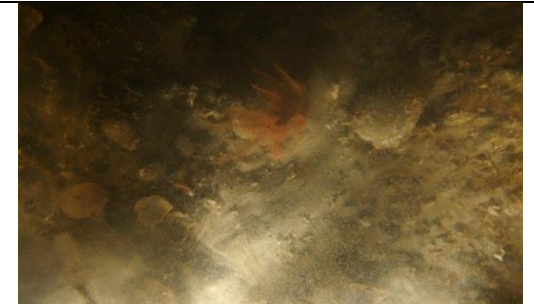
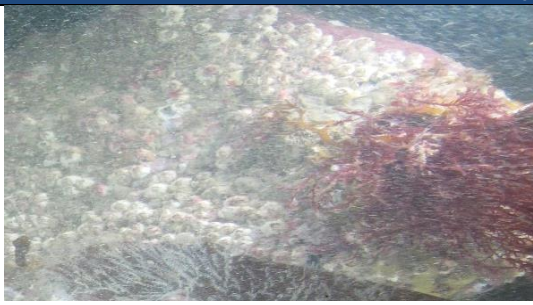
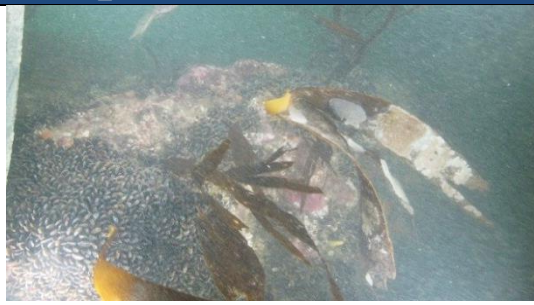
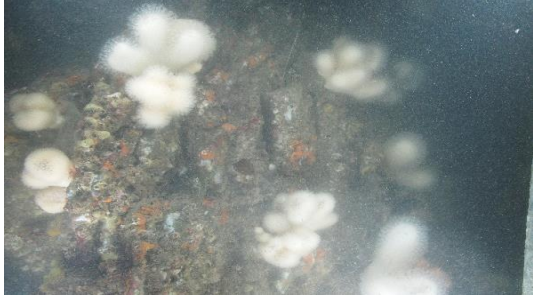
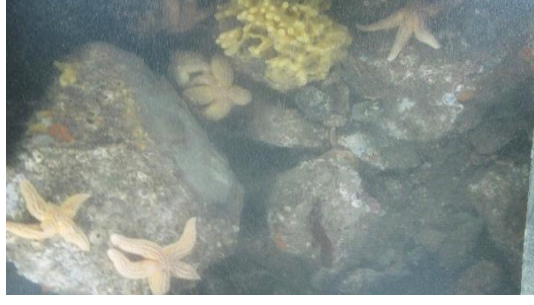
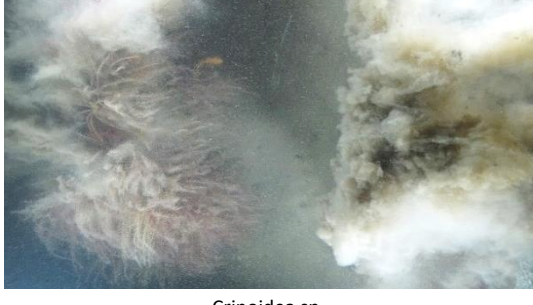
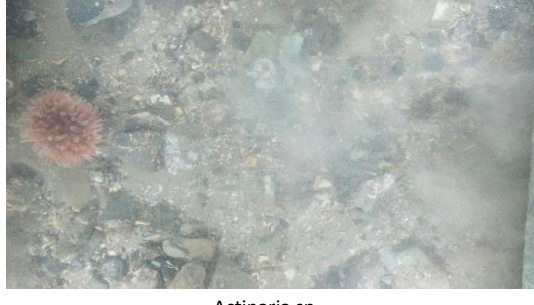
Figure 5.4: Examples of Conspicuous Fauna

Analysis of the photographic stills revealed the presence of a fine rippled sand spanning the initial approximately 1km of the proposed outfall pipeline route (marine section). Conspicuous fauna observed over this substrate type was sparse and was primarily comprised of mobile crustaceans (*Pagurus* sp. and *Pleocyemata* sp.), likely due to the high mobility of the surface sediments this close to the shore. This fine sand was replaced by sand with a minor gravel component spanning out to approximately 3km from the shore, with razor clams (*Ensis* sp.) and Ophiuroidea sp. (*Ophiura ophiura* and *Ophiura albida*) being the most dominant fauna observed (Figure 5.6). A coarser and more variable substrate to the north of Ireland's Eye spanned a distance of approximately 1km and ranged from sandy gravel to cobbles with minor variation in-between. Fishing gear was observed along this section of the proposed outfall pipeline route (marine section) with Pectinidae sp. frequently observed in addition to a notable sessile epifaunal community that included *Alcyonium digitatum*, Porifera sp., encrusting bryozoans and calcareous tube dwelling worms (Serpulidae sp.). The easternmost extent of the proposed outfall pipeline route (marine section), spanning a distance of approximately 0.5km from the proposed marine diffuser location, was also classified as gravelly sand; albeit with a higher gravel component reflected by the presence of sporadic sessile epifauna including *Actinaria* sp., Porifera sp. and *Alcyonium digitatum*. Example images of conspicuous fauna observed along the proposed outfall pipeline route (marine section) are provided in Figure 5.4.

Areas of flat and sloping bedrock were observed to the north (S1) and south-east of Ireland's Eye (S3 and S4) as well as immediately to the south (ENV_27), with boulders typically in close proximity. Exposed rock was often heavily encrusted with sessile epifauna including barnacles (*Cirripedia* sp.), encrusting bryozoans, anemones (*Actinaria* sp.), encrusting and erect sponges (*Porifera* sp.), dead man's fingers coral (*Alcyonium digitatum*), red seaweeds (*Rhodophyta* sp.) and kelp (*Laminaria* sp.). However, in some areas, notably transect S3, high levels of siltation were apparent which led to an obvious reduction in the quantity and range of sessile epifauna. Mobile epifauna observed across the areas of bedrock and boulders consisted predominantly of the velvet crab (*Necora puber*) and the common starfish (*Asterias rubens*), with aggregations of feather stars (*Crinoidea* sp.) observed in some instances. Areas of fine sand featuring varying levels of shell fragments were found to the north of Ireland's Eye and were characterised by sparse conspicuous fauna with the occasional common starfish (*Asterias rubens*) and encrusting sessile epifauna such as calcareous tube dwelling worms (*Serpulidae* sp.) and encrusting bryozoans in areas featuring higher concentrations of shell fragments. Finally, a mixed mosaic of fine sands, shell fragments and rock fragments interspersed between areas of boulders and bedrock was apparent across transect ENV_27. Exposed rock fragments were often heavily encrusted with barnacles (*Cirripedia* sp.) and calcareous tube dwelling worms (*Serpulidae* sp.) as well as encrusting bryozoans, whilst areas of coarse shell fragments were typically associated with the presence of anemones (*Actinaria* sp.). Example images of conspicuous fauna observed across the Ireland's Eye survey area can be found in Figure 5.4 and Figure 5.6.

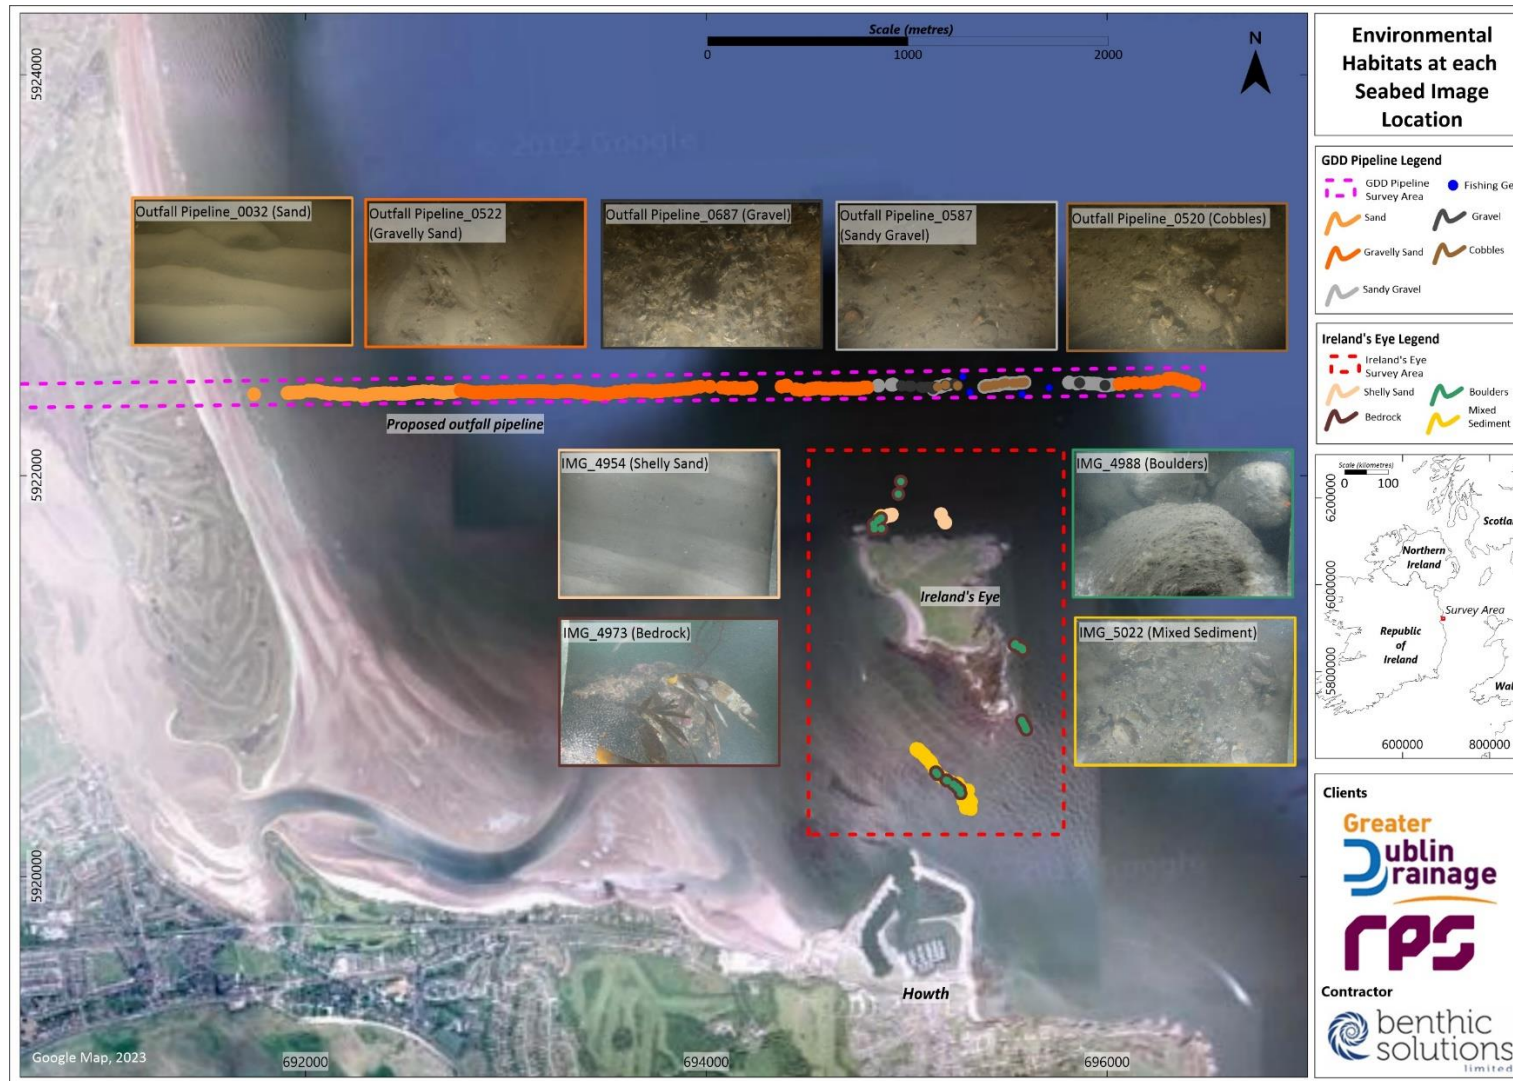
Figure 5.5: Summary of Environmental Habitats at each Seabed Location

Using the seabed substrate categories outlined in Table 5.1, it was possible to delineate sections of camera transects characterised by different substrates, with an overview for both survey areas displayed in Figure 5.5.

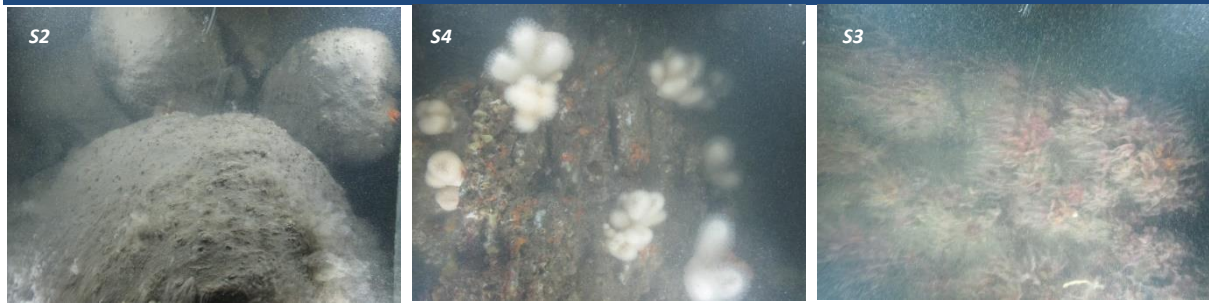
The recent survey visit carried out at each of the sublittoral reef sites has allowed for observations at the deeper parts of each sublittoral transect but only obtained intermittent results close to the shoreline and cliffs due to limited vessel access or steep seabed gradients. As with the previous surveys, two sites were located beneath the steep cliff face of the northern coast of Ireland's Eye (S1 and S2), and two located adjacent to the rocky shorelines in the south-east of the island (S3 and S4). Habitats and biotopes at the sublittoral stations were characterised by *Laminaria digitata* forests in the shallower part and replaced by the biotope 'Foliose red seaweeds with dense *Dictyota dichotoma* and/or *Dictyopteris membranacea* on exposed lower infralittoral rock'. The deeper extent was dominated by a 'Mixed turf of bryozoans and erect sponges with *Sagartia elegans* on tide-swept circalittoral rock' or in the case of Sublittoral S2, '*Flustra foliacea* and colonial ascidians on tide-swept moderately wave-exposed circalittoral rock'. The deeper biotope at Sublittoral S4 was categorised as possible '*Polyclinum aurantium* and *Flustra foliacea* on sand scoured tide-swept moderately wave-exposed circalittoral rock'. The 2023 survey confirmed a high level of suspended sediment within the water column and areas on the rocky reef substrate and confirmed high levels of sedimentation and silt burden both on open rocky surfaces as well as within the faunal swards (Figure 6.3).

Figure 6.3: Seabed Camera Observations Show Example Images Taken in High Water Turbidity Showing Heavily Silted Boulders (S2), Soft Corals on Bedrock (S4) and Heavily Silted Foliose Red Algae (S3), January 2023

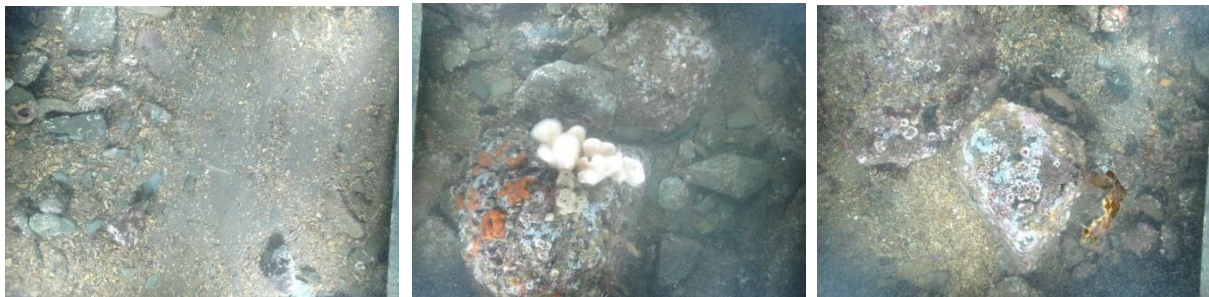
Figure 6.4: Seabed Camera Observations From Reference Site Station 27, Showing Silty Sands and Gravels (Left), Boulders with Occasional Soft Corals (Middle) and Boulders Punctuated by Biogenic Sands (Right), January 2023

As with the 2012 survey, the site was only investigated using photography in 2023. Images confirmed the presence of a heterogeneous seabed made up of mixed sandy gravels and areas of weathered bedrock and boulders punctuated by areas of biogenic sands and gravels. Close inspection of these granular pockets indicated a biogenic sand composed predominantly of dead shell fragments rather than that of dead maerl algae, although the presence of this substrate cannot be ruled out. Whilst the 2023 survey covered a significantly longer transect (i.e. 1.2km) than that previously surveyed by the drop-down video in 2012 (approximately 50m), no additional habitats of conservation importance were recorded, other than the existence of geogenic sublittoral reefs. The evidence of the 2023 survey shows that this rock habitat can be considered as a dominant component of the seabed between Ireland's Eye and Howth Harbour. An example of the range of observed habitats recorded during the current survey are summarised in Figure 5.5 and Figure 5.6.

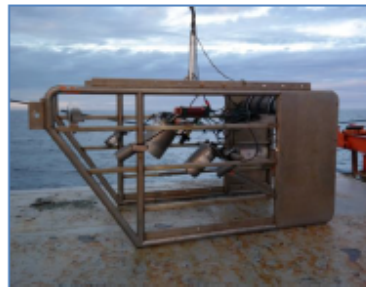
- Flexible deployment scenarios
- Depth rated to 3500m
- Superior stills and streaming video quality
- Near zero-delay shutter release
- Unattended time lapse photography
- Solutions for very low visibility environments

1. Deepwater real time
2. Shallow water real time
3. Ultra deepwater timelapse
4. Remote timelapse
