## **Appendix A16.10 Archaeological Testing Undertaken as Part of the Environmental Impact Assessment**

**ARCHAEOLOGICAL ASSESSMENT  
AT  
CLONSHAGH,  
COUNTY FINGAL**

**PART OF THE GREATER DUBLIN DRAINAGE  
PROJECT**

**IRISH WATER**

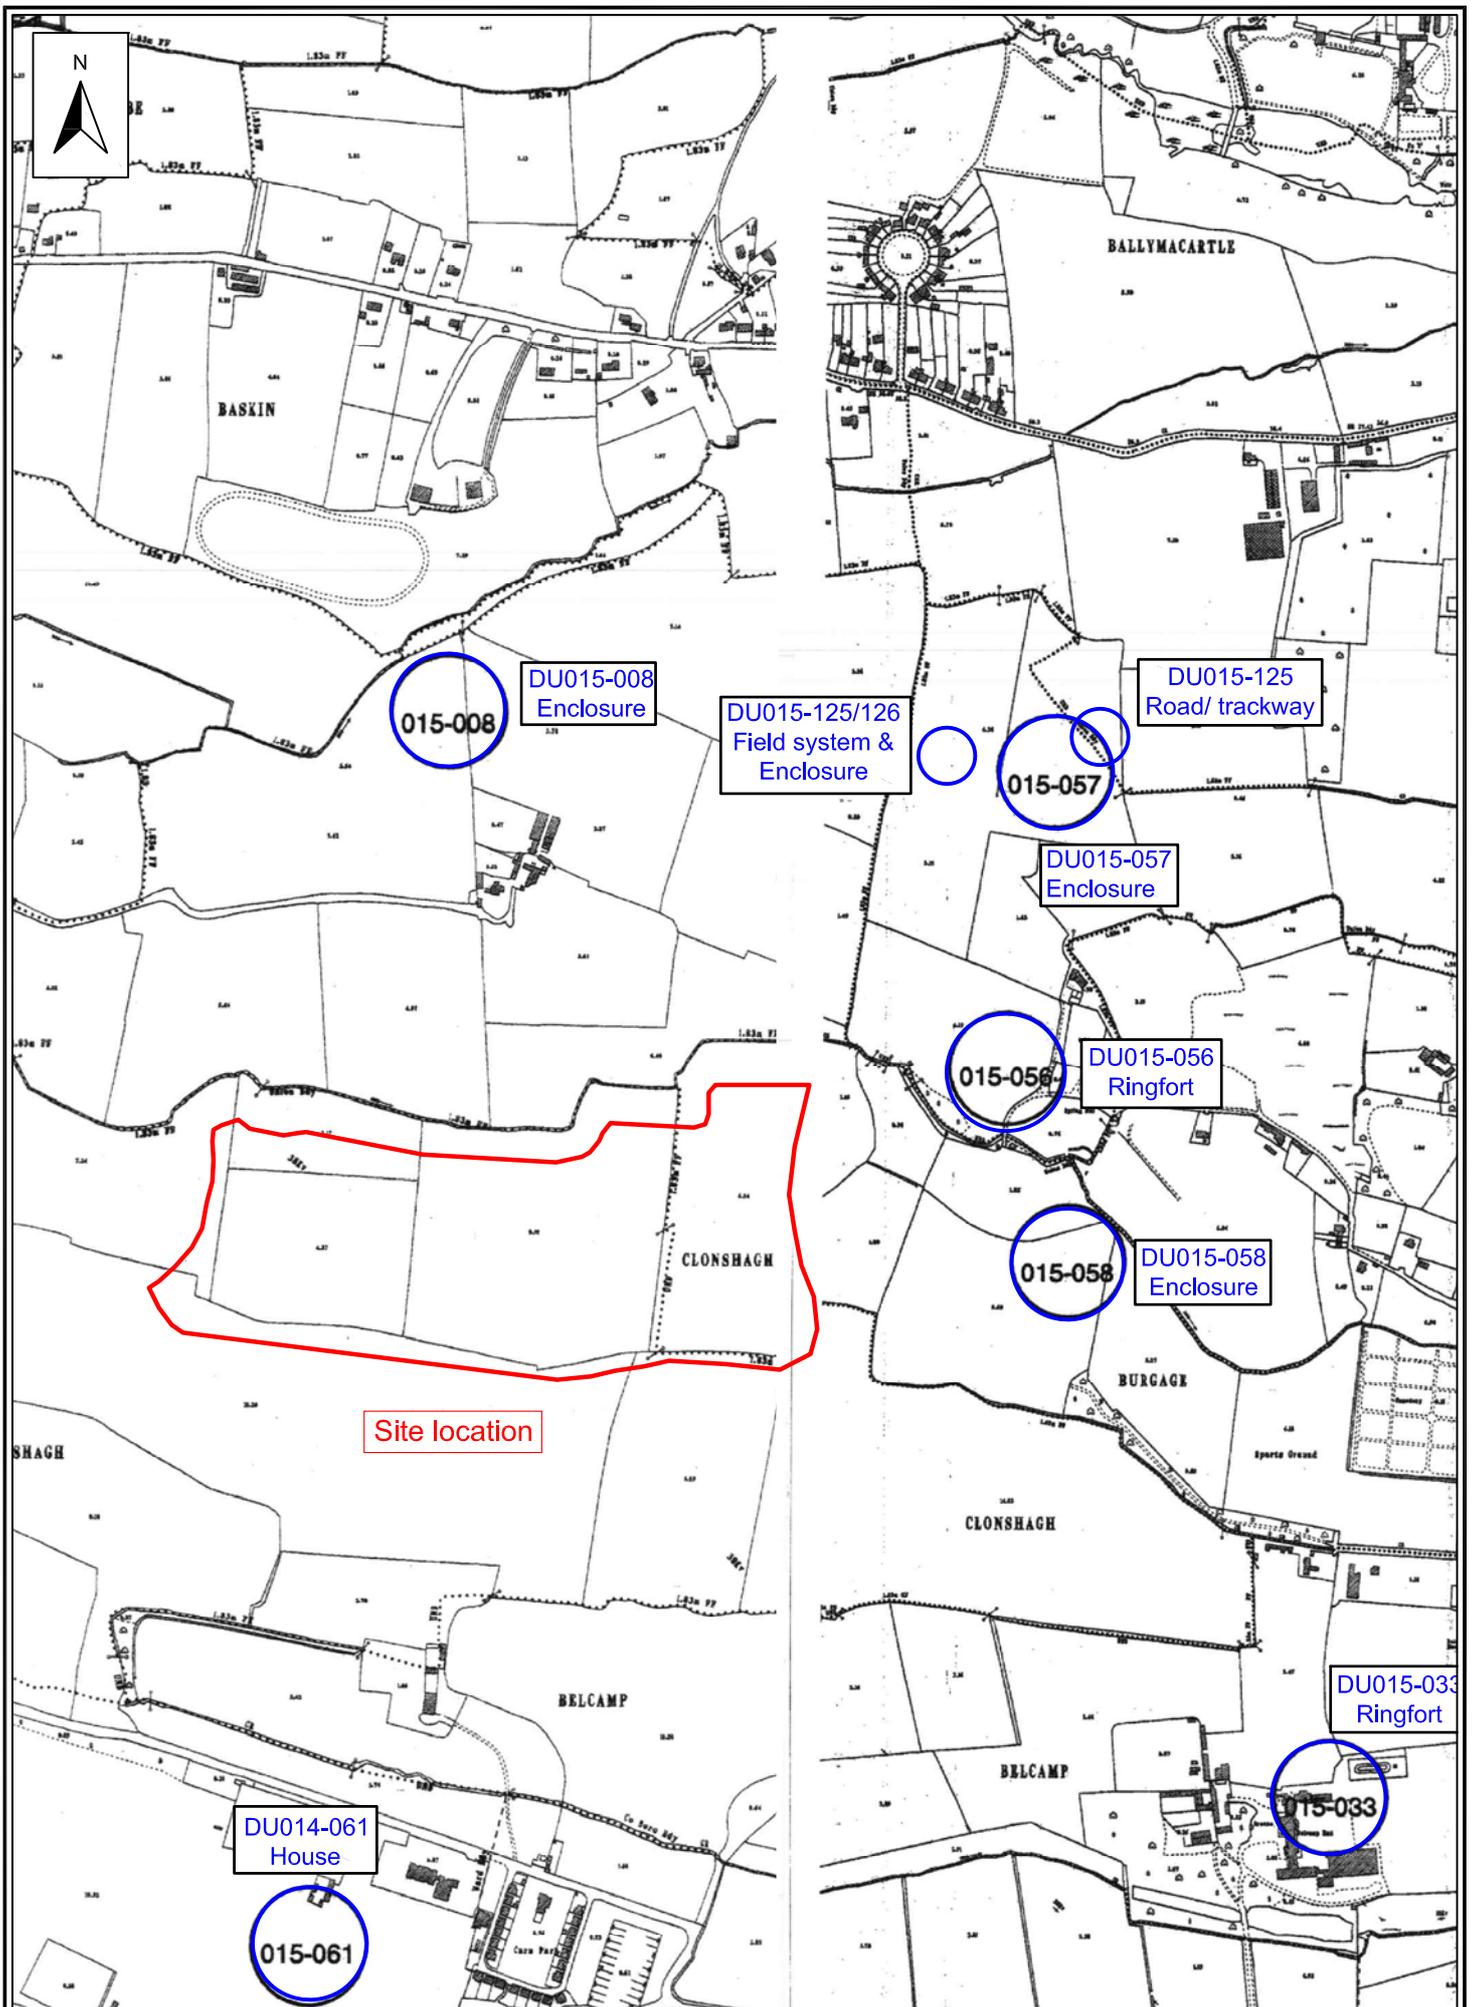
<b>Title</b>	Extract from the RMP map showing the area of proposed development	<b>Scale</b>	NTS @ A4	<b>Drawn by</b>	PD
<b>Project</b>	Greater Dublin Drainage Scheme	<b>Date</b>	17/02/15	<b>Checked by</b>	FB
<b>Client</b>	Irish Water	<b>Job no.</b>	J2664	<b>Fig.</b>	2
				<b>Rev.</b>	1

In November 2013 a number of new sites of archaeological potential were identified within the landscape surrounding the proposed wastewater treatment plant site as a result of new aerial photographic data sets becoming available on bing.com. These were added to the online SMR archive by the Archaeological Survey of Ireland ([www.archaeology.ie](http://www.archaeology.ie)) and increased the number of recorded archaeological sites within 1km of the treatment plant site from seven to 12 (Appendix 1). However, the closest recorded site to the proposed development area still consists of the recorded enclosure DU015-056 (Figure 2).

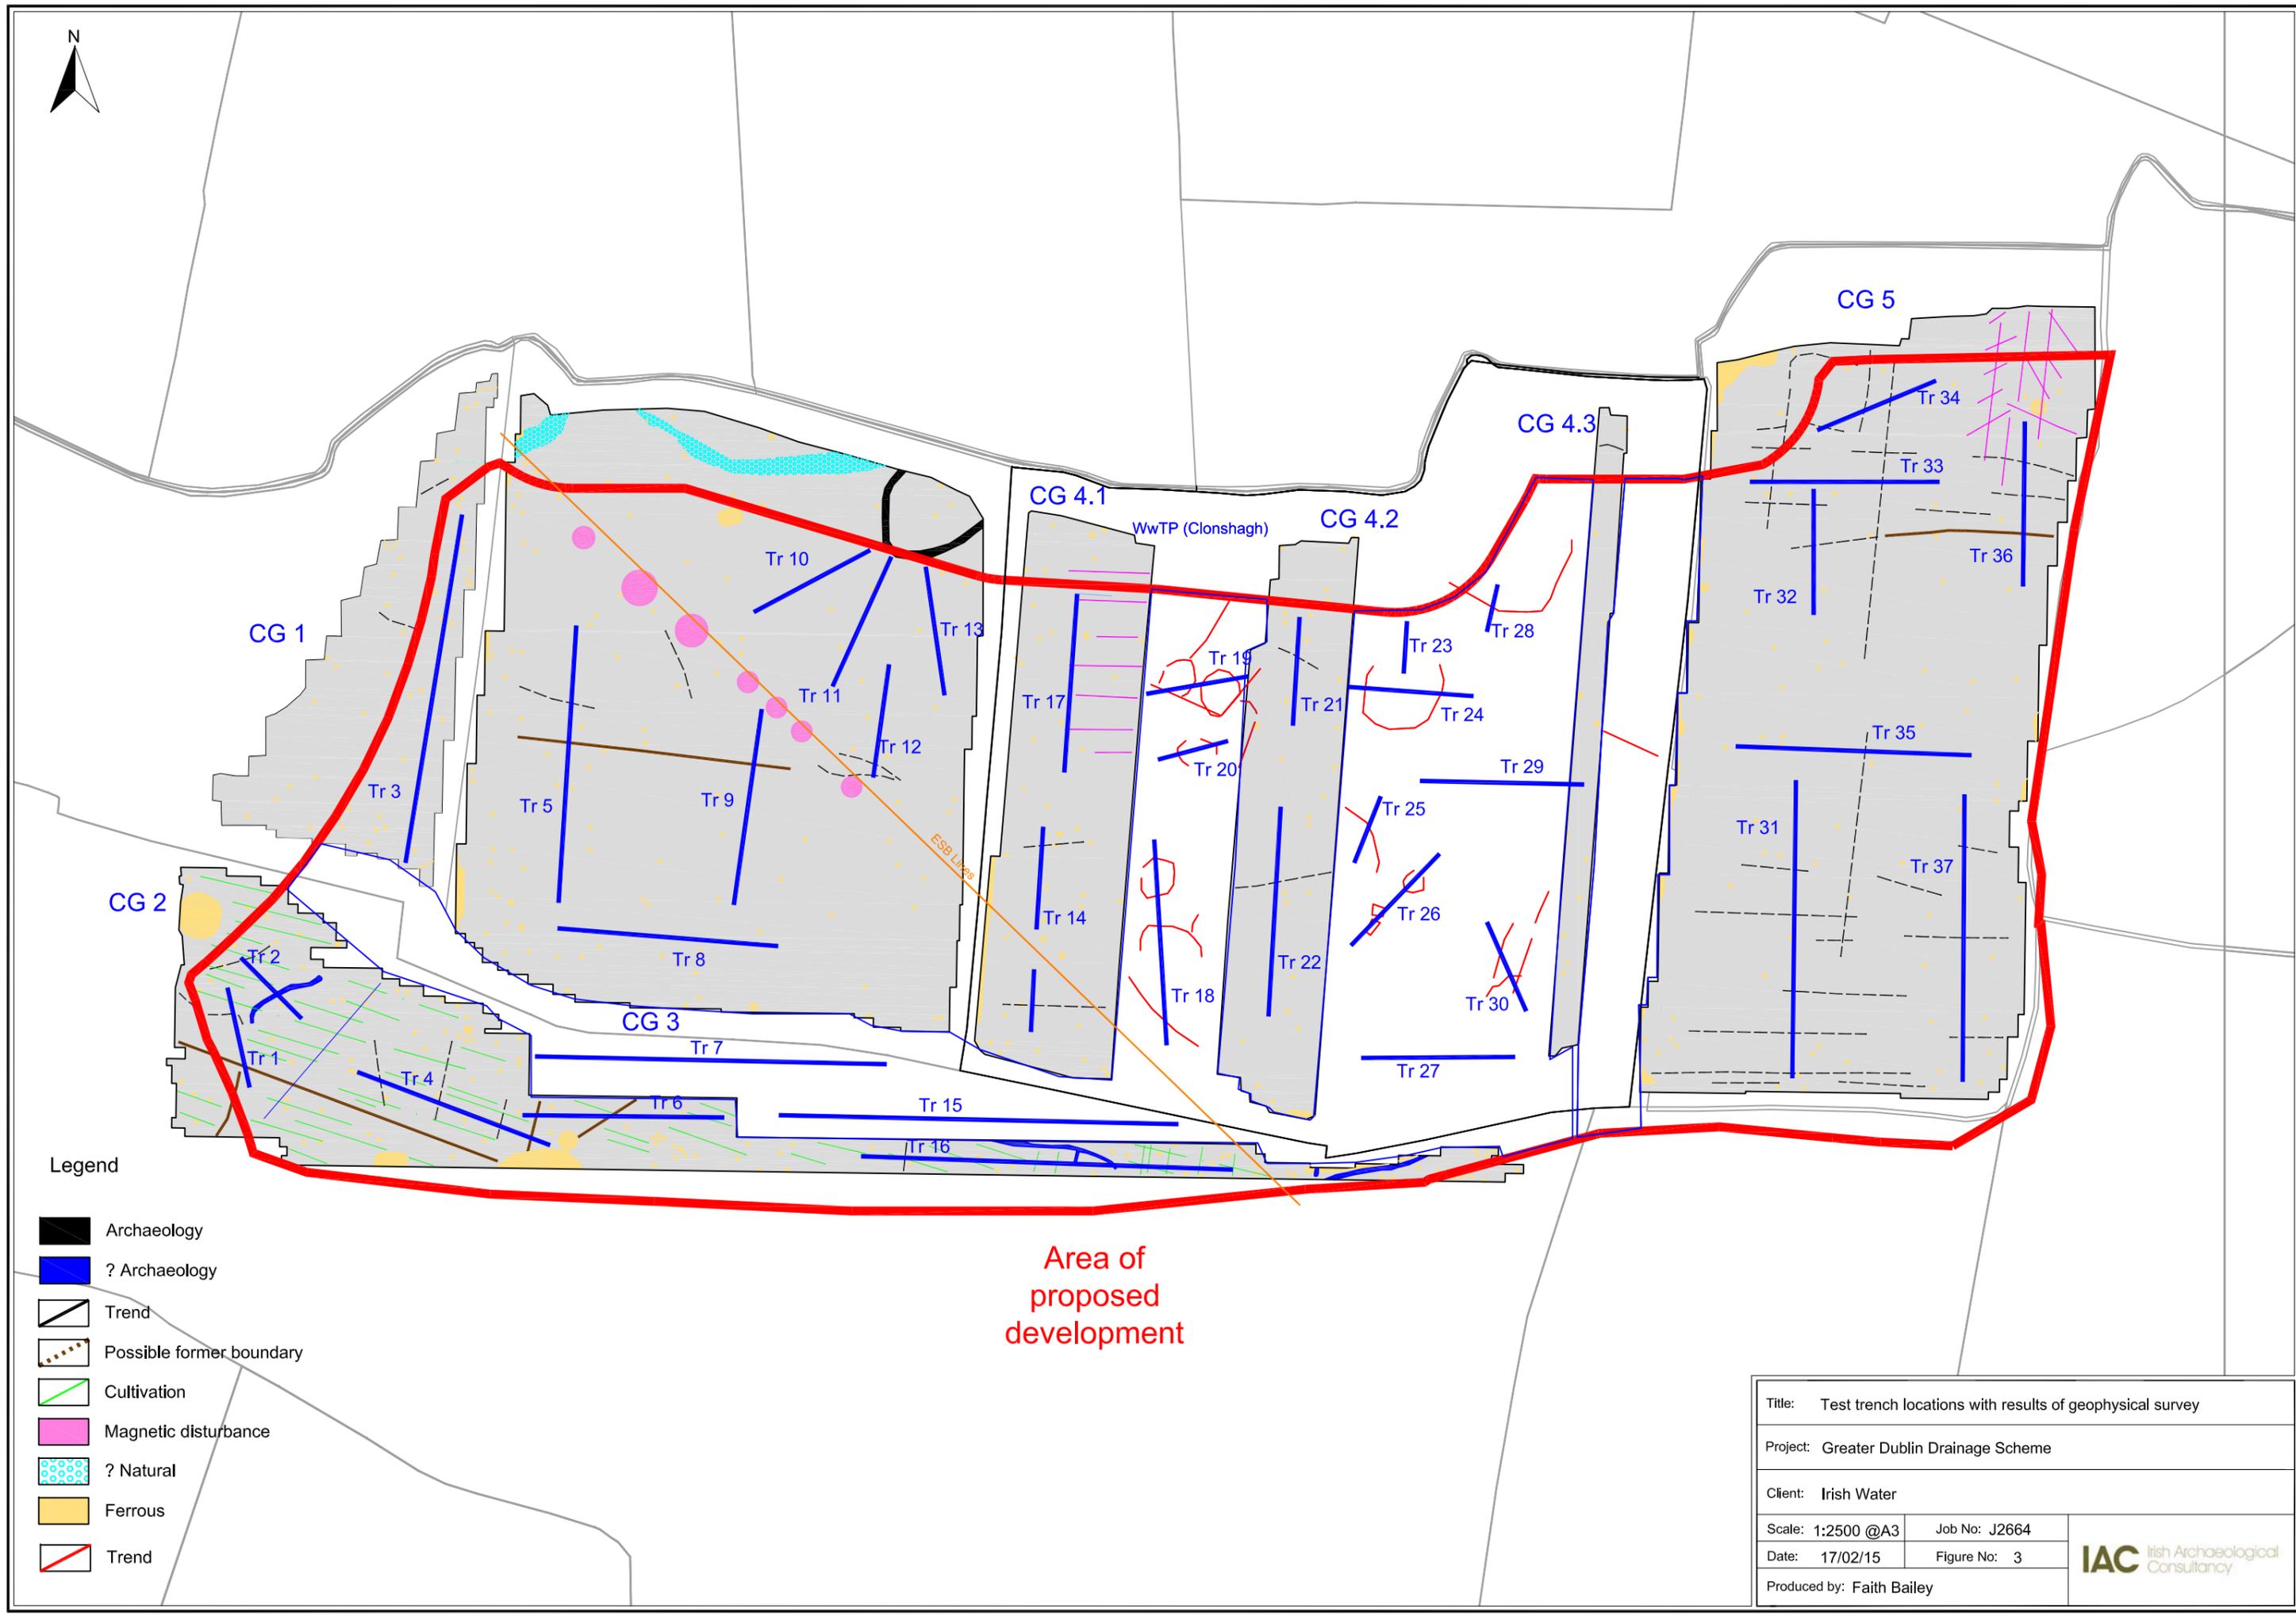
Title: Test trench locations with results of geophysical survey	
Project: Greater Dublin Drainage Scheme	
Client: Irish Water	
Scale: 1:2500 @A3	Job No: J2664
Date: 17/02/15	Figure No: 3
Produced by: Faith Bailey

*CG 1 is the western most field within the proposed development area. The geophysical results are characterised by the presence of a broad linear response, likely to represent a former paleo-channel. A small linear trend at the centre of the survey area may represent a natural feature or a boundary.*

CG 2 forms the southern portion of the proposed development area. Although the area subject to survey was relatively narrow, a number of strong magnetic linear anomalies were noted throughout the area. These are likely to represent former field boundaries, some of which are marked on the first edition OS map (1844). Discrete curving linear anomalies were noted in the north-west part of CG 2, which have the potential to represent a possible early medieval field system. These features extend outside of the proposed development area. Similar features were noted in the narrow eastern part of the survey area. These may represent an enclosure, although interpretation is difficult due to the narrow nature of the survey area.

The most interesting response within CG 3 consists of the remains of a possible sub-circular enclosure, located in the north-east corner of the field. The entire feature was not identified during the survey due to disturbance around the corner of the field. However, it is located to the immediate north-east of the boundary of the proposed development area. It occupies an area to the immediate south-east of a paleo-channel, which was also identified as an anomaly in the survey and is clear on some of the aerial photograph sets. The topography in the area shows that it partially occupies a gradual north facing slope that runs towards the stream, which currently borders the field. Other anomalies within CG 3 include magnetic disturbance from overhead cables and a number of linear features that are likely to represent former boundaries. The eastern linear trends have the potential to represent a plough damaged rectangular enclosure, although that interpretation is tentative.

Access within CG 4 was limited due to a vegetable crop. Three areas within the overall field were surveyed, revealing linear anomalies and trends, orientated east-west. These are likely to represent recent drainage.

Linear anomalies were also identified throughout CG 5. These are likely to represent drainage features, cultivation and a probably former boundary. The linear responses here are numerous and the potential that plough damaged archaeological remains may be indicated in this location should not be dismissed.

A series of linear and curvilinear weak magnetic anomalies were detected across the survey area, possibly associated with archaeological, geological or agricultural processes. A single small area of positive magnetic enhancement was also detected; this could represent the presence of possible archaeological material. The site has previously been partially surveyed by Target Archaeological Geophysics (Nicholls 2013). The type of features detected in this survey are similar to those in the previous survey.

Due to the presence of crops within the land parcel the test trenches was carried out in three phases. The first phase took place on the 26th August 2014 for one day; the second phase commenced at the site on 28th October 2014 and lasted for two days and the third phase took place on the 2nd February 2015 and lasted for one day. All trenches were excavated with a tracked mechanical excavator equipped with a flat, toothless bucket, under strict archaeological supervision. A total of 37 trenches, were mechanically investigated across the test area. These were placed in order to assess the geophysical anomalies identified during the initial non-invasive survey (Figure 3).

Target Archaeological Geophysics undertook a survey of the proposed development area at Clonshagh as part of the overall site selection assessment (Nicholls 2013). This was carried out under licence 13R25 during March and April of 2013. The results of the survey are summarised below and shown on Figure 3:

Due to adverse weather conditions, which produced very wet ground conditions, some areas were not available for survey during this phase of works. Therefore, additional survey was carried out by Earthsound Archaeological Geophysics in April 2014 under licence 14R0045 (Figure 3) (Bonsall & Regan 2014). This concluded the following:

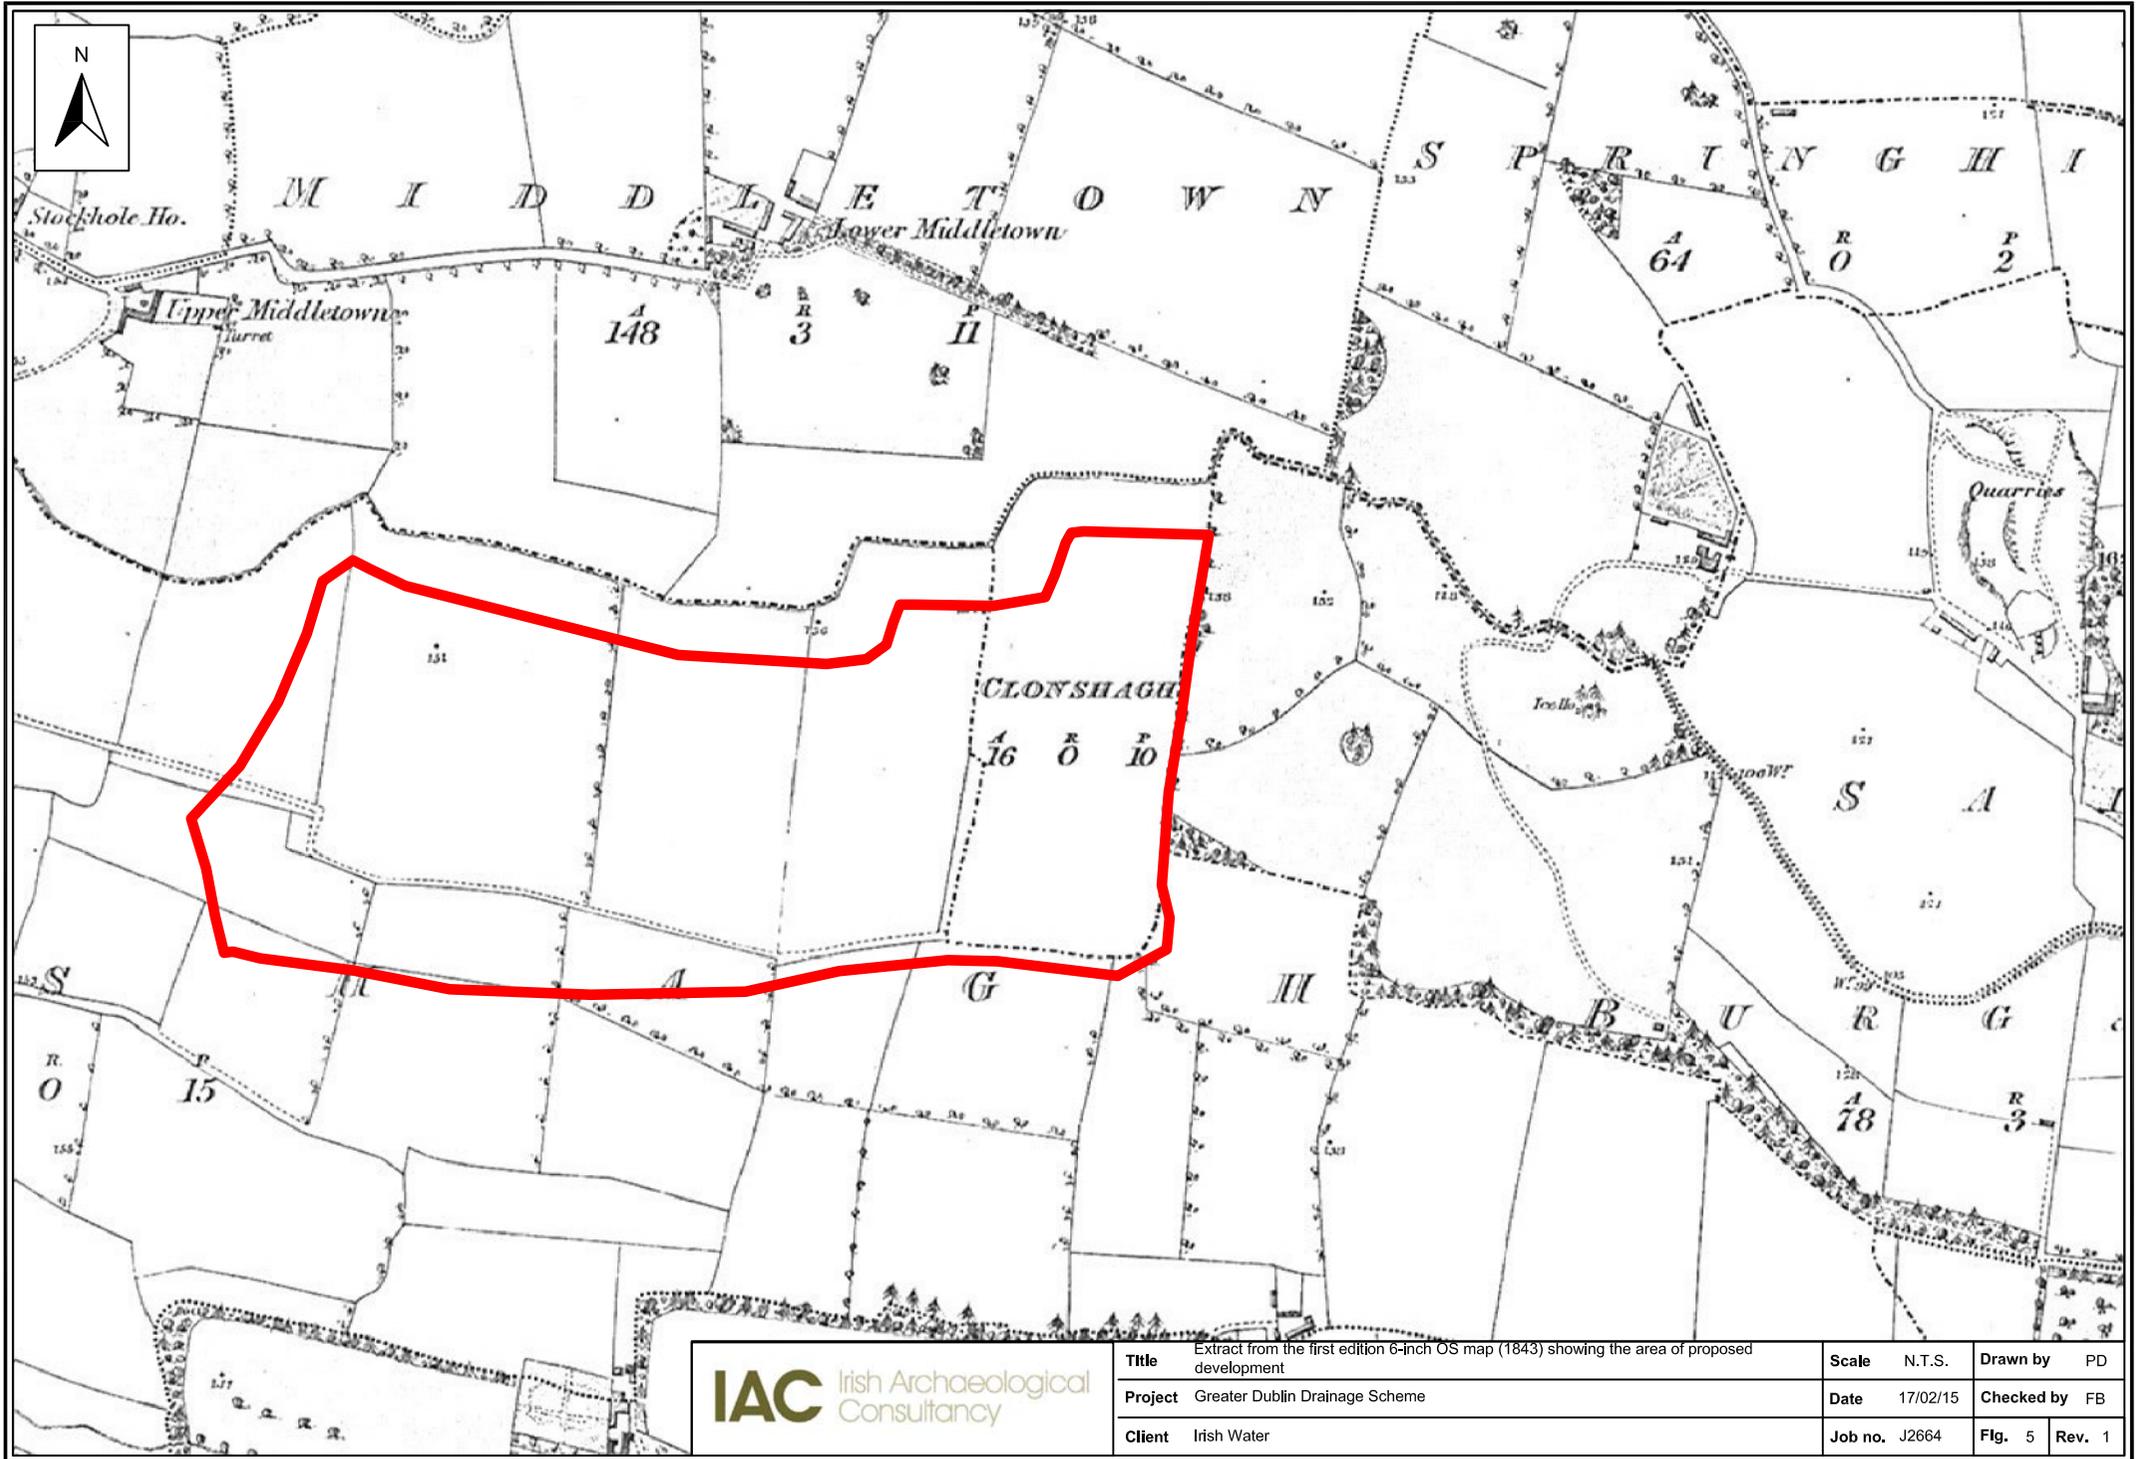
A review of the historic mapping shows that Rocque's Map (1760) is the first map to show the approximate area of the development area. It is shown as comprising all or part of eight fields of pasture located to the south and north of watercourses (Figure 4). *Bellcamp* House is shown to the east of the site surrounded by landscaped gardens. *Clonsilogh* (Clonshagh) is annotated to the west of the site with several houses along a roadway, south of Stockhole. To the north of the river there a number of houses annotated as *Mill Town*, *Balkins*, *The Park* (demesne lands) and *Rikin Head* (later Springhill House RPS 792). *St. Doolagh's Hills* are annotated to the north-east and *St. Doolagh's Church* (DU015-009) and well are to the east of these. No buildings or features of archaeological significance are shown on the later OS map editions (Figure 5).

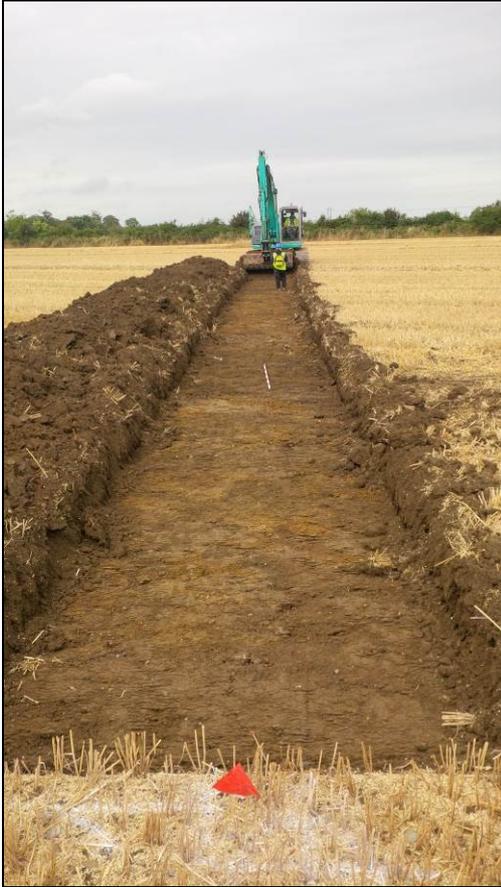
Plate 1 – Trench 1, facing NNW

Trench No	Length (m)	Depth (m)	Orientation	Geophys. Anomaly	Results
1	45	0.3	NNW-SSE	Linear trend	A post medieval field boundary, which is present on the first edition OS map of 1844 was identified c 11m from the northern end of the trench at the location of the geophysical anomaly (Plate 1).
2	38	0.4	North-west-south-east	Linear archaeology?	A post medieval field boundary was identified c. 15m from the southern end of the trench, which was filled with a brown sandy clay and sherds of transfer printed ceramics. The ditch was 2.2m wide and 0.4m deep (Plate 2).
3	157	0.35	NNE-SSW	N/a	The topsoil possessed a depth of 0.35m and sealed a natural sub-soil consisting of a firm, mottled yellow clay. No features of archaeological potential were identified.
4	92	0.3	WNW-ESE	Linear trends	Four linear trends were targeted by this trench. However, only one feature was identified within the trench. This consisted of a former post medieval field boundary exposed 8m from the western end of the trench. A ginger beer bottle was recovered from the fill.

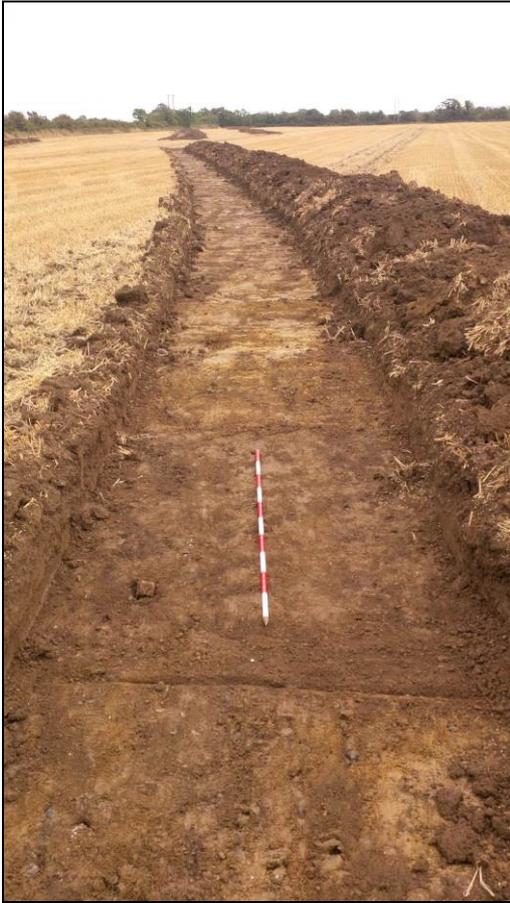
Plate 3 – Trench 6, facing north

5	123	0.35	North-south	Linear trends	The topsoil possessed a depth of 0.35m and sealed a natural sub-soil consisting of a firm, mottled yellow clay. No features of archaeological potential were identified.
6	90	0.4	East-west	Linear trends	A former post medieval field boundary was identified 4m from the western end of the trench, which did not appear in the geophysical survey. No features appeared at the other geophysical anomaly locations. The ditch of the boundary was 2.5m wide and the fill contained fragments of red brick and post

Trench No	Length (m)	Depth (m)	Orientation	Geophys. Anomaly	Results
					medieval pottery (Plate 3).
7	156	0.4	East-west	N/a	The topsoil possessed a depth of 0.4m and sealed a natural sub-soil consisting of a firm, mottled yellow clay. No features of archaeological potential were identified.
8	98	0.4	East-west	N/a	The topsoil possessed a depth of 0.4m and sealed a natural sub-soil consisting of a firm, mottled yellow clay. No features of archaeological potential were identified.
9	88	0.4	NNE-SSW	Linear trend	The topsoil possessed a depth of 0.4m and sealed a natural sub-soil consisting of a firm, mottled yellow clay. No features of archaeological potential were identified.
10	58	0.4	North-east-south-west	N/a	The topsoil possessed a depth of 0.4m and sealed a natural sub-soil consisting of a firm, mottled orange brown clay. No features of archaeological potential were identified.
11	63	0.4	NNE-SSW	N/a	The topsoil possessed a depth of 0.4m and sealed a natural sub-soil consisting of a firm, mottled orange brown clay. No features of archaeological potential were identified.

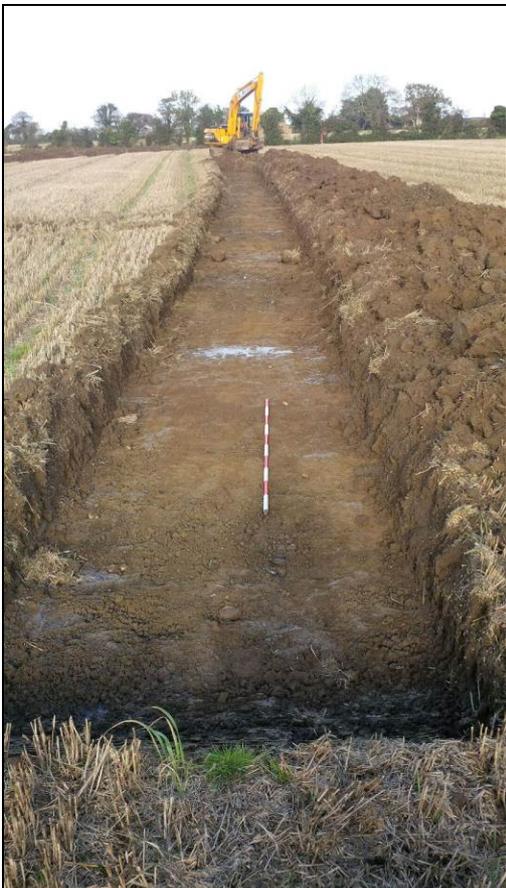
Plate 4 – Trench 12, facing north

12	57	0.4	NNE-SSW	Linear trends	The topsoil possessed a depth of 0.4m and sealed a natural sub-soil consisting of a firm, mottled yellow clay. No features of archaeological potential were identified (Plate 4).
13	57	0.4	NNW-SSE	N/a	The topsoil possessed a depth of 0.4m and sealed a natural sub-soil consisting of a firm, mottled orange brown clay. No features of archaeological potential were identified.
14	71	0.4	North-south	Linear trends	The topsoil possessed a depth of 0.4m and sealed a natural sub-soil consisting of a firm, mottled brown clay. No features of archaeological potential were identified. A small section of the trench was not excavated to allow for an exclusion zone for overhead wires.
15	178	0.4	East-west	N/a	The topsoil possessed a depth of 0.4m and sealed a natural sub-soil consisting of a firm, mottled brown clay. The remains of a post medieval field boundary were identified 57m from the western end of the trench. This had a width of 2m.

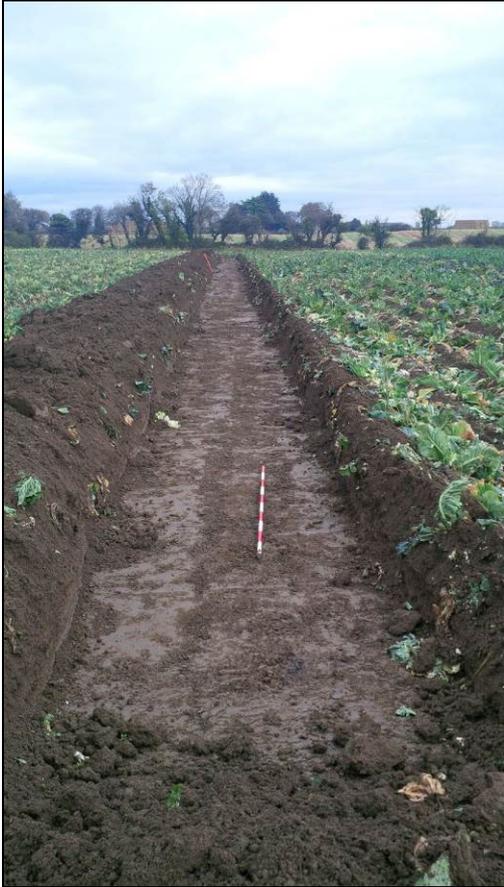
Plate 5 – Trench 17, facing north

Trench No	Length (m)	Depth (m)	Orientation	Geophys. Anomaly	Results
			south	features	sealed a natural sub-soil consisting of a firm, mottled brown clay. No features of archaeological potential were identified (Plate 5).
18	91	0.4	NNW-SSE	Linear trends	The topsoil possessed a depth of 0.4m and sealed a natural sub-soil consisting of a firm, mottled brown clay. No features of archaeological potential were identified.
19	46	0.4	WSW-ENE	Linear trends	The topsoil possessed a depth of 0.4m and sealed a natural sub-soil consisting of a firm, mottled brown clay. No features of archaeological potential were identified.
20	32	0.4	WSW-ENE	Linear trends	The topsoil possessed a depth of 0.4m and sealed a natural sub-soil consisting of a firm, mottled brown clay. No features of archaeological potential were identified.
21	48	0.4	North-south	Linear trend	The topsoil possessed a depth of 0.4m and sealed a natural sub-soil consisting of a firm, mottled brown clay. No features of archaeological potential were identified.

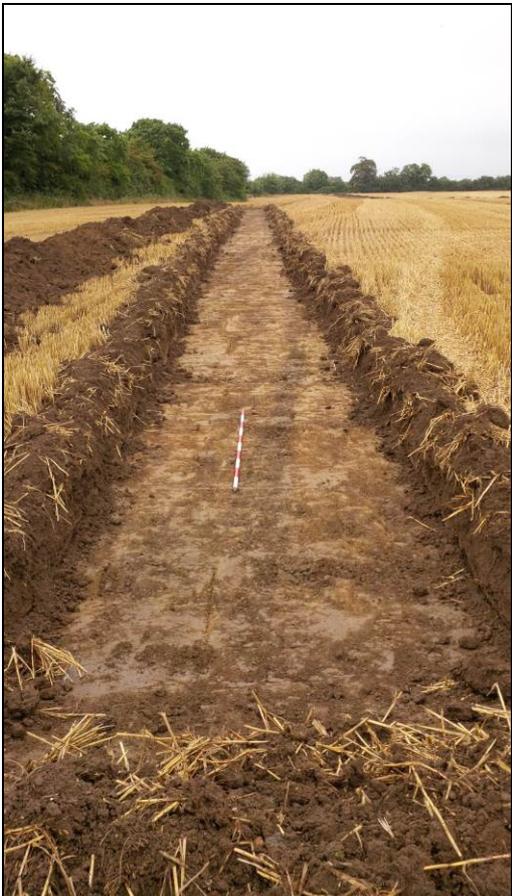
Plate 8 – Trench 37, facing south

34	57	0.4	ENE-WSW	Linear trends	The topsoil possessed a depth of 0.4m and sealed a natural sub-soil consisting of a firm, mottled yellow brown clay. No features of archaeological potential were identified.
35	105	0.35	East-west	Linear trend	The topsoil possessed a depth of 0.35m and sealed a natural sub-soil consisting of a firm, mottled yellow brown clay. No features of archaeological potential were identified.
36	73	0.3-5	North-south	Linear trends	The topsoil possessed a depth of 0.3-5m and sealed a natural sub-soil consisting of a firm, mottled yellow brown clay. No features of archaeological potential were identified.
37	128	0.4	North-south	Linear trends	The topsoil possessed a depth of 0.4m and sealed a natural sub-soil consisting of a firm, mottled yellow brown clay. No features of archaeological potential were identified (Plate 8).
