VARTRY WATER SUPPLY PROJECT

VARTRY WATER TREATMENT PLANT

Ecological Impact Assessment (EcIA)

March 2016

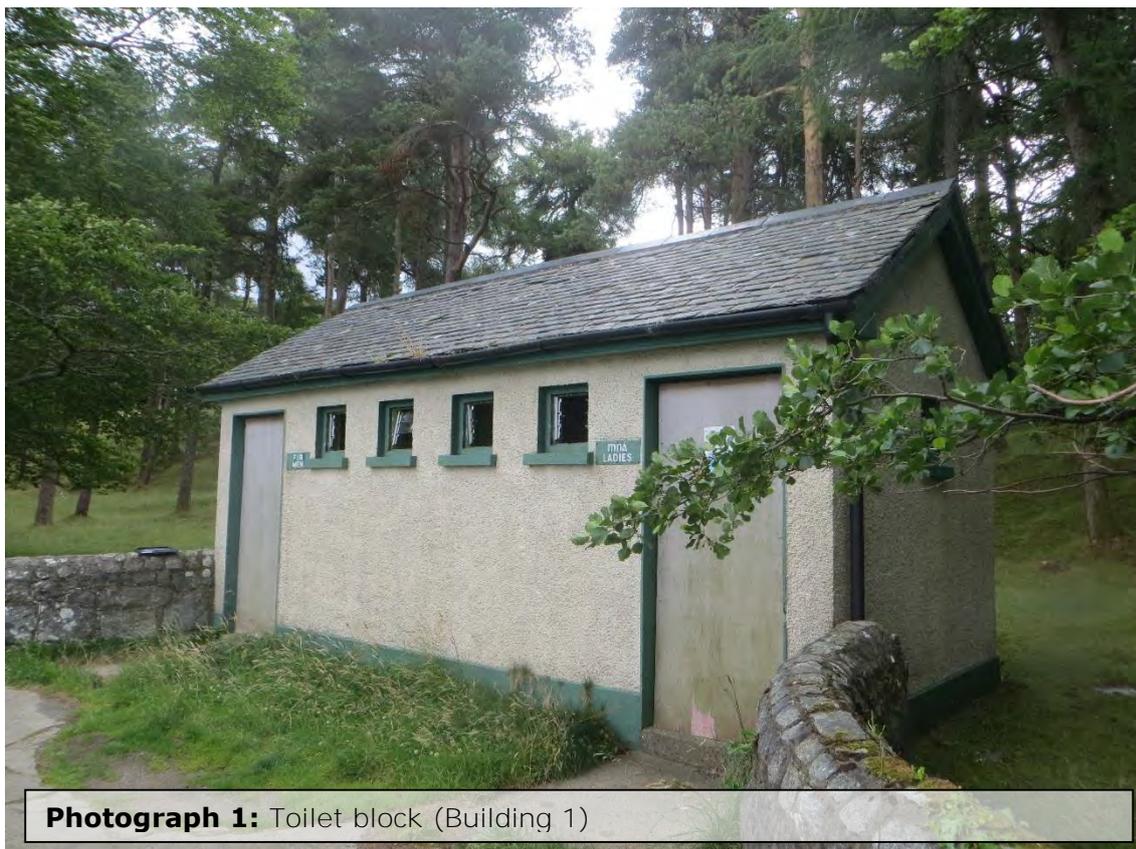
Photograph 1: Toilet block (Building 1)

tiles were in a poor state of repair with numerous tiles missing, providing potential access to the internal roof void. The interior comprised several ground-floor rooms with a self-contained roof void above a plastered ceiling. The ground-floor rooms were light and draughty as a result of the open windows which reduced the suitability for roosting bats. The roof void was not inspected for evidence of roosting bats due to a lack of access but was considered to provide potential roosting habitat for a range of open-roosting and crevice-dwelling bat species. The building was generally considered to have a **moderate roosting potential for bats** according to the Bat Survey Good Practice Guidelines (Bat Conservation Trust 2012).

No bats were observed emerging from the building during the four emergence surveys.

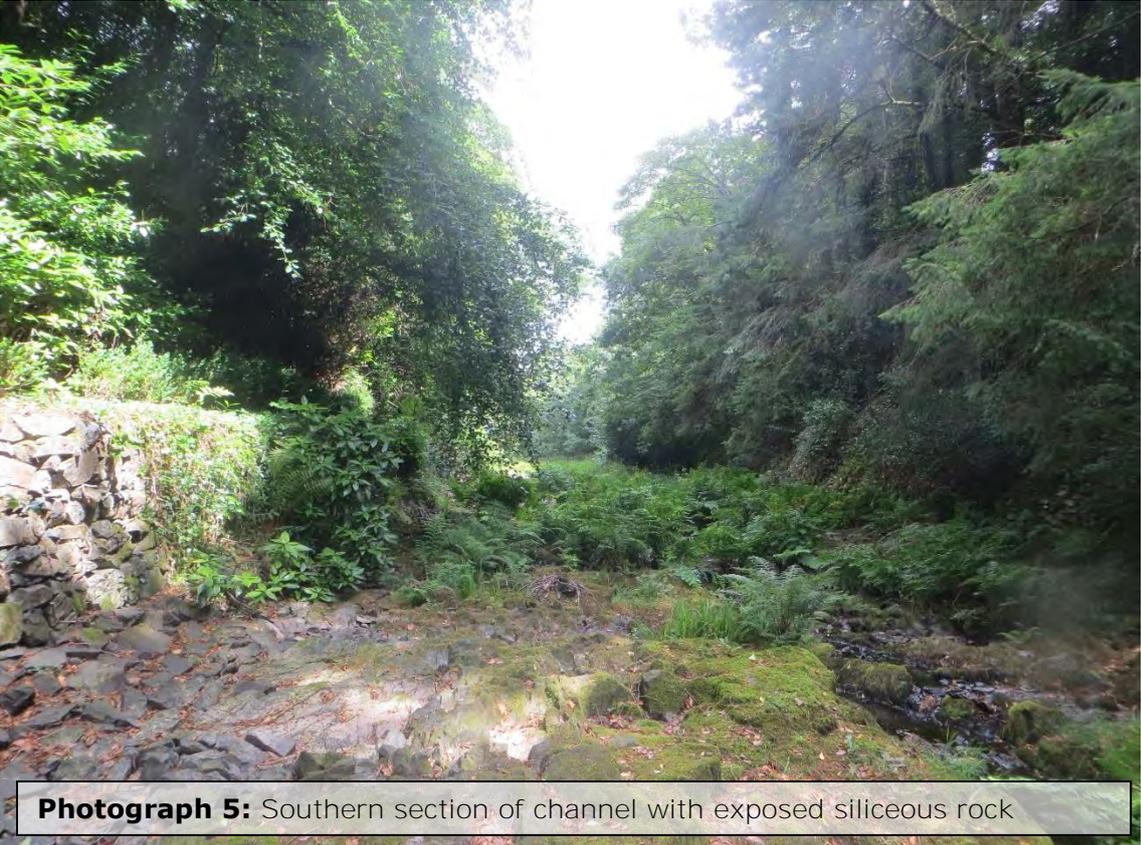
Photograph 5: Southern section of channel with exposed siliceous rock

Further south along the spillway the channel bed consisted of exposed siliceous rock **ER1** that was frequently covered by mosses but also contained pockets of grasses, ferns and sapling trees on higher ground that included species such as creeping bent *Agrostis stolonifera*, false oat grass *Arrhenatherum elatius*, smooth-meadow grass *Poa pratensis*, royal fern *Osmunda regalis*, bracken *Pteridium aquilinum* and sapling ash *Fraxinus excelsior* and sycamore *Acer pseudoplatanus*.

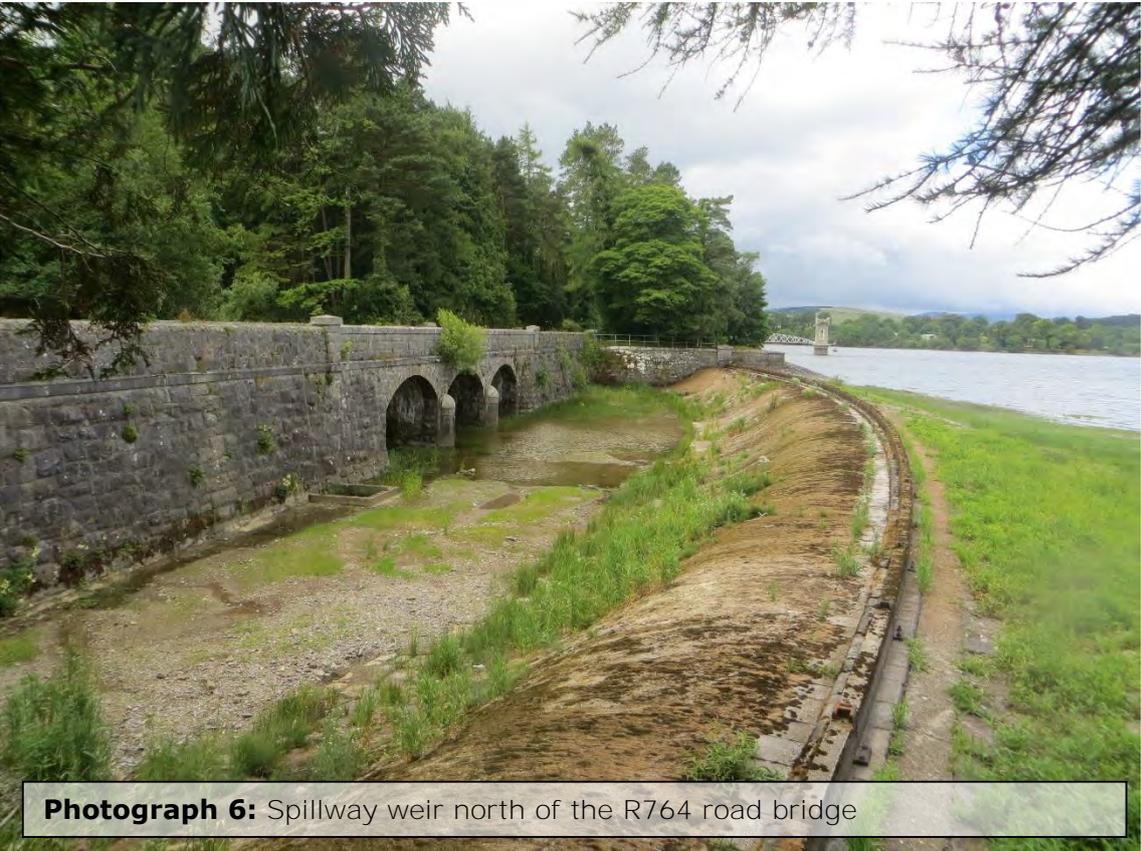
Photograph 6: Spillway weir north of the R764 road bridge

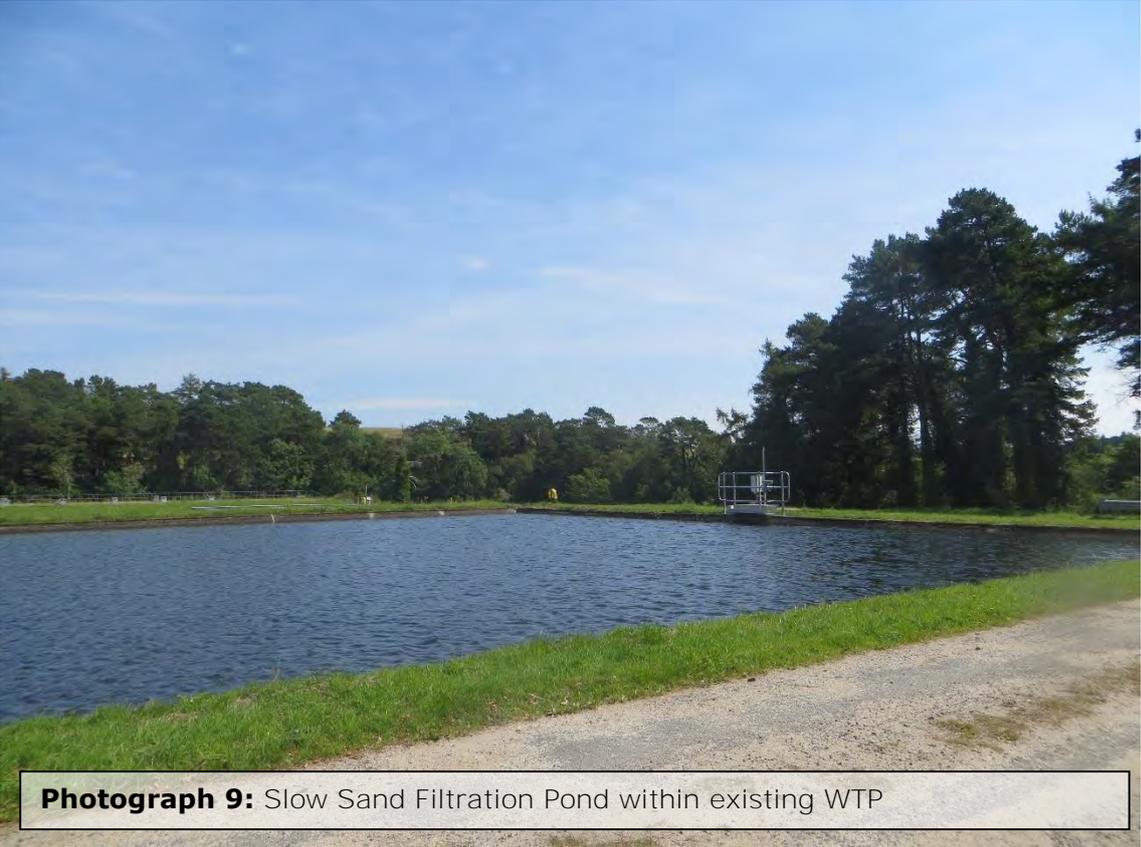
Photograph 9: Slow Sand Filtration Pond within existing WTP

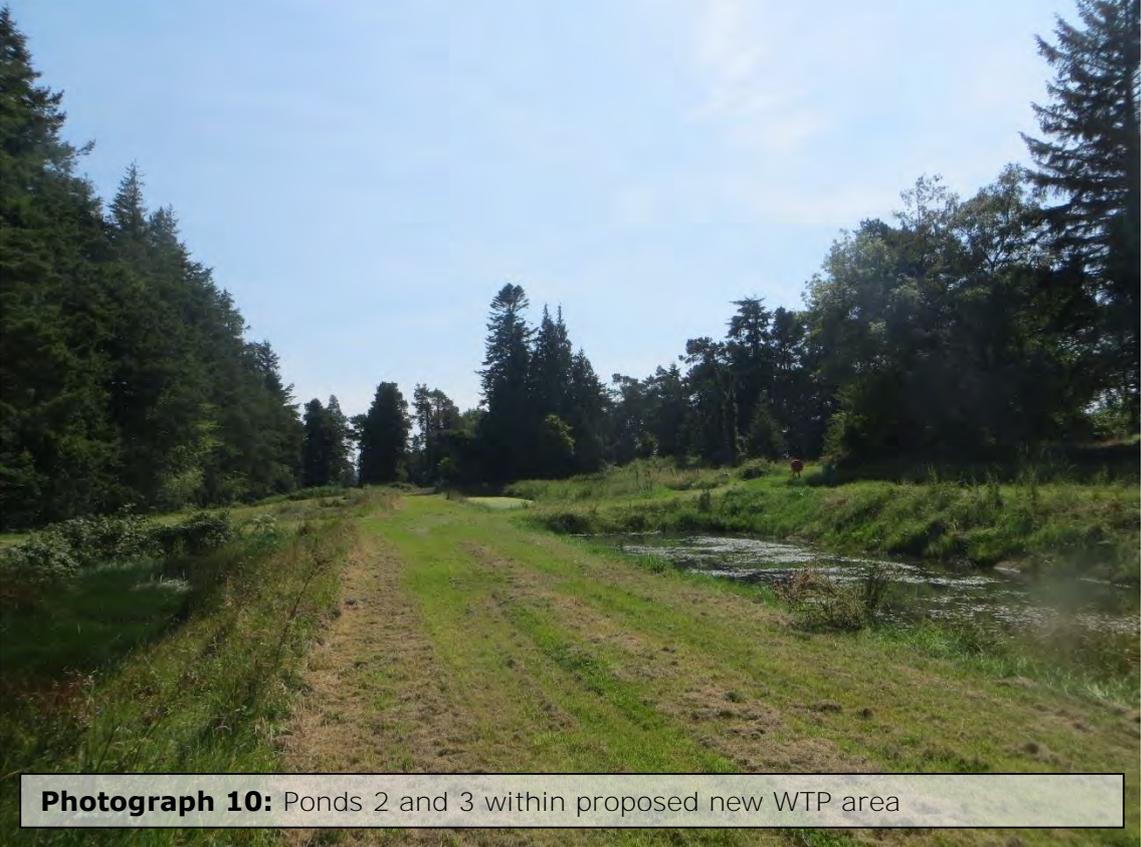
Photograph 10: Ponds 2 and 3 within proposed new WTP area

- Ponds 1 – 7 are subject to regular dredging and vegetation clearance to ensure their continued functionality as sediment settlement ponds. This is considered to greatly reduce their suitability to support breeding amphibians although individuals may opportunistically use these ponds for breeding on occasion. It is recommended that the ponds are drained and filled in during the period September – January when amphibians are likely to be absent.

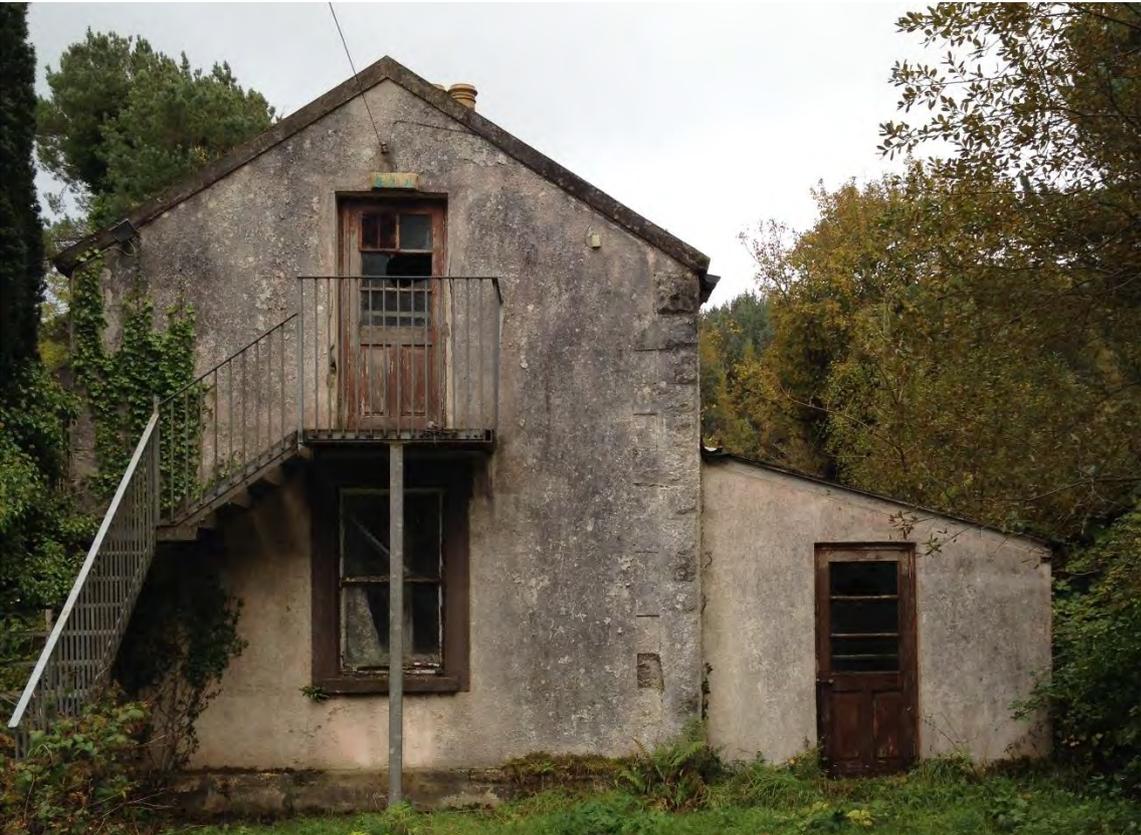
Photograph 14: Derelict Building at Callowhill

The building is a two-storey house with cement rendered walls and a pitched slate tiled roof. The building is in a poor state of repair having not been occupied for many years. There are numerous potential entry points for bats through broken windows and missing roof tiles. The interior was relatively light and draughty but there is likely to be areas within the interior such as roof voids and cupboards that provide more suitable conditions for roosting bats. The building was generally considered to have a **good roosting potential for bats** according to the Bat Survey Good Practice Guidelines (Bat Conservation Trust 2012).
