Cork Lower Harbour Main Drainage Scheme. Estuary Crossing Feasibility Report

Cork Dockyard to Monkstown

**A supplementary Feasibility Study Report in
respect of the installation of pumped sewer mains
by trenchless methods between Cork Dockyard and
Monkstown.**

S3 – 08 July 2016 –FINAL

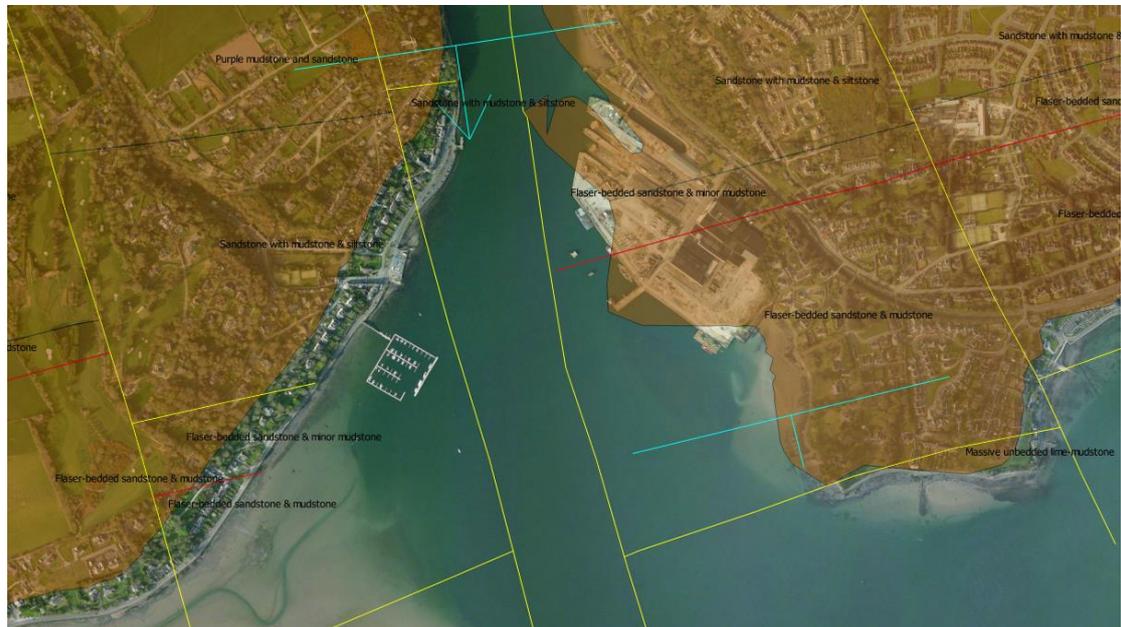
Figure 3 - Geological data copyright DCMNR and Government of Ireland. Image base Digital Globe, GeoEye & Microsoft 2014

The GSI 1:100,000 scale geological mapping (Figure 3) indicates that the bedrock below the site varies generally from east to west and north to south. There are also faults in the bedrock to be traversed by the crossing route as well as folded or inclined bedding.

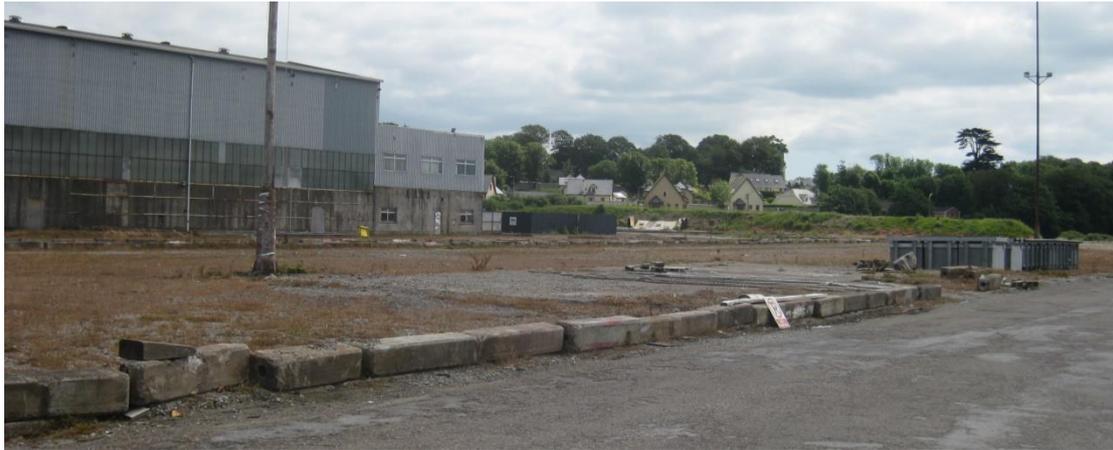
Figure 4 – Cork Dockyard – Proposed Pump Station and works area centre rear.

At Cork Dockyard, there is currently ample open area and excellent vehicular access to support a drilling operation. A working area of at least 2500m² should be considered as a minimum for contractors operations.

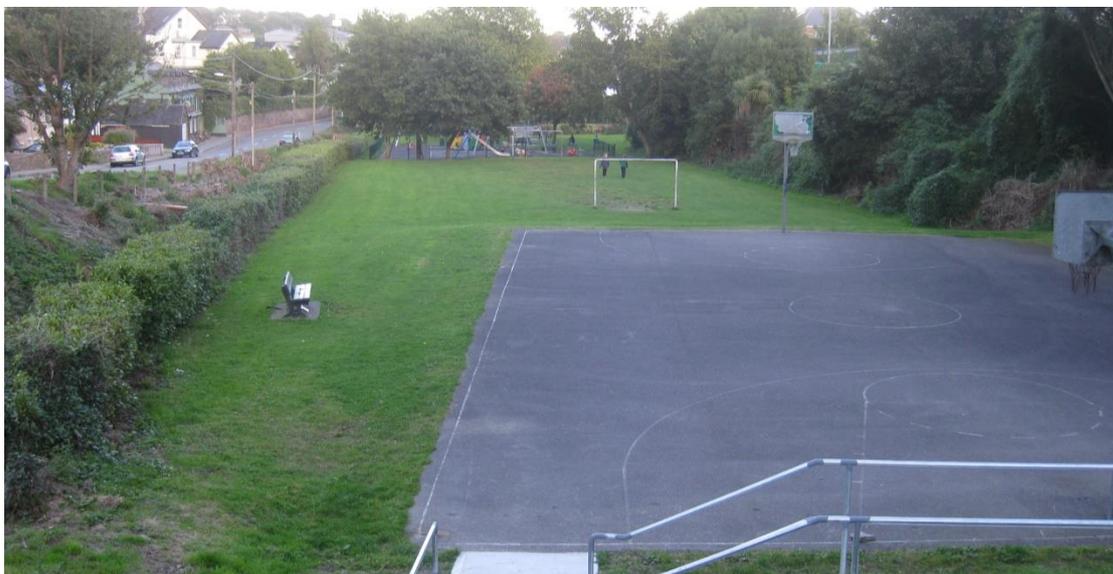
Figure 5 - Proposed drill exit point - adjacent to Glen Road.

The proposed reception site at Monkstown is adjacent to a play area alongside Glen Road. Maintaining access to the play area during the works is an unreasonable and restrictive requirement which any contractor would find difficulty in meeting. A temporary bridge over, or culverting of, the water course alongside Glenbrook will be required in order that full site access can be gained to the west of the play area.

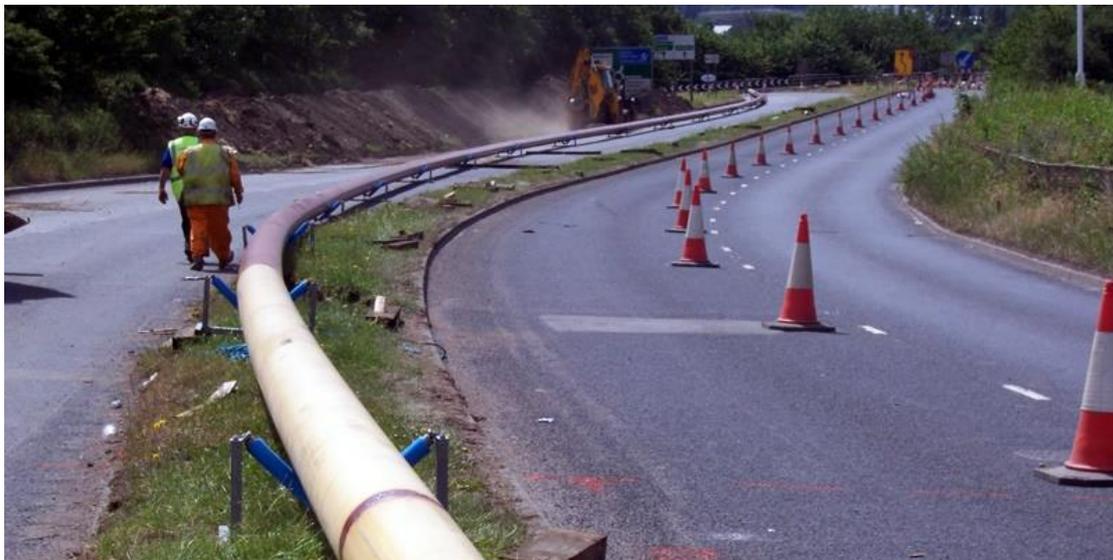
Figure 6 - Pipe laydown example (Image A E Yates)

The pipe is set on rollers to eliminate the risk of damage during pull-in.

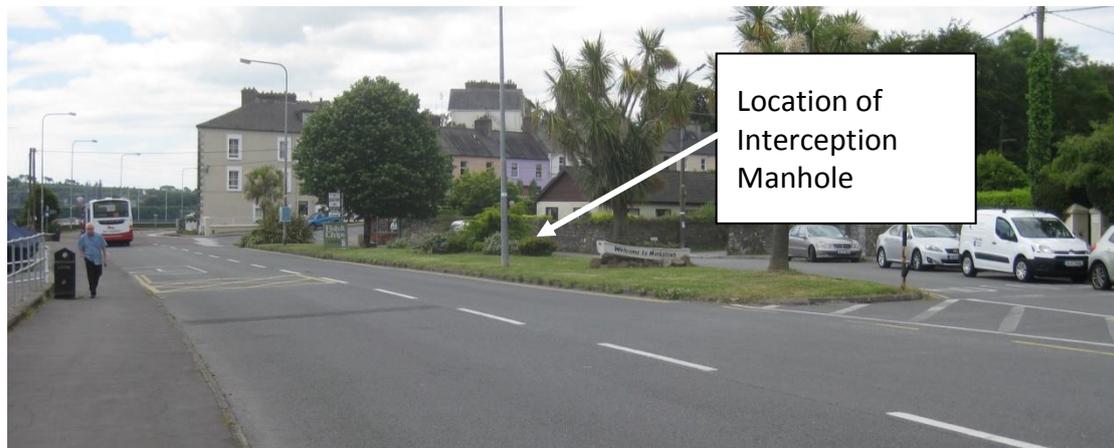
Figure 8 - Proposed location for interception manhole at Marine Villas

At Monkstown the preliminary design has an invert elevation at the proposed tie-in structure at Marine Villas (Figure 8) of -15mOD (Figure 14). The location of this structure is approximately 170m east of the proposed reception site adjacent to Glen Road. The ground elevation at the reception site is around +5m elevation. This configuration results in a likely drill exit angle of around 6 degrees, being in the normal range for drilling operations and in good alignment with the pipe pull-in alignment from Glen Road.

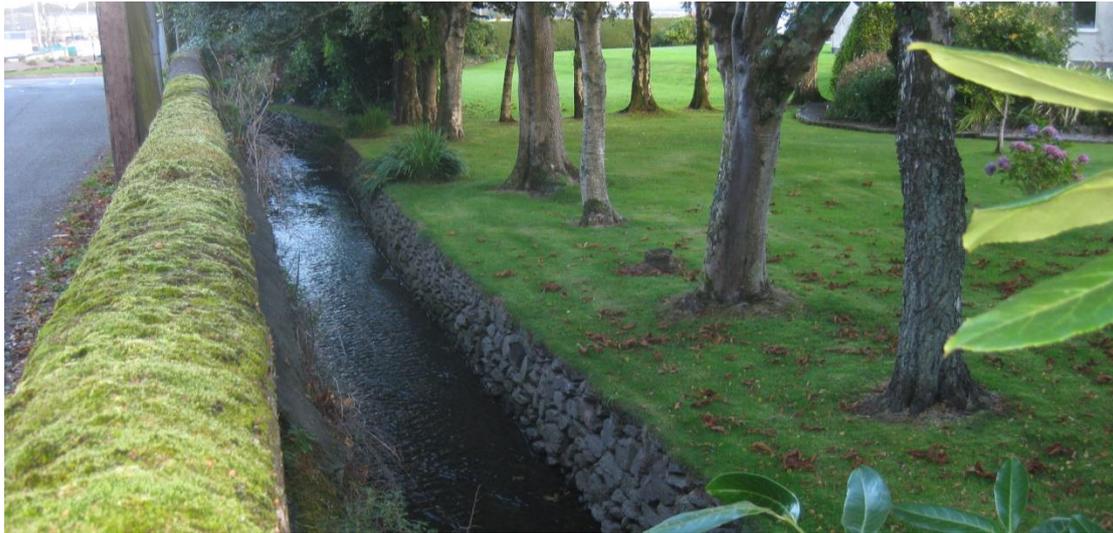
Figure 9 - Water course and low lying gardens adjacent to Glen Road

- a. There is increased risk of inadvertent drilling mud returns to the water course running alongside Glen Road and/or the low lying gardens above the route (Figure 9).
- b. Ground conditions through this section includes low strength silts and infill material possibly associated with the original water course channel.

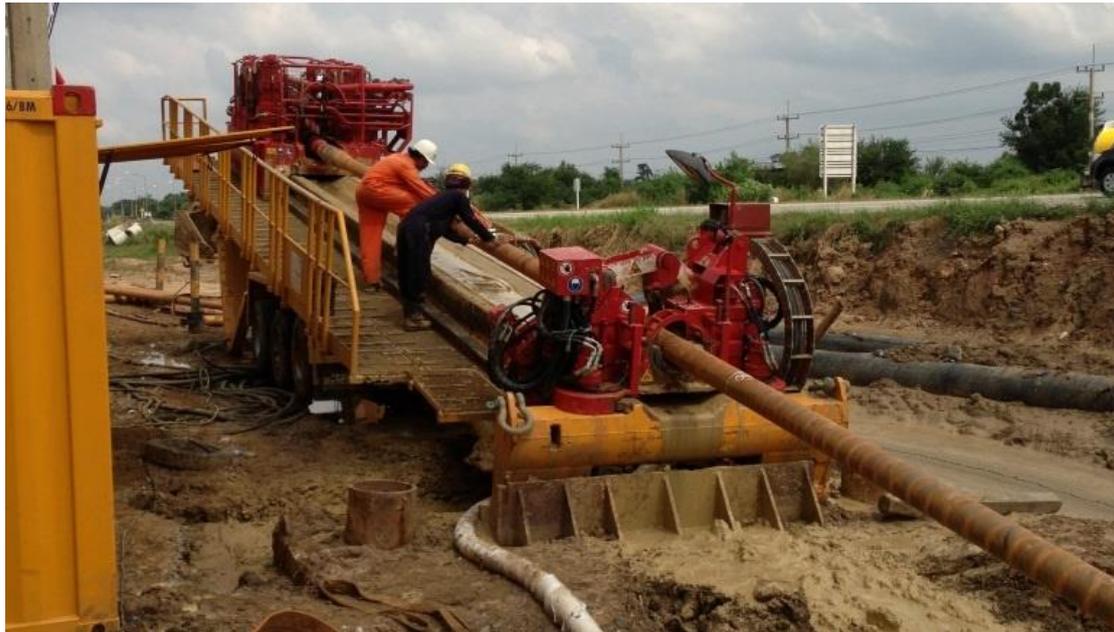
Figure 20 - Horizontal Directional Drilling Rig (Thailand)

Horizontal Directional Drilling (HDD) is a Trenchless Technology process whereby a pipeline is installed from one point to another without excavating a trench.

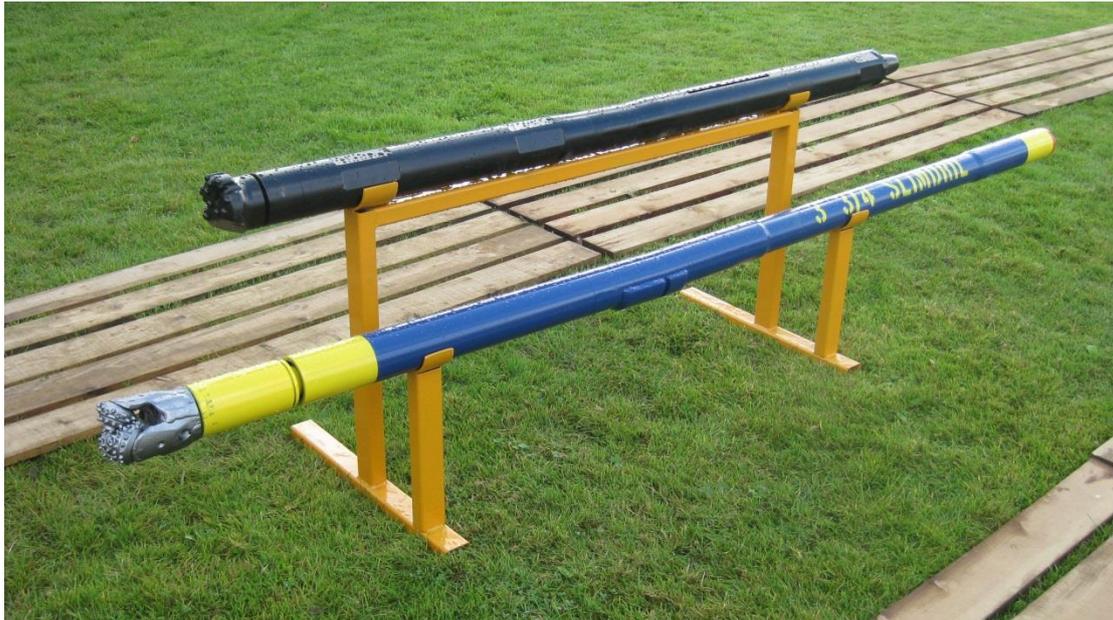
Figure 22 - Mud Motor (Slimdril)

When drilling through rock the pilot hole is normally created using a bit driven by a downhole motor. This motor is powered by the drilling mud pumped through it. Due to the arrangement of the mud motor and other components of the BHA the minimum steerable radius for the pilot bore is limited. It is the minimum bend/turning radius of the drill pipe and BHA and not the proposed HDPE that is likely to limit the minimum radius of the bore profile.

Mud motors require significant flow rate and therefore a significant volume of suitably formulated drilling mud, and hence a good supply of potable water. In turn the process of mud recycling is a larger operation. Operation of a mud motor also requires a higher mud pump pressure than for other stages. While the majority of the pressure dissipates in driving the motor the remaining pressure combined with the high fluid flow volume can increase the risk of inadvertent fluid returns, especially at shallower elevations or in more permeable formations.

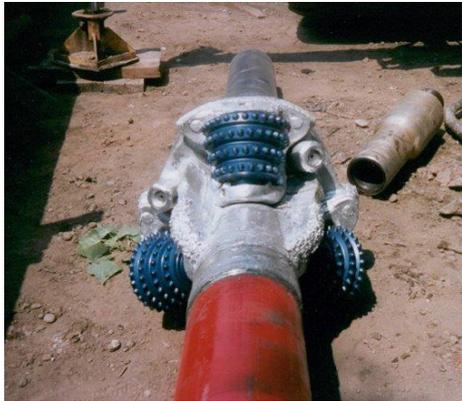
Figure 24 - Hole Opener

Reaming, or hole opening in rock formations, increases the diameter of the cut bore in increments. For example, 12-inch (300mm) to 18-inch (450mm) to 26-inch (610mm) to 30-inch (750mm) to 36-inch (900mm). The final diameter reamed is typically between 1.2 to 1.5 times the external diameter of the Product Pipe with the diameter required increasing as bore complexity increases and bore quality decreases.

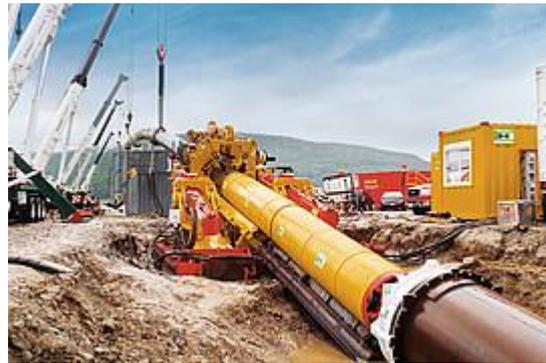
A slurry based microtunnelling machine is used at the leading end of a continuous welded steel pipeline. A pipe thruster unit grips the steel pipeline externally in order to advance the microtunnelling machine and the pipeline into and through the ground.

Figure 26 Herrenknecht Direct Pipe® system

The use of a Direct Pipe approach on a crossing length of over 1km would require the direct installation of a steel pipe of at least 1.2m or possibly 1.5m diameter. This would create a casing of sufficient size in which to install the twin sewer mains into a single crossing. The installation of a single smaller diameter steel casing to house a single DN500 sewer main is not possible due to length of the crossing required.

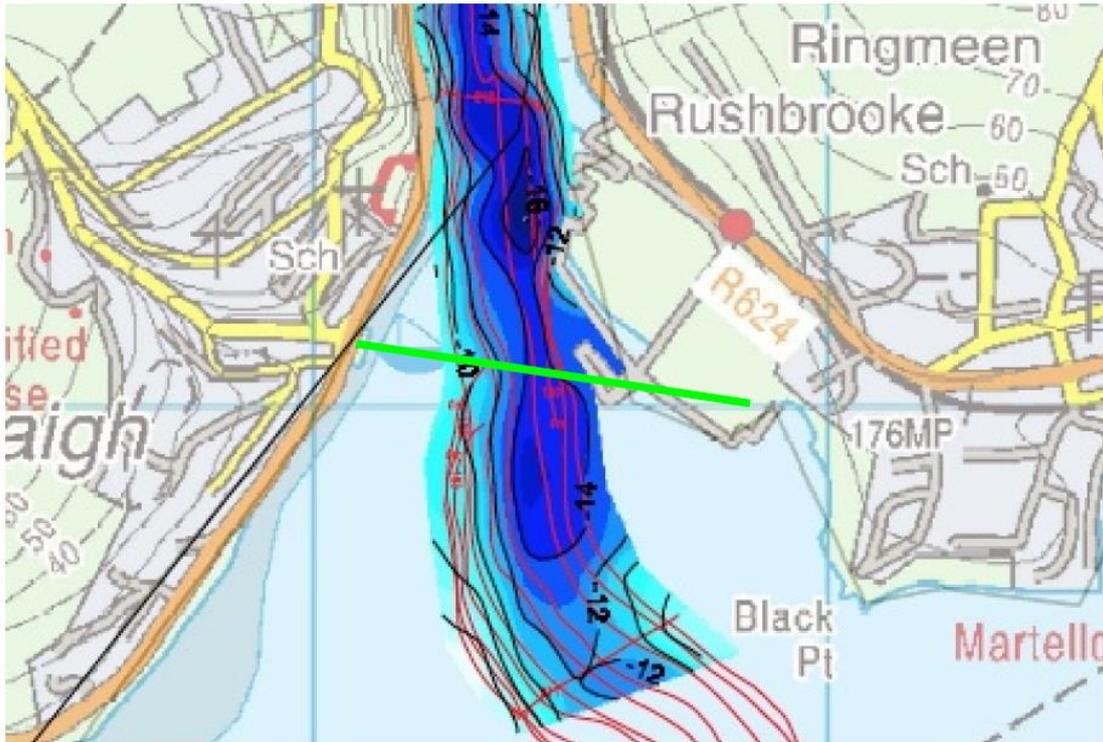
Fig 5.2. Apex Geoservices seabed elevation. Green line-Estuary crossing.

- Fig 5.1. *Infomar* bathymetry (A) and shaded relief (B).
- Fig 5.2. *Apex* seabed elevation.

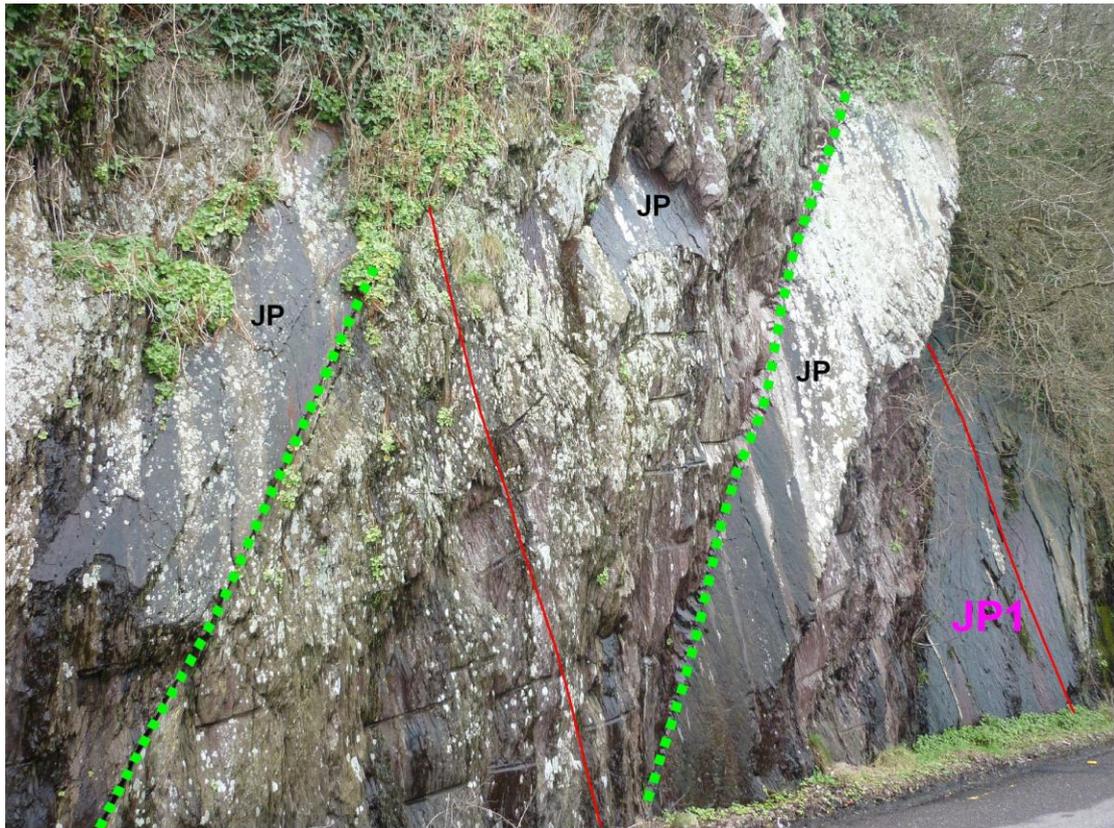
Fig 13.2. Ballytrasna Formation Passage Road, Monkstown showing selected intersecting bedding planes (green lines), joint planes (JP and purple lines) and cleavage planes (red) in purple/red fine-grained sandstones and siltstones. The strike of the joints intersects the strike of the bedding and cleavage at very high angles. The same rock face is shown in both images but viewed from a different angle. JP1 is the same joint plane in both images.

The bedrock here is dominated by purple mudstones (mostly siltstones) and fine-grained sandstones of the Ballytrasna Formation. These sediments are thinly-bedded to thickly-bedded and are internally laminated or locally massive. The rock types are similar to Facies 2 and 3 described below in the Gyleen Formation (Figs 13.2, 13.3 & 13.23).

Cleavage is strongly developed throughout all the outcrops (Figs 13.2-13.19). This is closely spaced in the finer lithologies and more widely spaced in sandstones.

The bedrock is strongly and intensely jointed (Figs 13.2-13.19). Frequently, these joints contain significant amounts of vein quartz infillings. This is particularly notable where joints traverse sandstone units (Facies 1) (Figs 13.17-13.19).

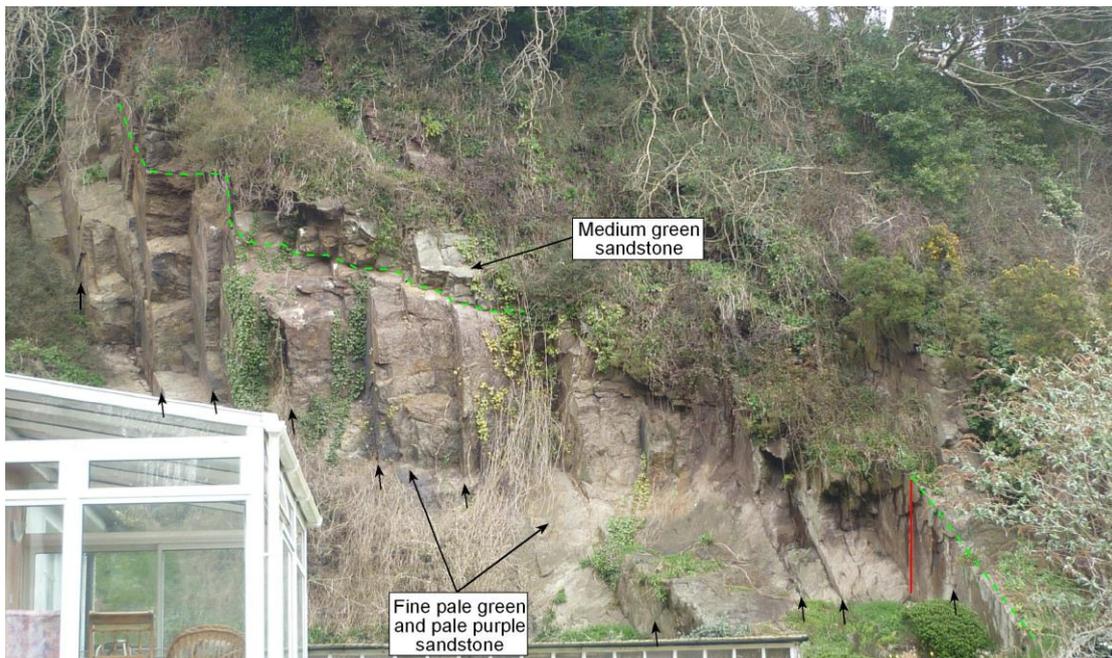
Fig 13.5. Jointing in Facies 1 pale green sandstones and siltstones of the Gyleen Formation at Glen Road Quarry (upper).
Arrows-Joints, Green line-bedding, Red line-cleavage.

These are illustrated in Figs 13.5 to 13.18. A schematic log of the formation at Glen Road Quarry is shown in Fig 13.24.

A good example of the general type of bedrock in the location of these boreholes can be seen at outcrops in Glen Road Quarry, Monkstown (Figs 13.4-13.19). The fracture pattern as seen in these rock outcrops can be expected to be also present in the bedrock beneath the playground and extending to the Sand Quay. However, weathering patterns could vary between the two areas.

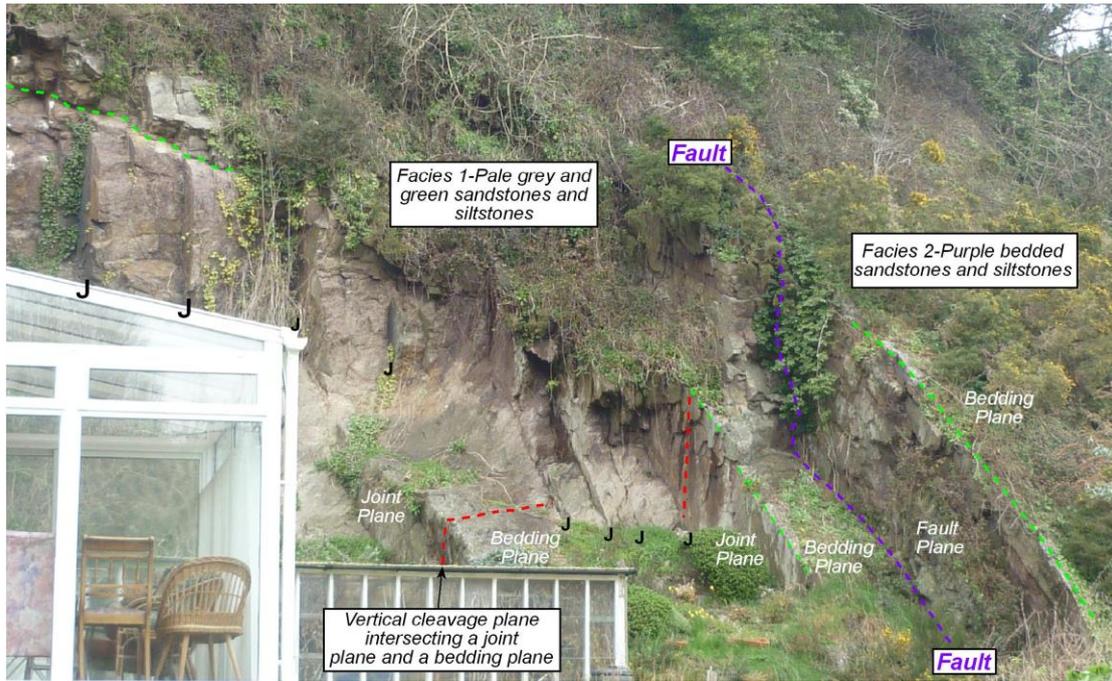
Fig 13.6. Jointing, bedding and cleavage in Facies 1 pale green sandstones and siltstones of the Gyleen Formation at Glen Road Quarry (upper).
 J-Joints, Green line-bedding, Red line-cleavage, Purple line-Fault.

Four faults have been identified along the 100m length of Glen Road Quarry that was examined (Figs 13.6, 13.8, 13.12-13.15). Three of these are relatively tight structures with minimal fault width measuring less than c100mm. One fault (Figs 13.12-13.14) appears to be filled with a (c.300mm thick) clay-grade possible fault gouge. Minor faults of these types are typical of this region.

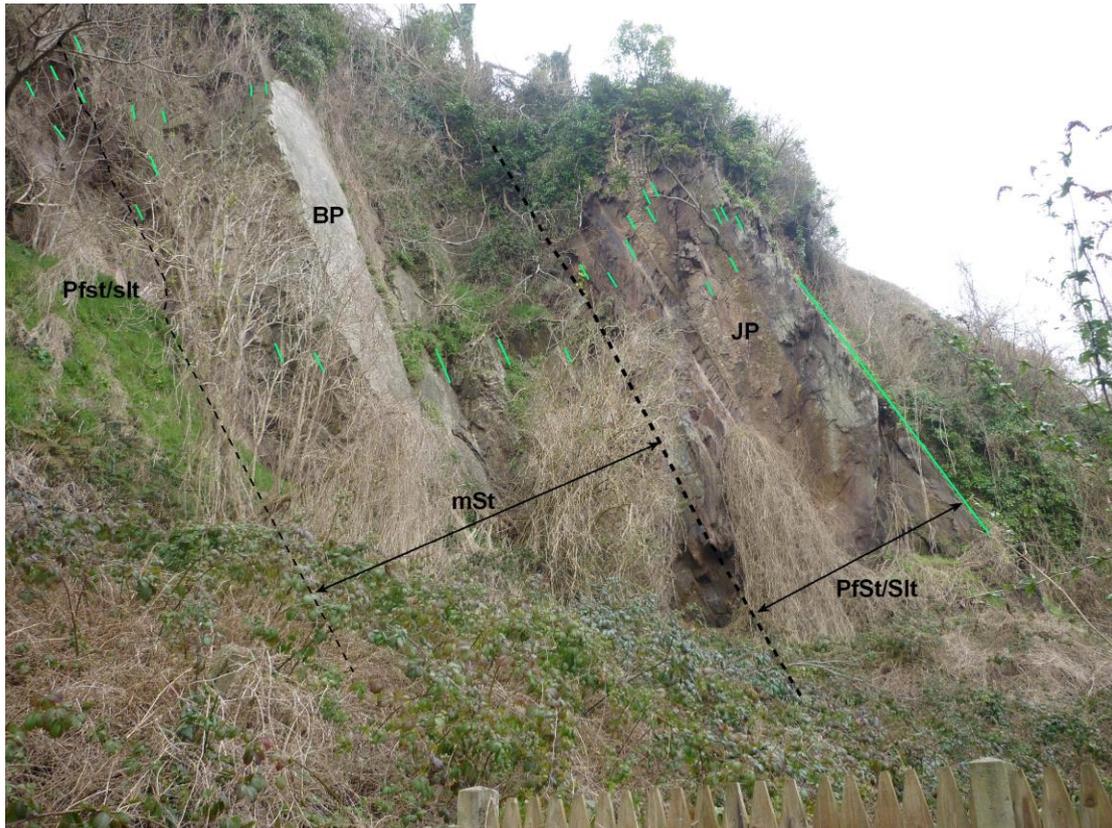
Fig 13.7. Steeply dipping bedding planes in the Gyleen Formation at Glen Road Quarry (middle).

Green lines-Bedding.

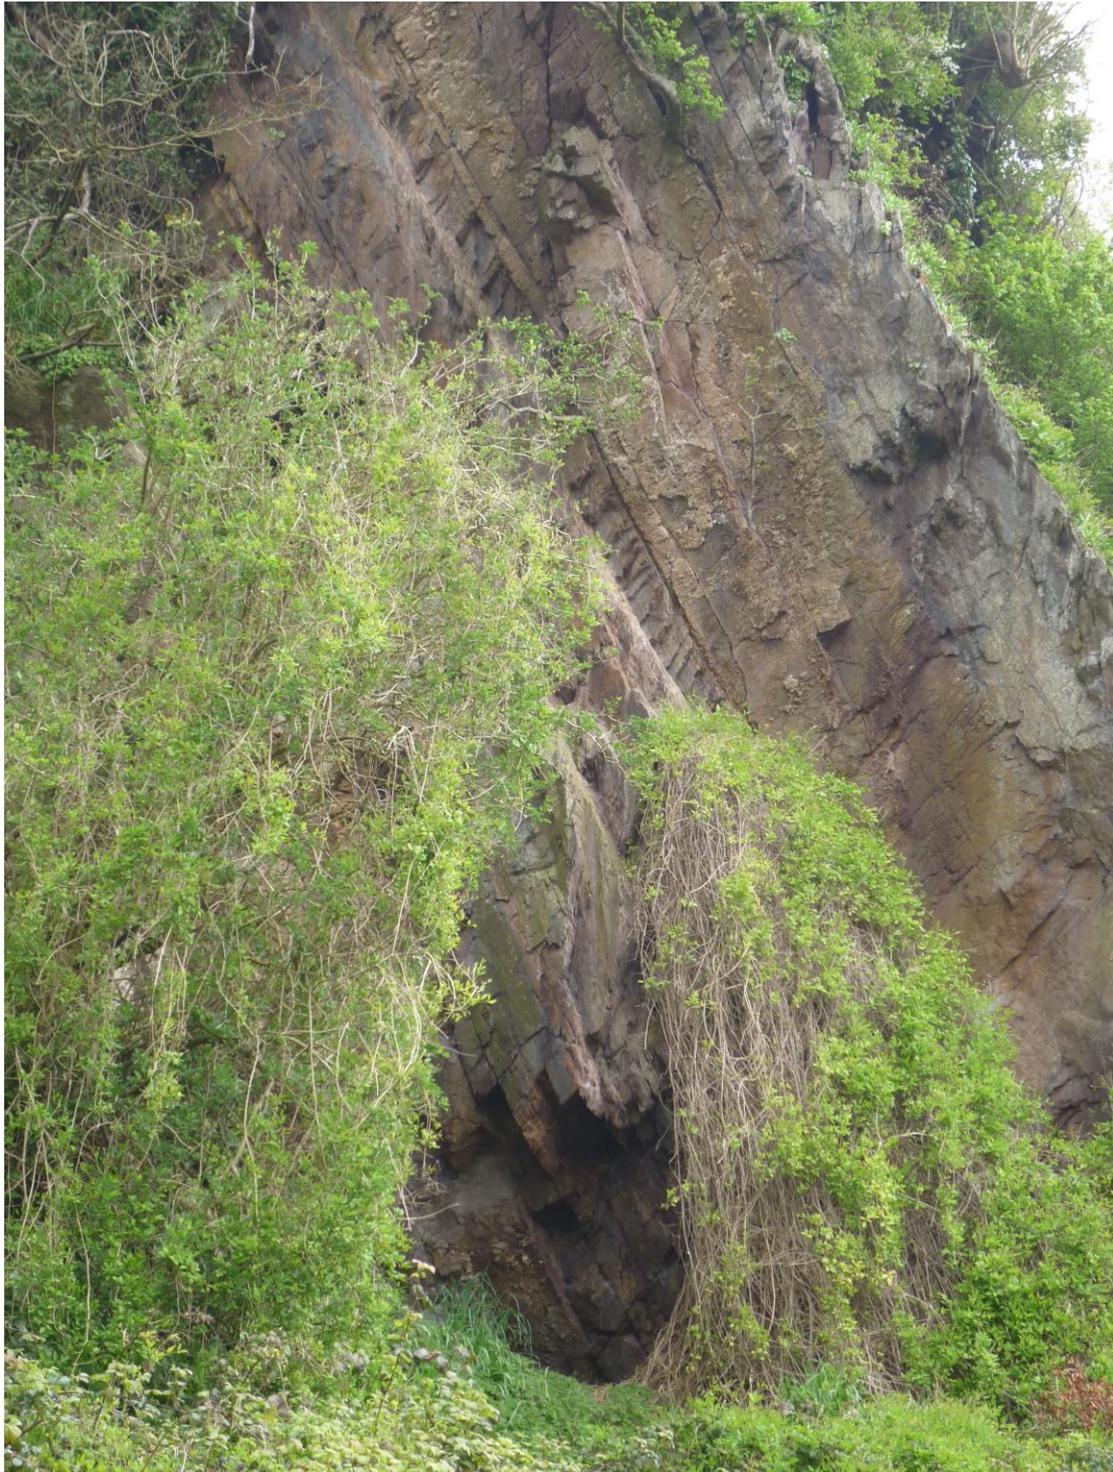
Fig 13.8. Steeply dipping bedding planes in the Gyleen Formation at Glen Road Quarry (middle). Facies 2-Bedded purple fine-grained sandstones and siltstones. Note vertical fracture at top of image that appears to be part of a bedding-parallel thrust fault associated with layer-parallel shortening that took place at the initial stages of deformation. The fracture commenced parallel to lower level bedding planes and then cut upwards across the bedding.

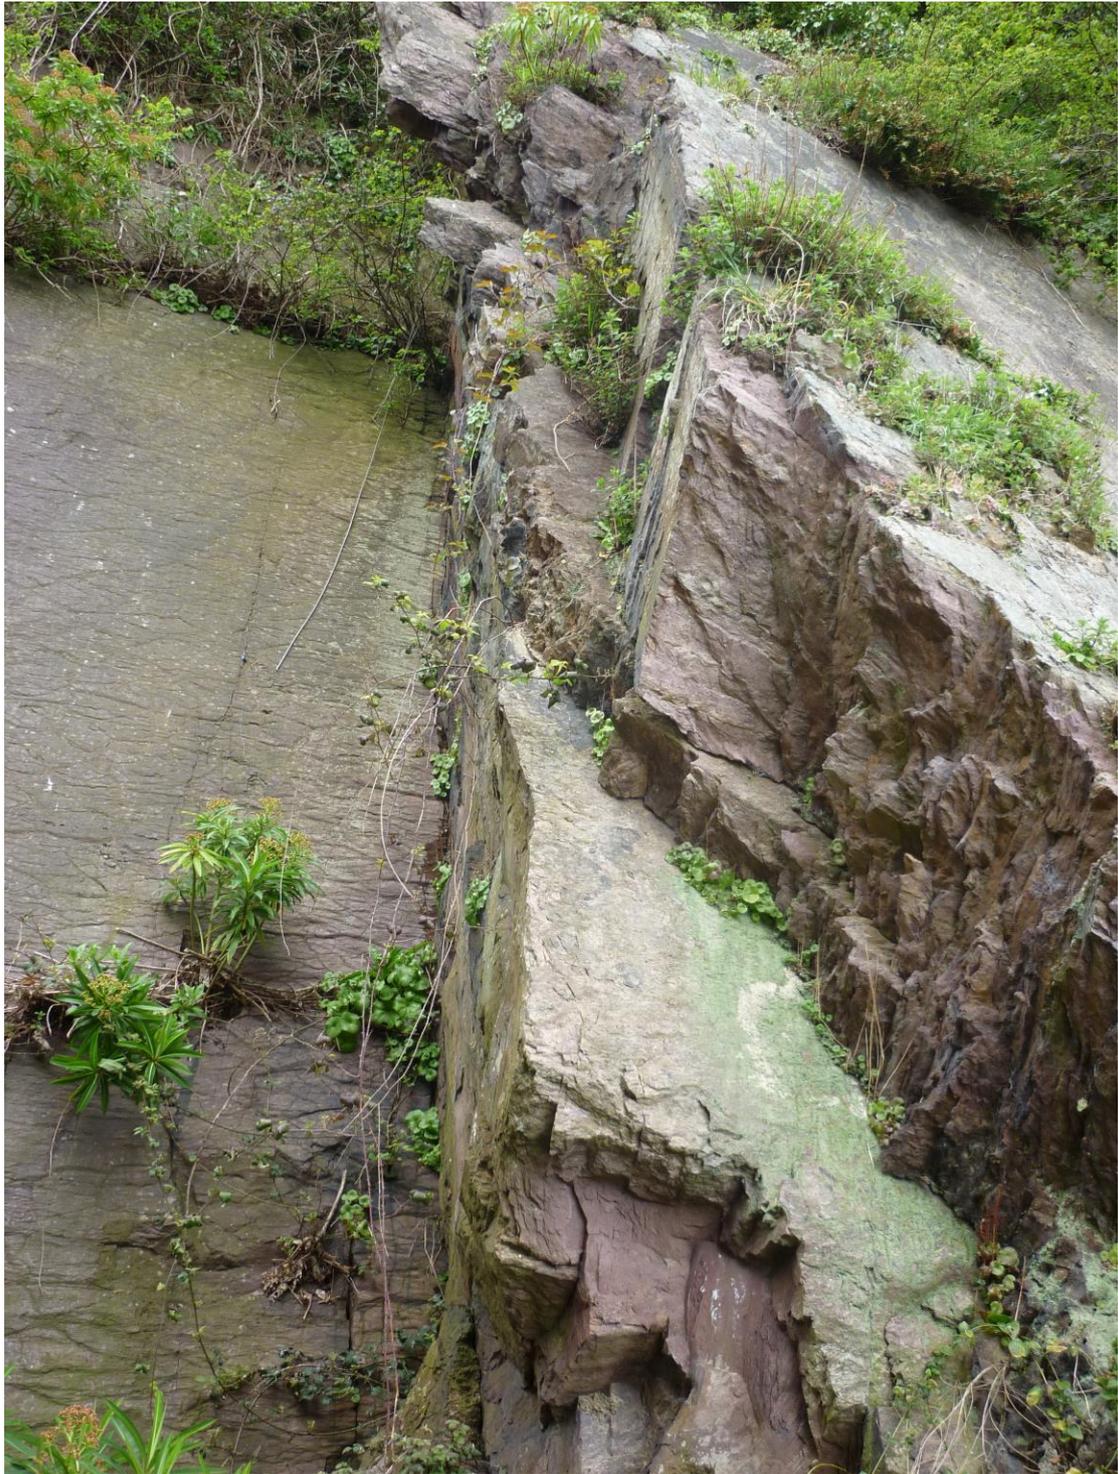
Fig 13.9. Gyleen Formation at Glen Road Quarry (lower) showing steeply inclined jointing in Facies 2-Well-bedded alternating purple sandstones and mudstones. The planes inclined towards the viewer are bedding planes.

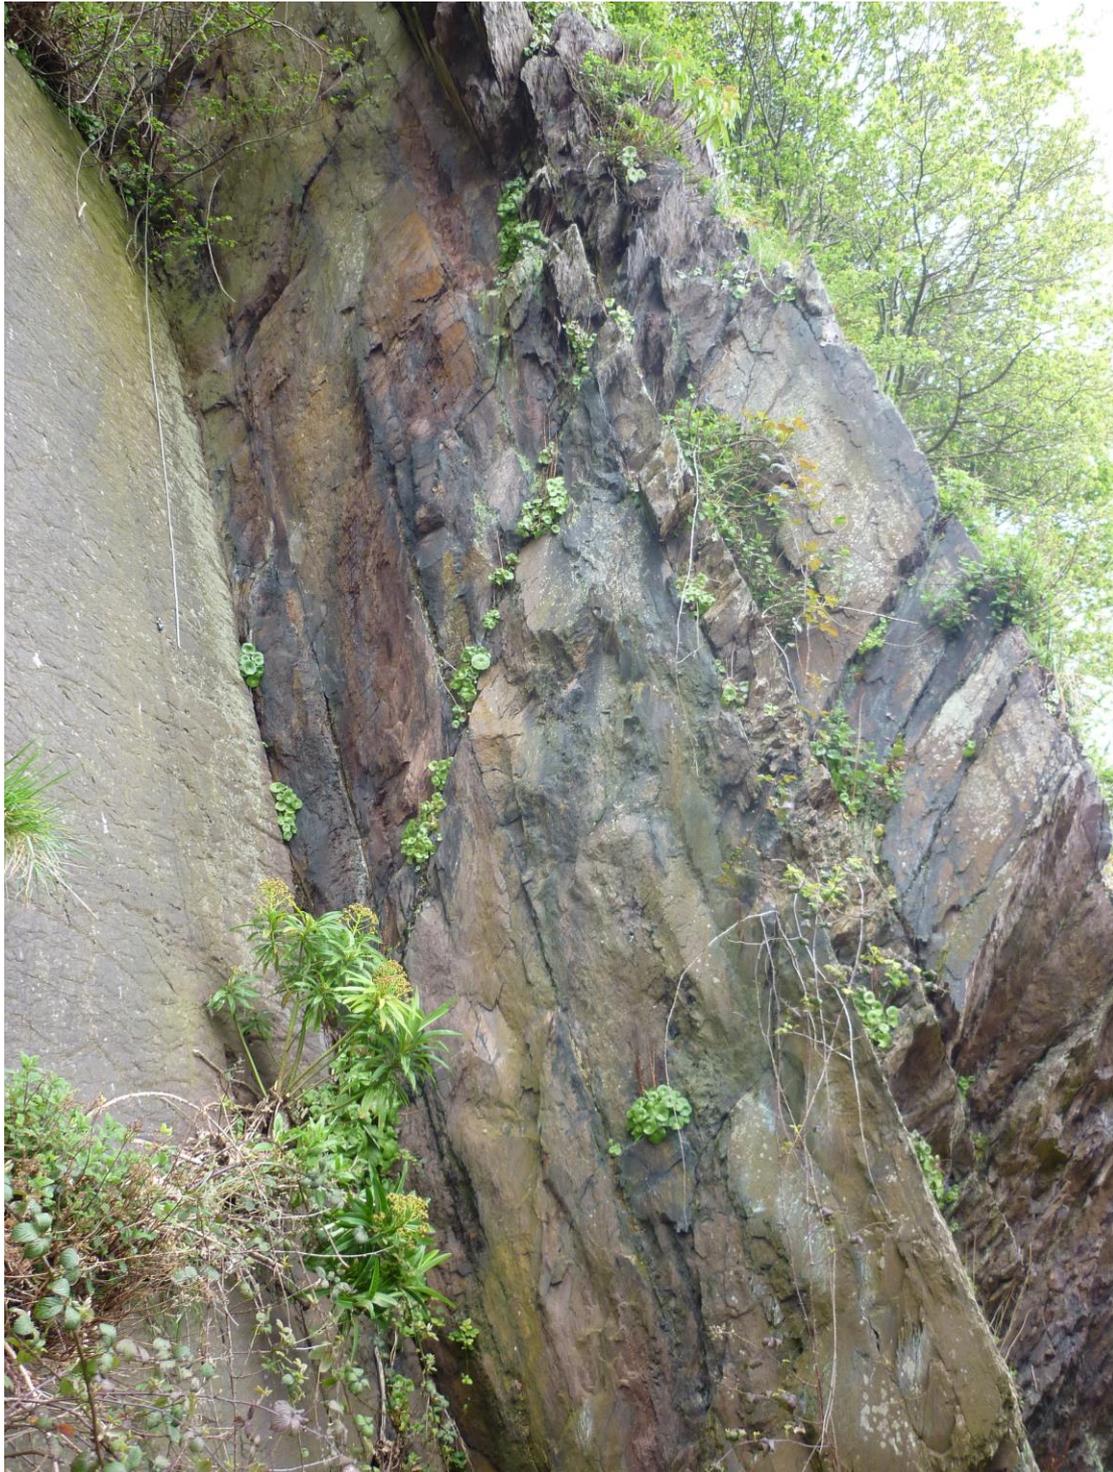
Fig 13.10. Gyleen Formation at Glen Road Quarry (lower). The surface in the centre is a joint plane. The pale coloured surface on the left side is a bedding plane. Facies 2- Well-bedded alternating purple sandstones and mudstones. Bedding planes dip steeply to the right (southwards).

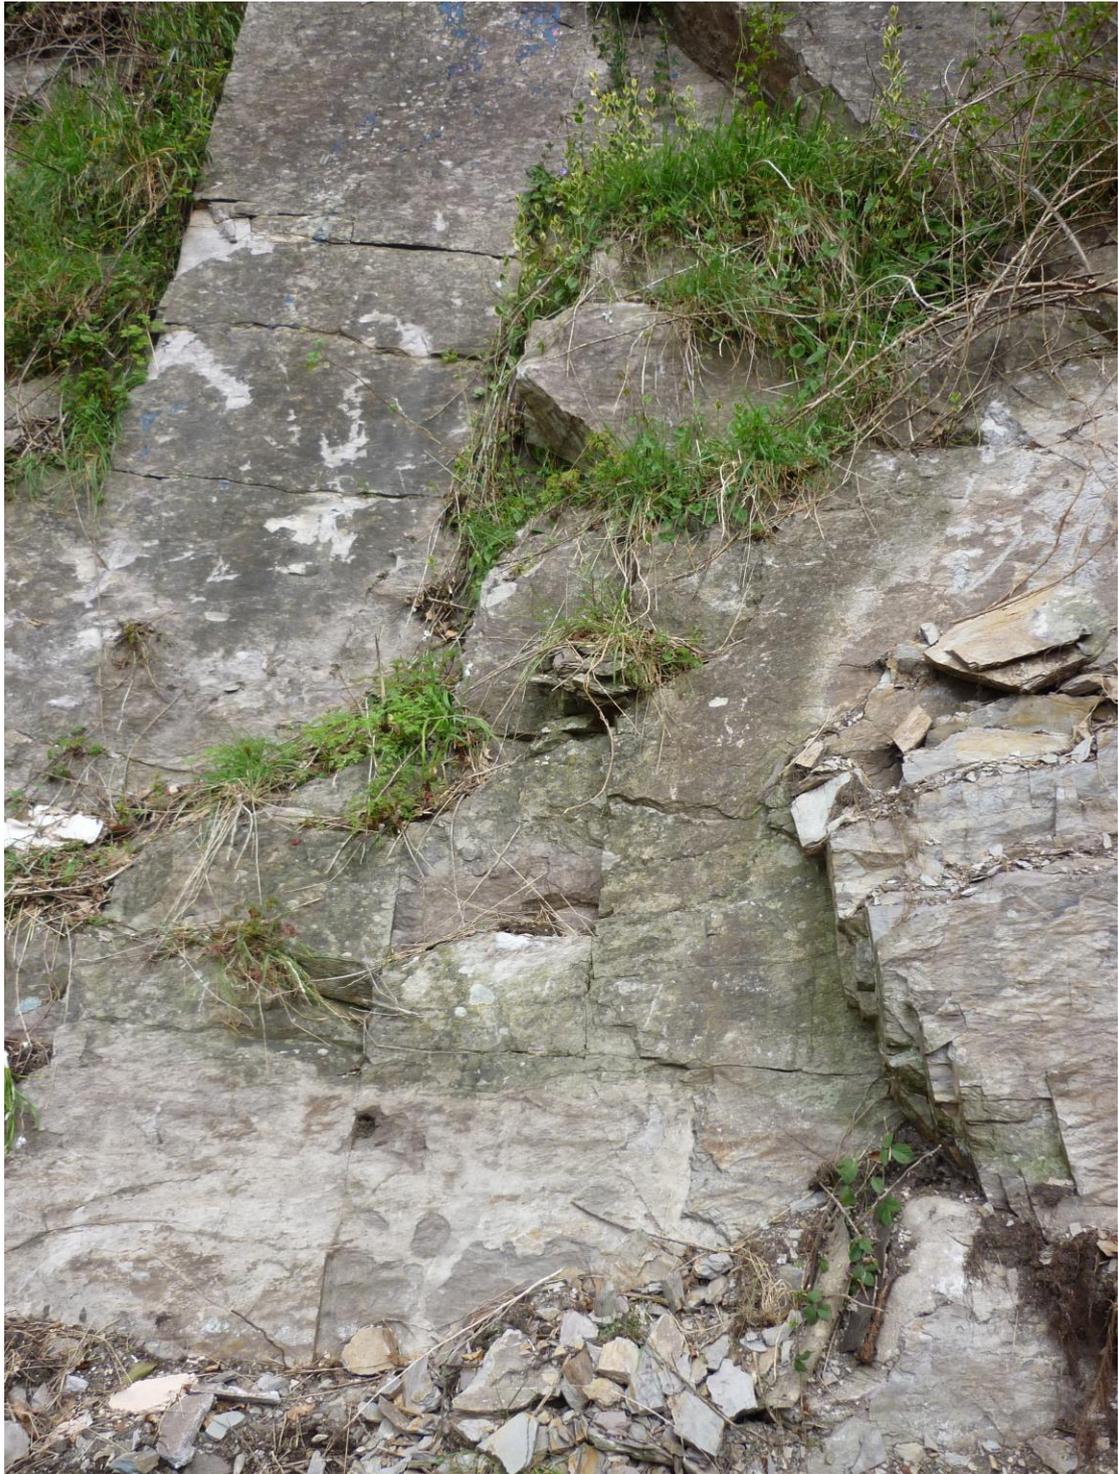
Fig 13.11. Gyleen Formation Glen Road Quarry (lower) showing fracture patterns in Facies 2-Well-bedded alternating purple sandstones and mudstones. Planes inclined towards the viewer are bedding planes.

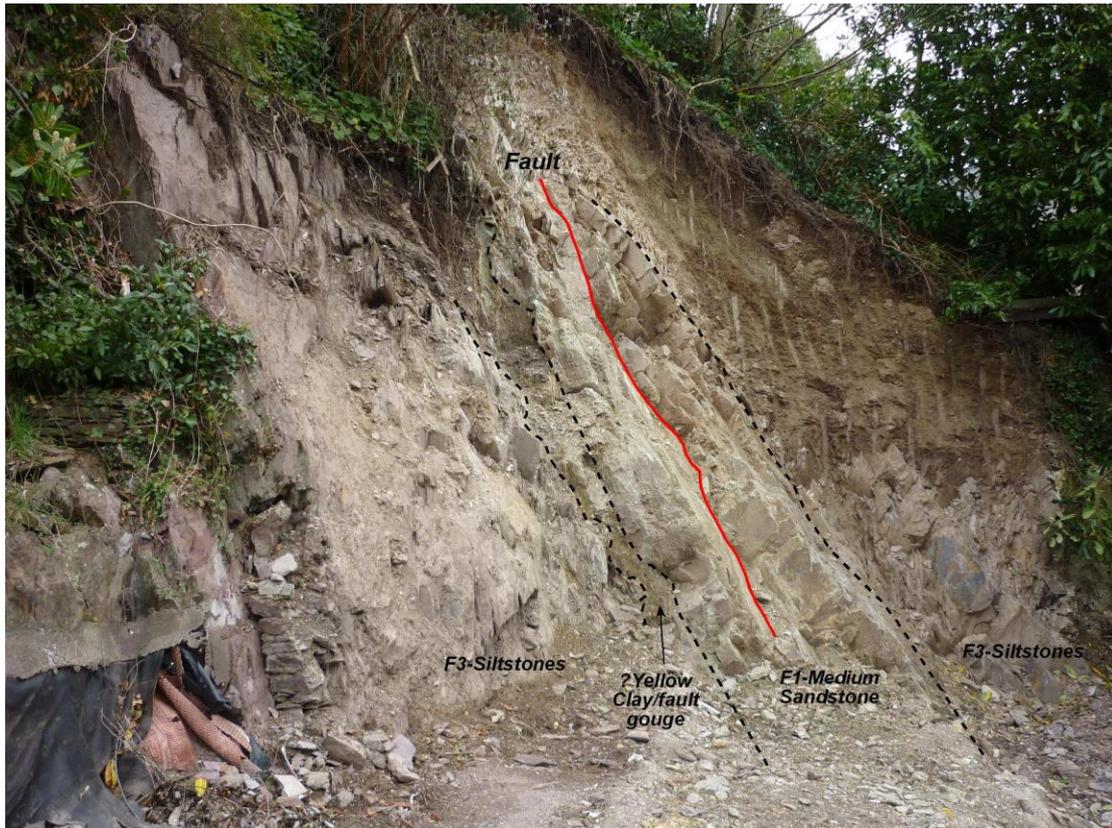
Fig 13.12. Gyleen Formation Glen Road Quarry (lower). F1-Facies 1-Pale green medium-grained sandstones. F3-Pale purple siltstones with partial green secondary colouration derived from overlying sandstones. Note thrust fault (red line) in sandstone unit.

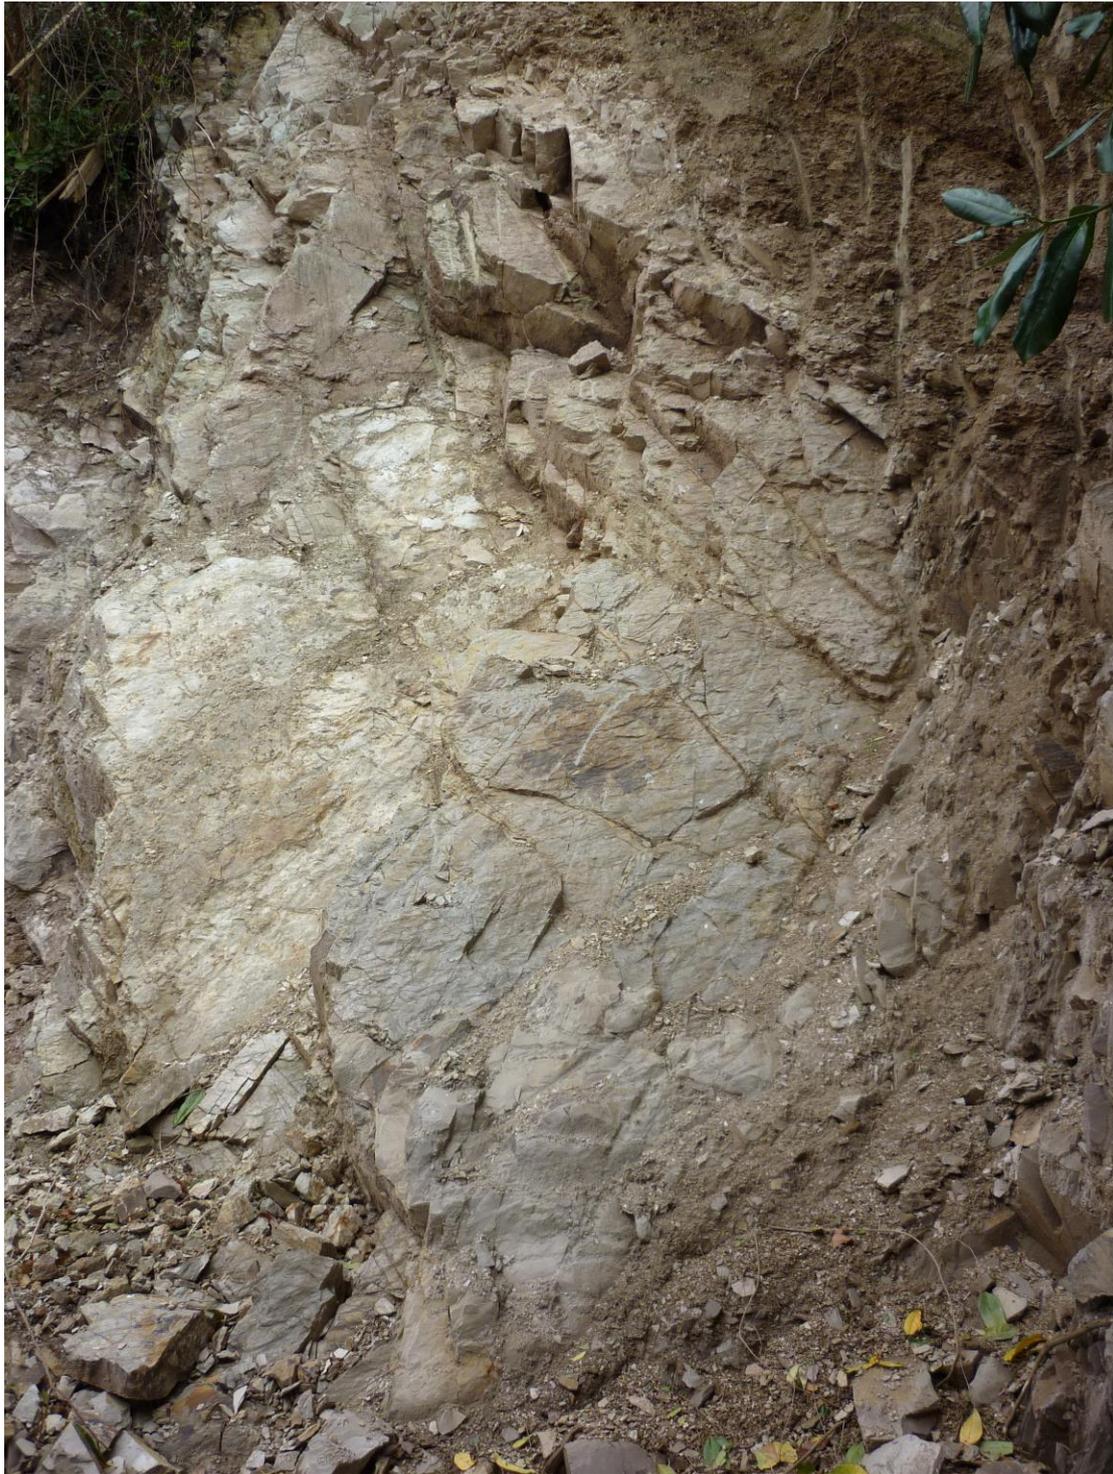
Fig 13.15. Gyleen Formation Glen Road Quarry (lower) showing intersection of joints on bedding plane in Facies 1 sandstones as shown in Fig 13.13. The bedding plane is inclined towards the viewer. The pale coloured plane on the left is a fault plane.

Vein mineralisation similar to that seen in the onshore outcrops (Figs 13.13-13.19) should be anticipated in the offshore area. Veins consisting mostly of quartz are common particularly in sandstones. Minor veins are composed of calcite.

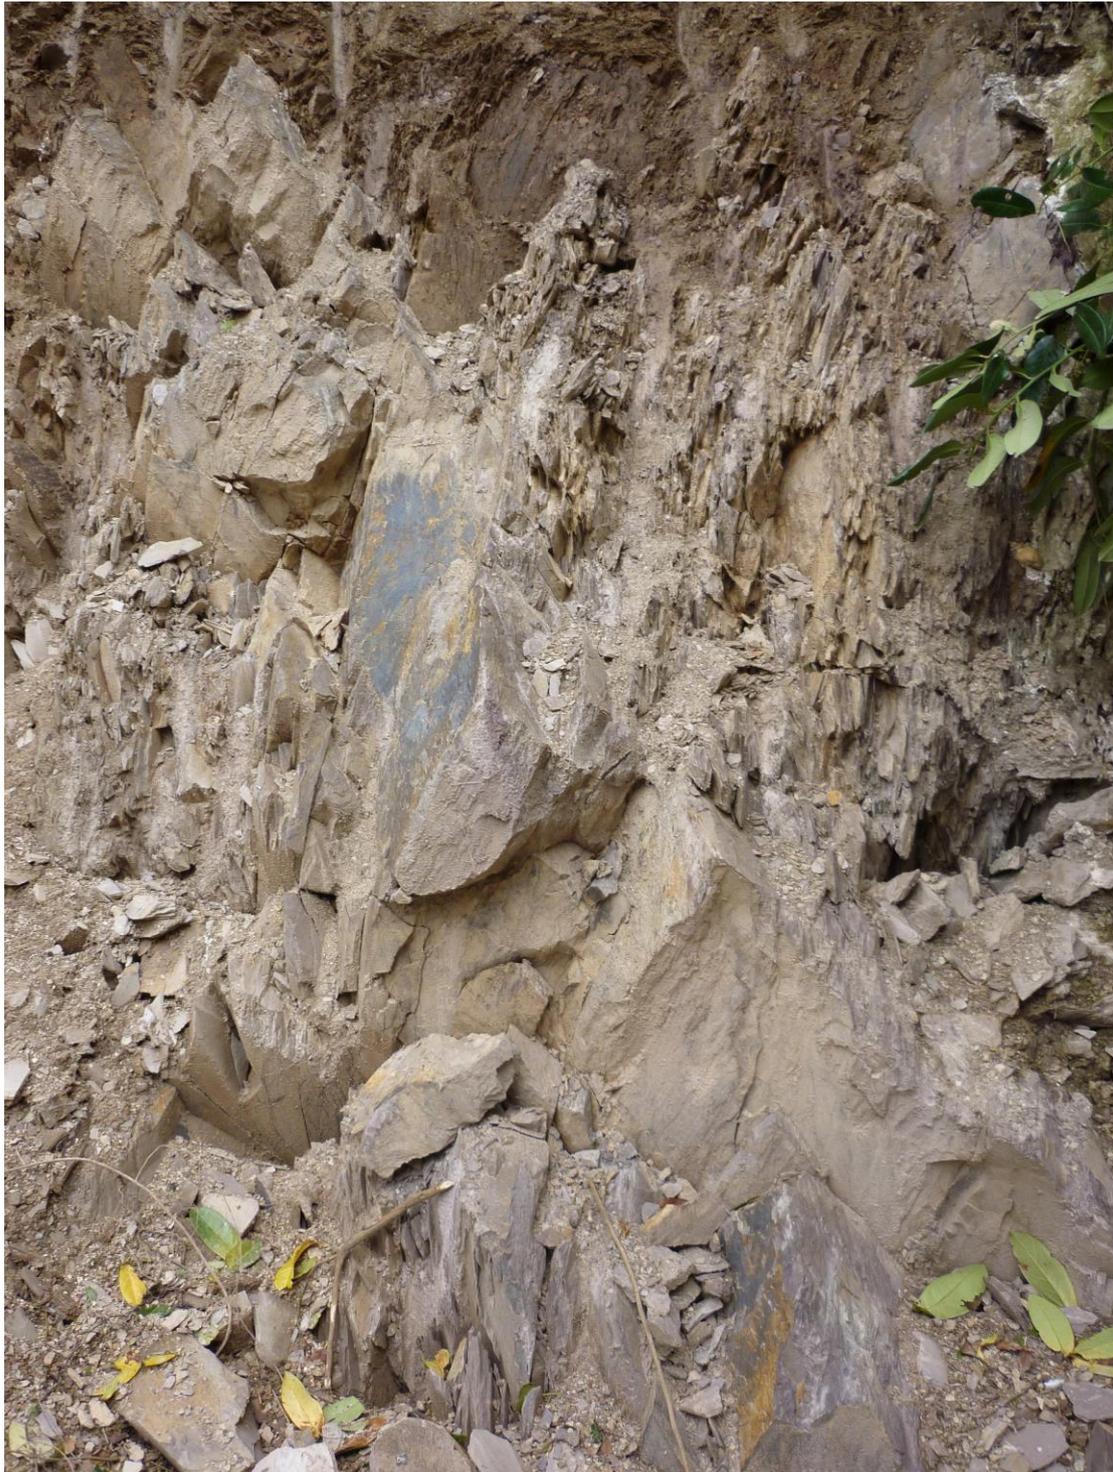
Fig 13.16. Gyleen Formation Glen Road Quarry (lower) showing Facies 3-Purple mudstones with strong sub-vertical cleavage fabric. Bedding planes are inclined to the right at about 45°.
