Cork Lower Harbour Main Drainage Scheme. Estuary Crossing Feasibility Report

Cork Dockyard to Monkstown

**A supplementary Feasibility Study Report in
respect of the installation of pumped sewer mains
by trenchless methods between Cork Dockyard and
Monkstown.**

S3 – 08 July 2016 –FINAL

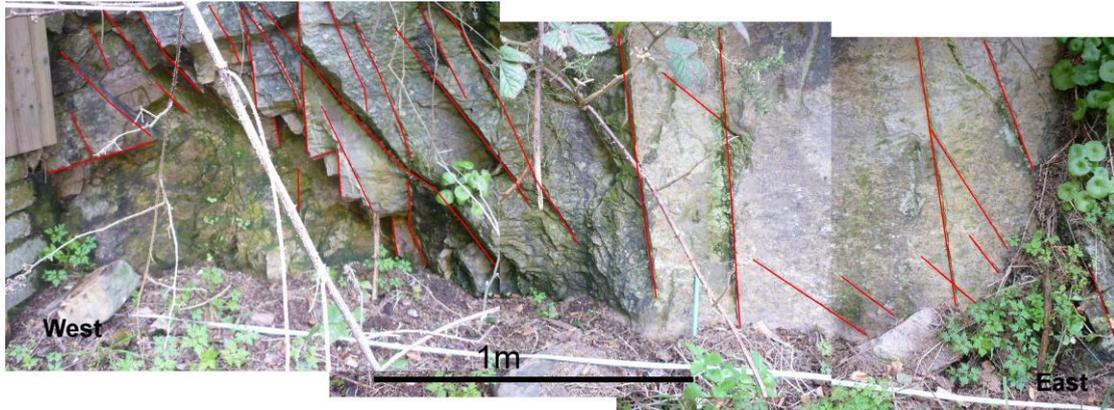
Fig 13.17. Example of the style of jointing (red lines) in the Gyleen Formation at The Haggart, Glen Road Quarry (middle), Monkstown.

Vein mineralisation similar to that seen in the onshore outcrops (Figs 13.13-13.19) should be anticipated in the offshore area. Veins consisting mostly of quartz are common particularly in sandstones. Minor veins are composed of calcite.

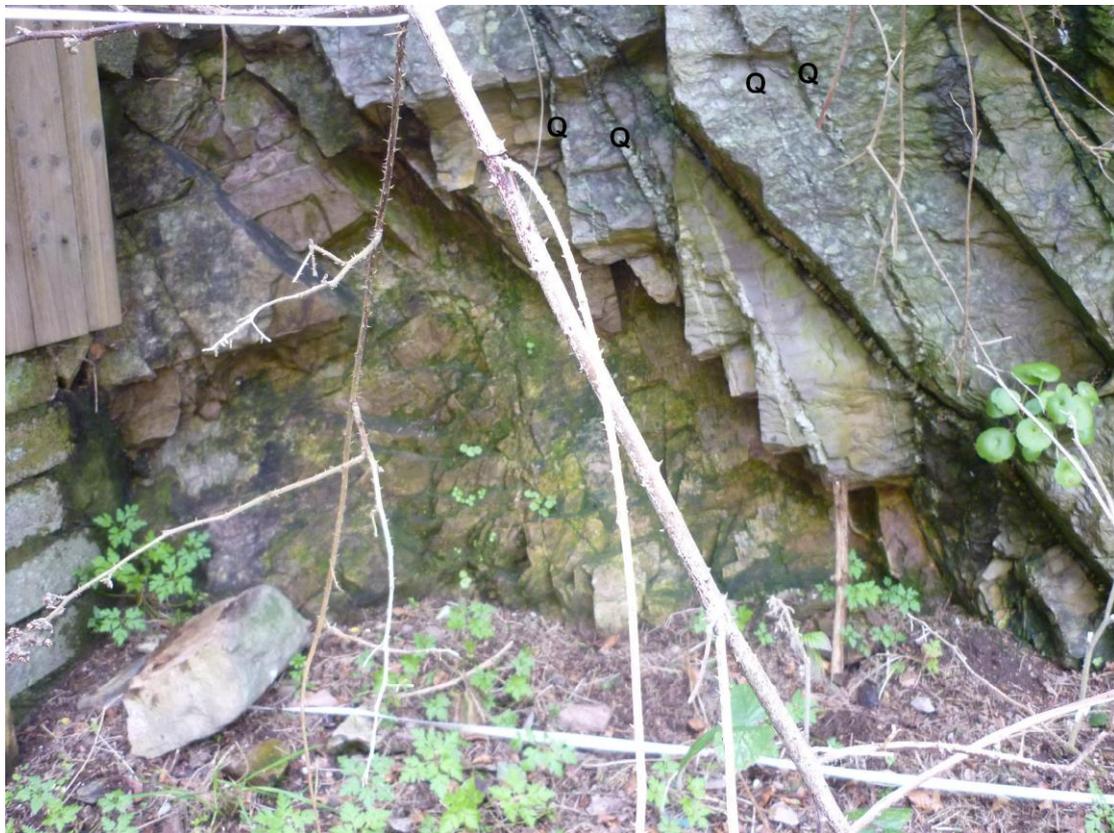
Fig 13.18. Detail of part of Fig. 13.17 showing intense jointing in the Gyleen Formation Glen Road Quarry (middle), Monkstown.

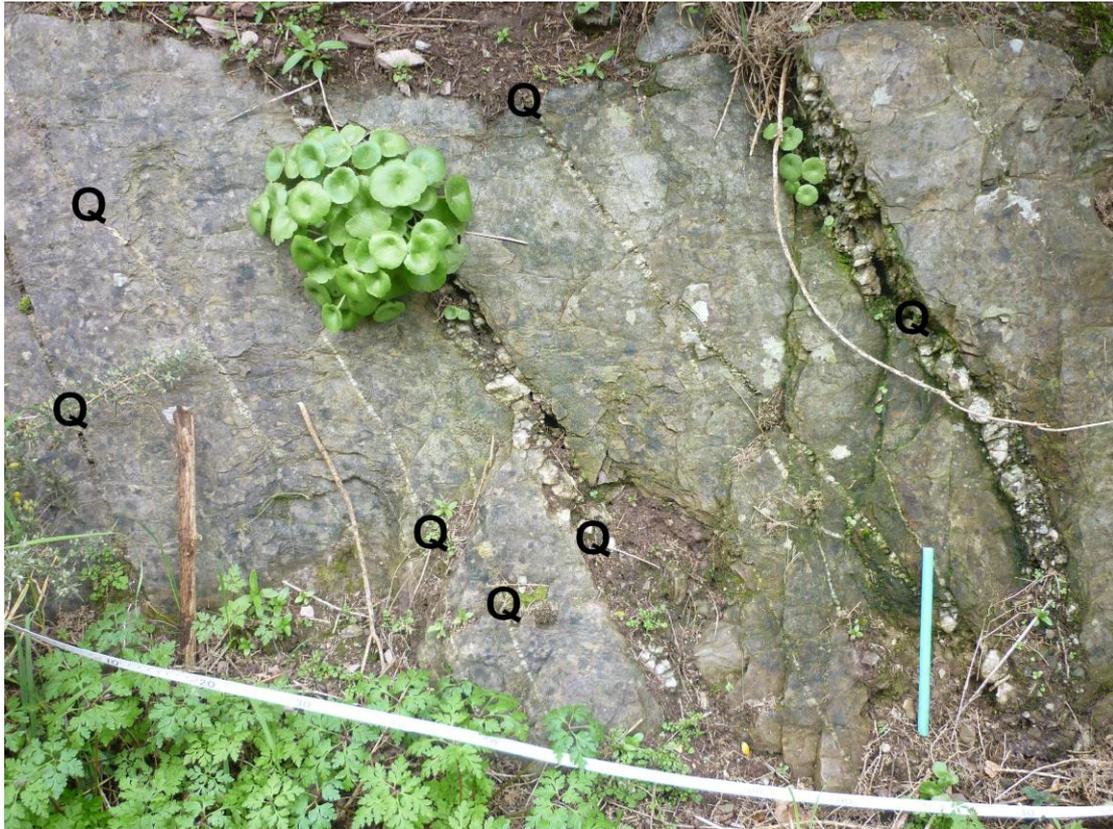
Fig 13.19. Jointing in the Gyleen Formation, The Haggart, Glen Road Quarry (middle), Monkstown. Q-Quartz filled joints.

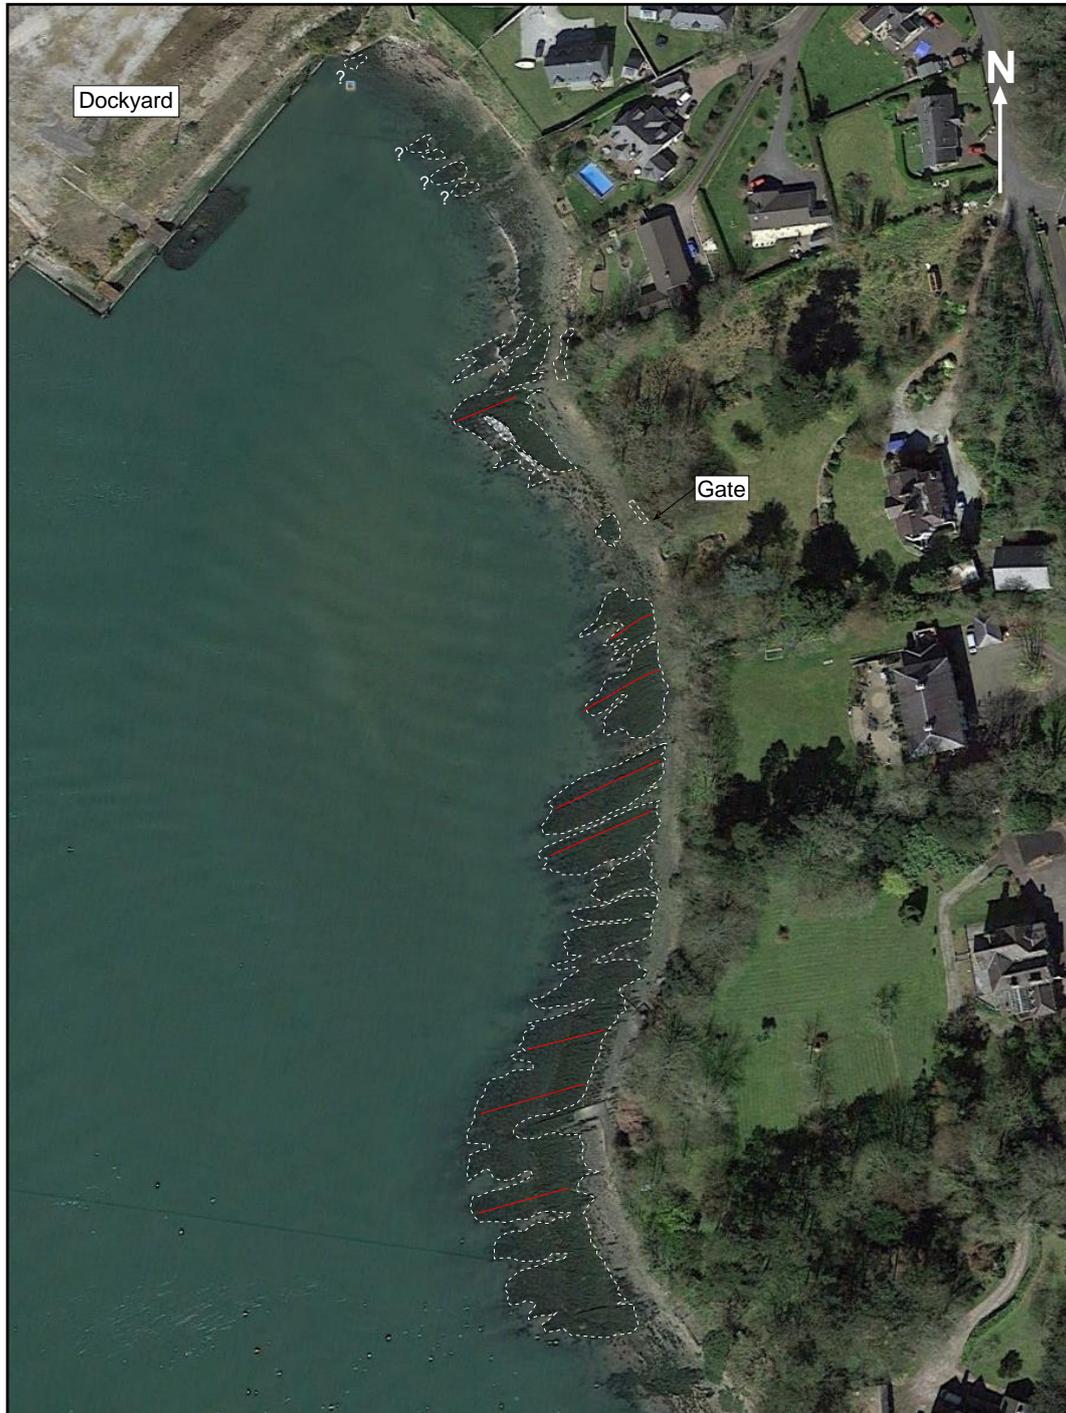
Photo A6/1a. Aerial view of Ringacolting coastal zone showing approximate areas of bedrock outcrop outlined in white line. Strike of bedding/cleavage shown in red.
Image *Google Earth*.

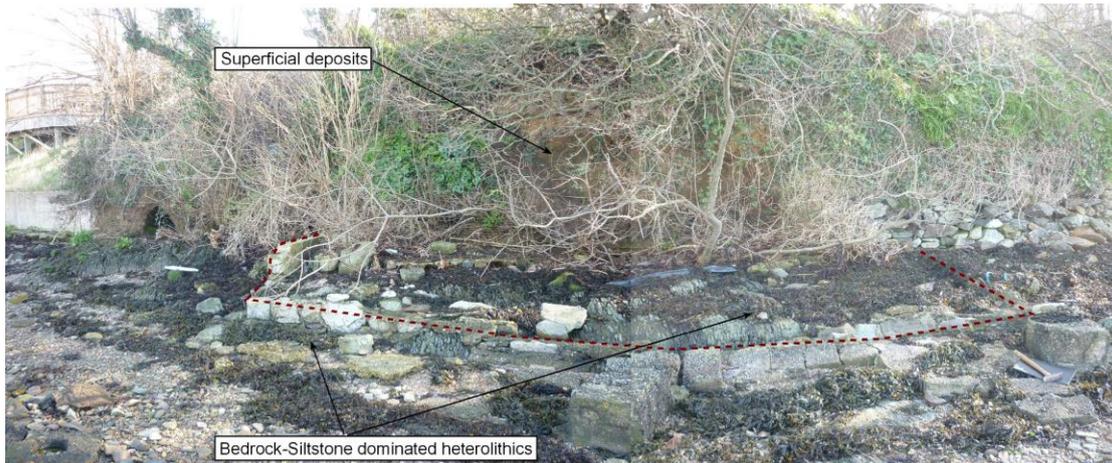
Photo A6/2. Bedrock 1. c.0-20m. Superficial deposits resting on the bedrock which is composed of fine-grained heterolithic rocks with intense fracture cleavage fabric. Red line shows outline of ruined house foundations.

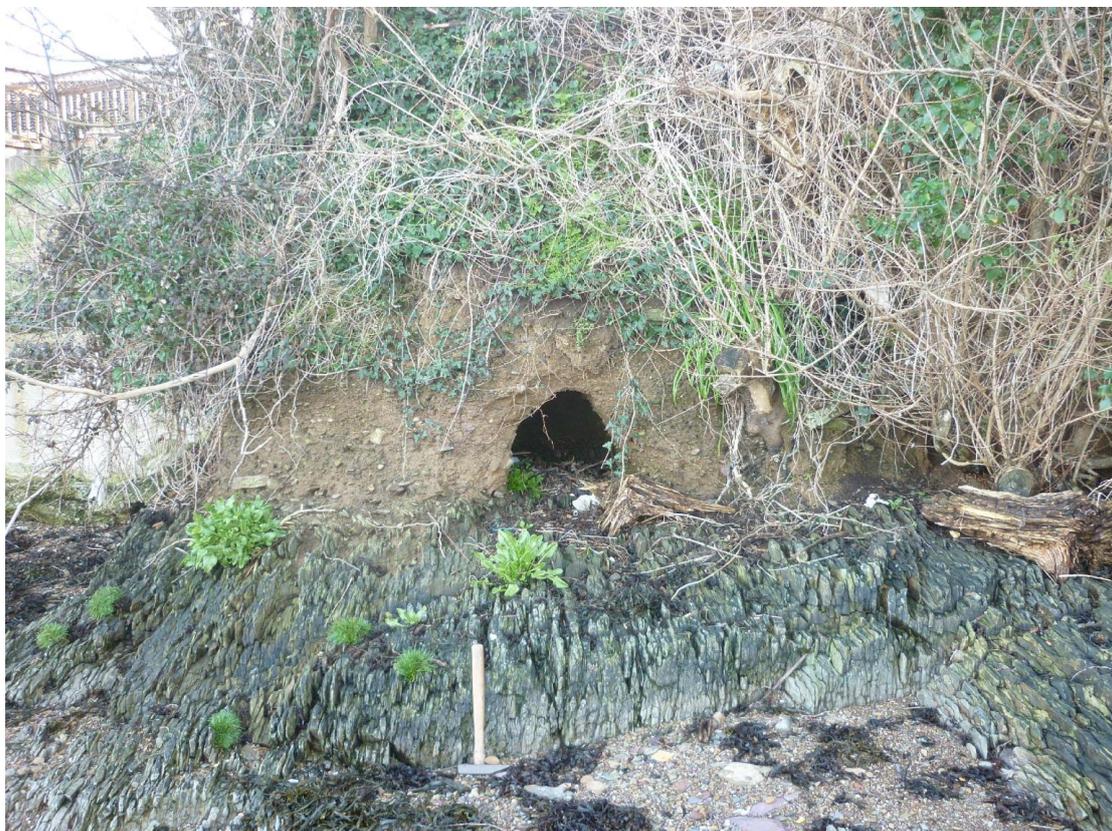
Photo A6/3. Bedrock 1- c.0-5m. Superficial soil deposits resting on strongly cleaved mudstones and heterolithic rocks.

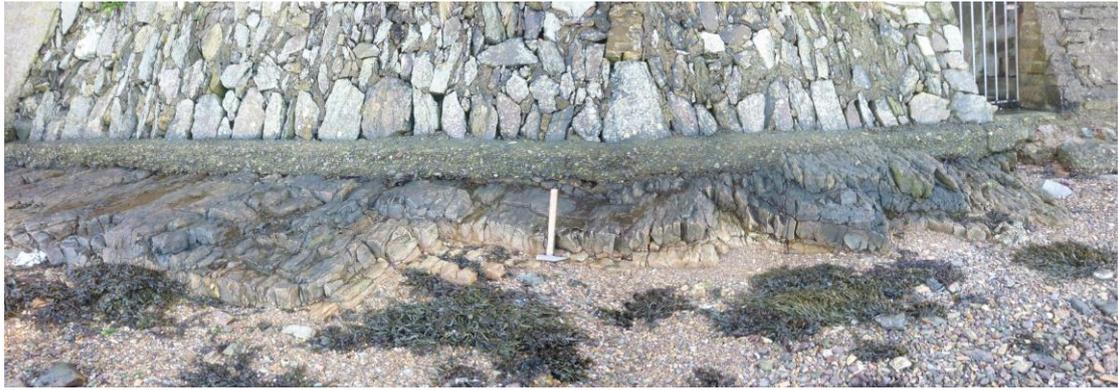
Photo A6/4. Bedrock 5. 50-60m Undulating beds in sandstones of the Cuskinny Member.

The beds are extensively fractured by a vertical fracture cleavage and intense jointing.

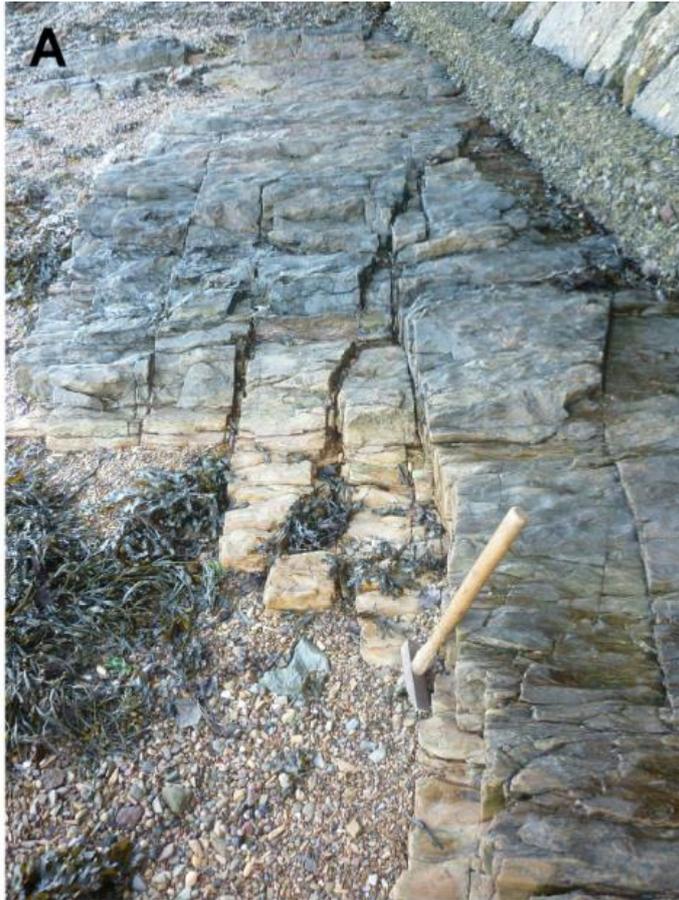
Photo A6/5. Bedrock 5. C.55m. Vertical north-south orientated joints in fractured sandstones. The fabric parallel to the tape is a fracture cleavage. Scale 1m.

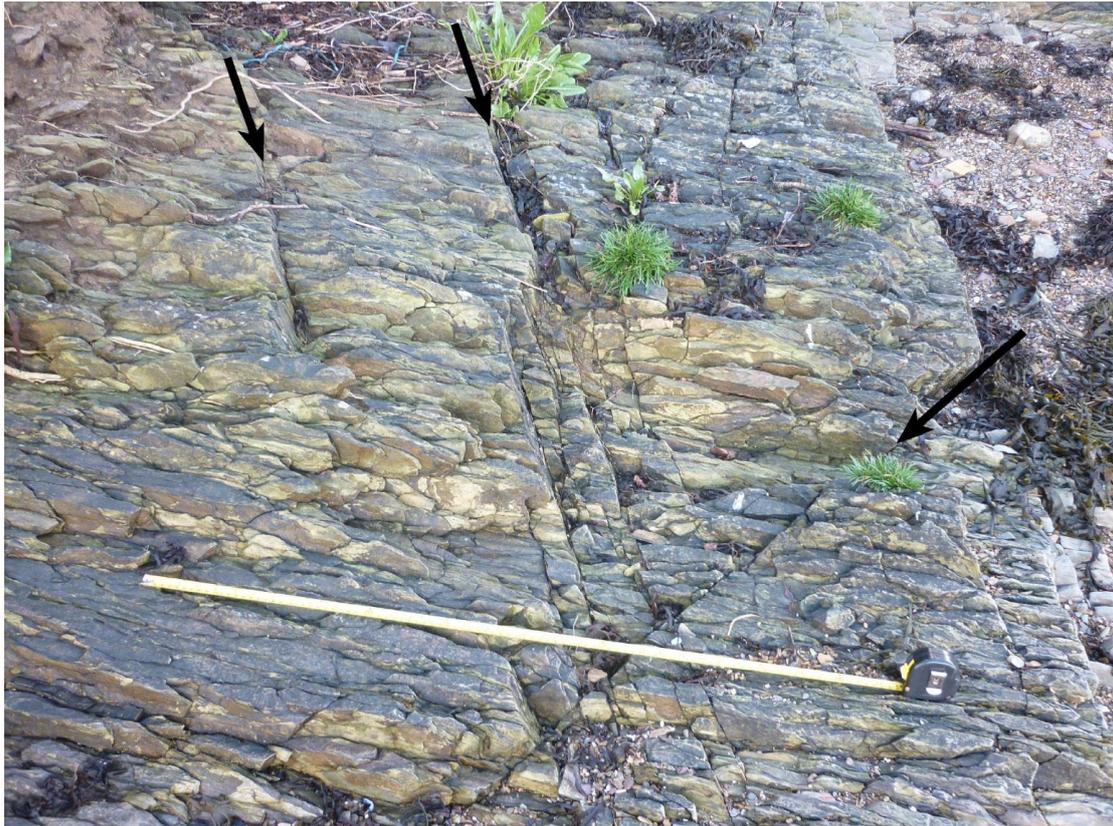
Photo A6/6. Bedrock 1. C.5m. Two sets of intersecting joints in cleaved heterolithics bedrock. Scale 1m.

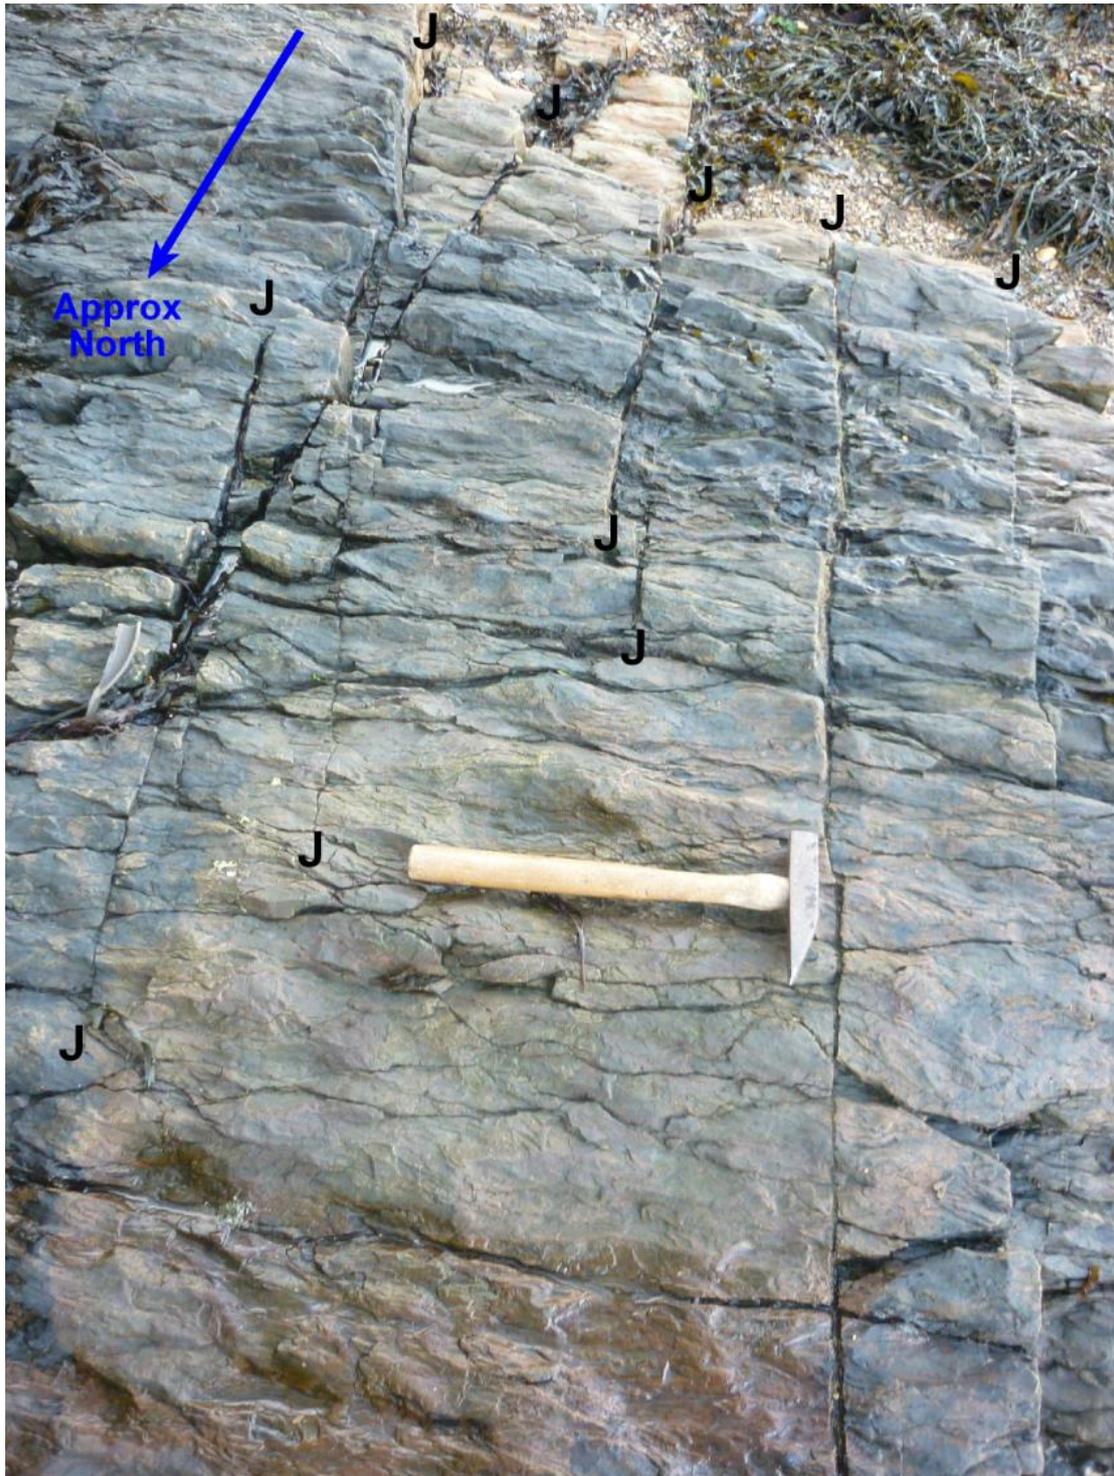
Photo A6/7. Intersecting joint sets in fractured sandstones of the Cuskinny Member at Ringacoltic shore north. The fractures parallel to the hammer shaft are a fracture cleavage. This is a widely spaced cleavage that persists through sandstones. Note that some of the joints are laterally discontinuous. The top surface of the bedrock here is a bedding plane.

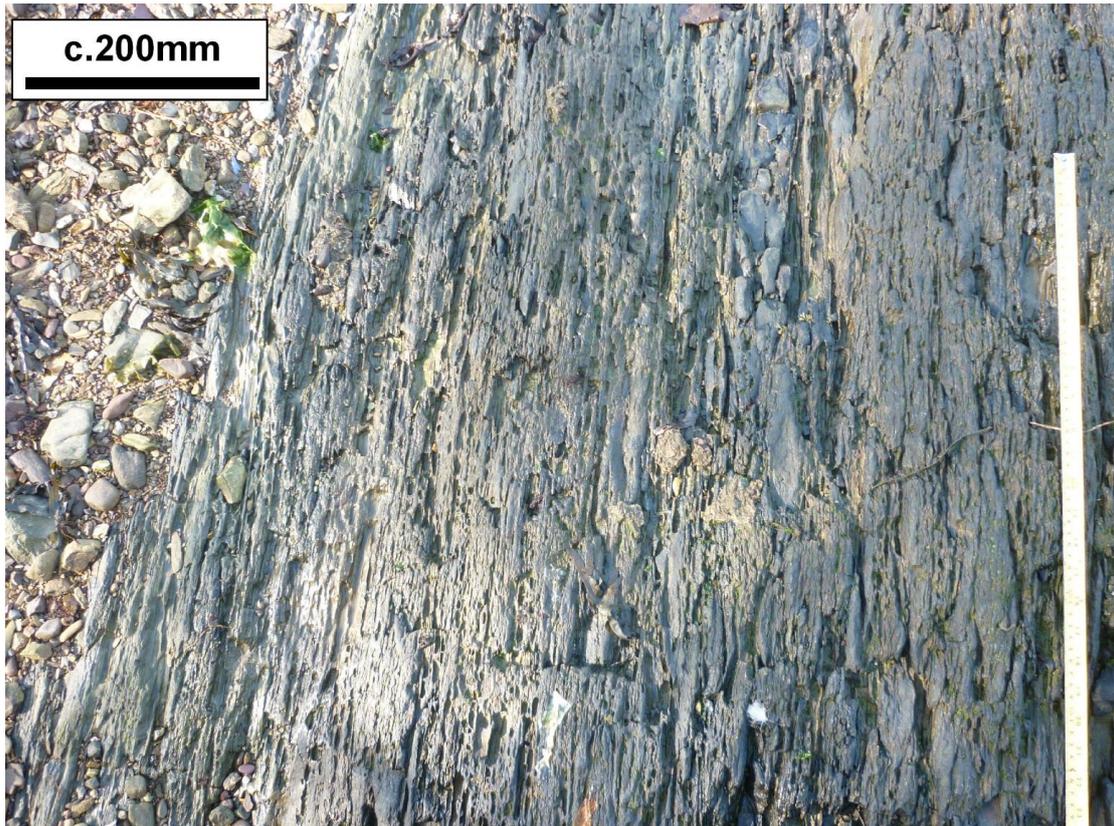
Photo A6/8. Cleaved mudstones and heterolithics at Ringacoltig north. Cleavage planes are parallel to the tape and are closely spaced and inclined steeply to the north (left).

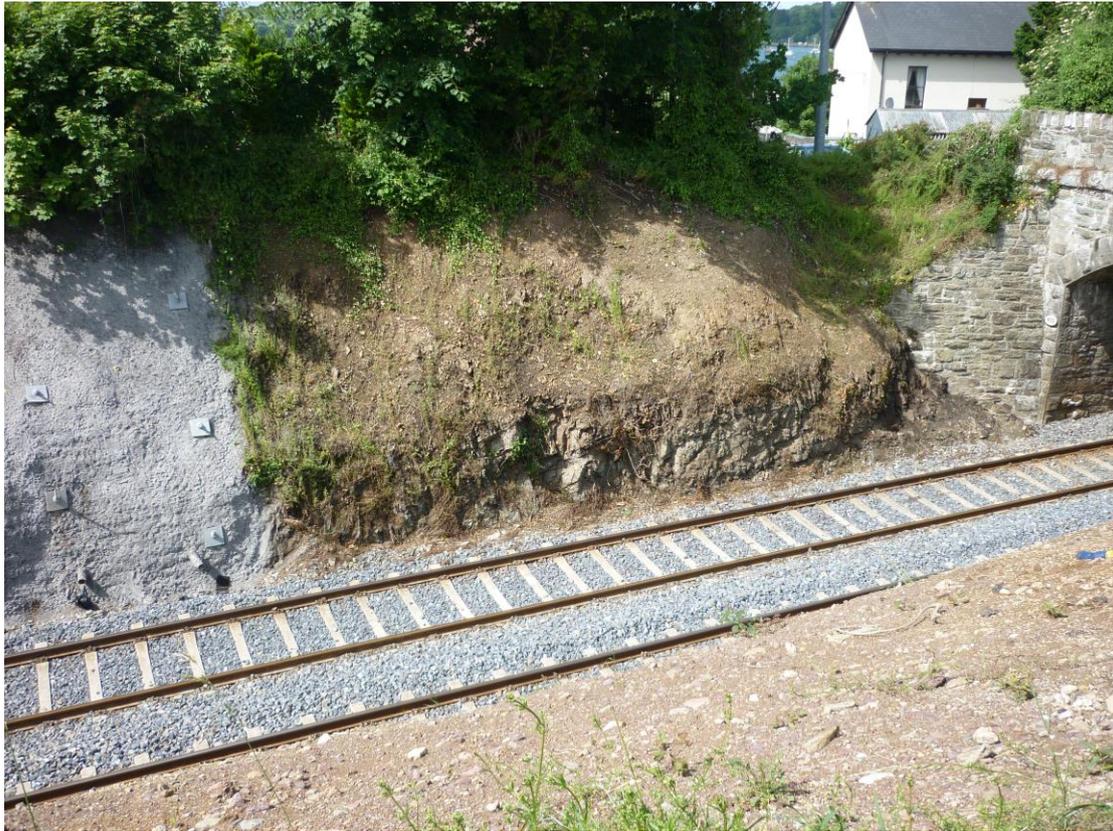
Photo A7/2. View westward of the railway section on the eastern side of Bridge 2.
The bedding dip is towards the left (i.e. to the south-southeast).

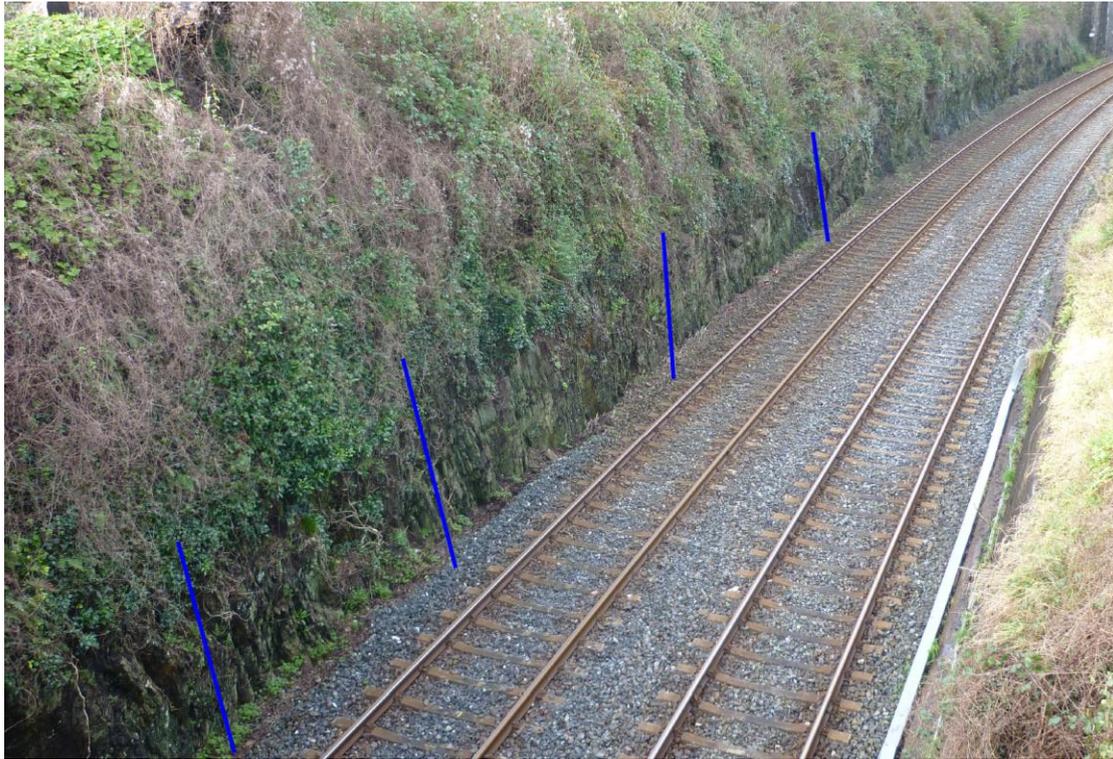
Photo A7/5. This is a view looking northwestwards from Bridge 4 towards Bridge 3. Blue lines show the general development of the cleavage fabric here. The fabric is vertical to sub-vertical and is oriented NE-SW. This is typical of these rocks in the region.

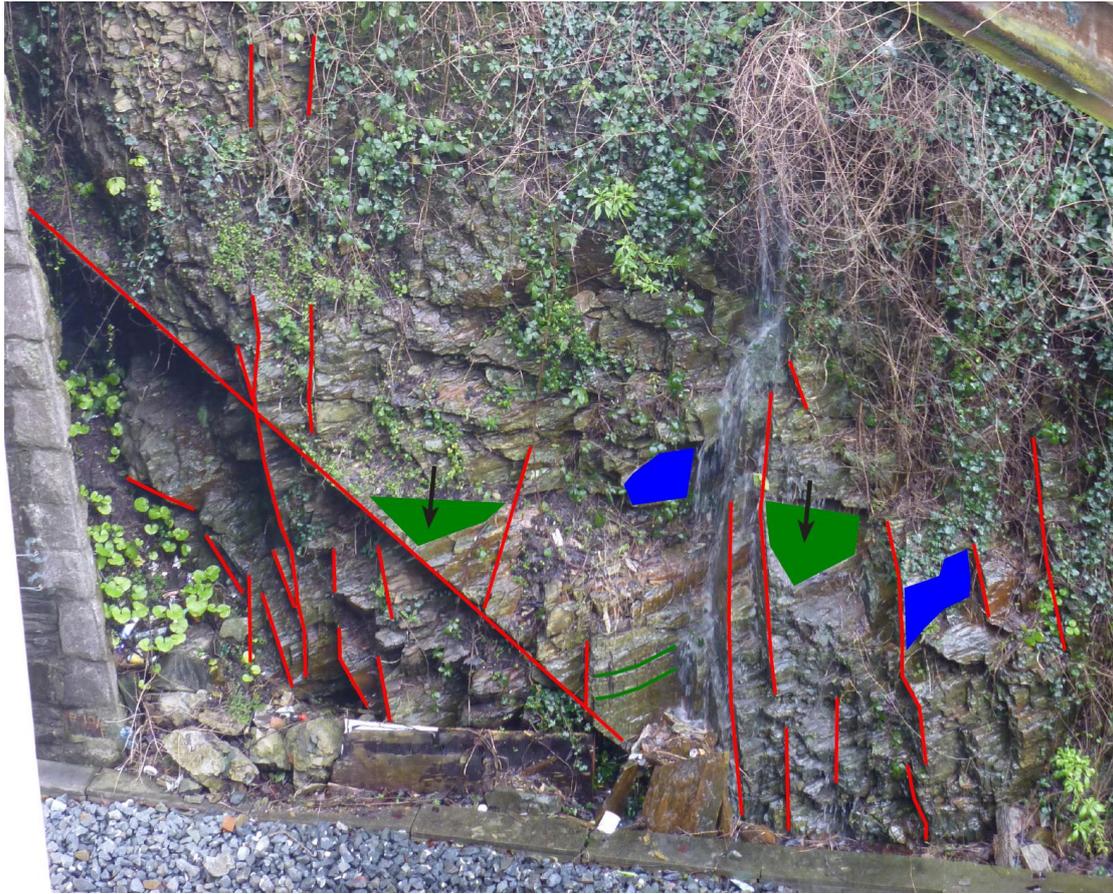
Photo A7/7a. Jointing (red), bedding planes (green) and cleavage planes (blue) in the Cuskinny Member on the eastern side of Bridge 4 looking northwards.

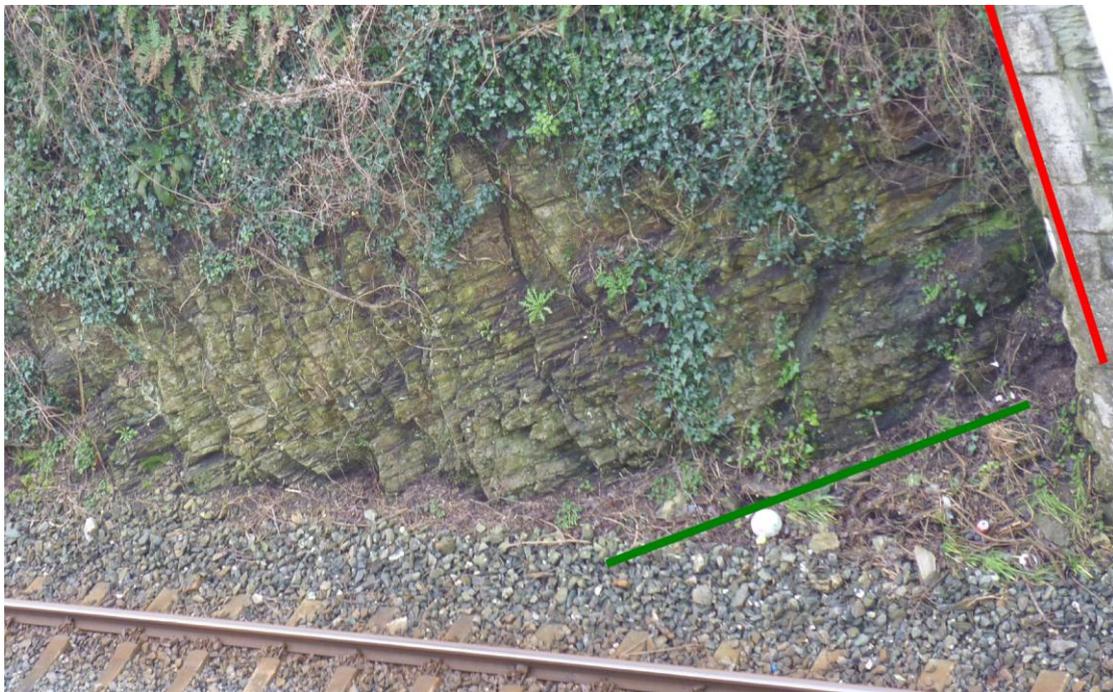
Photo A7/8. Jointing (parallel to the red line) and bedding (parallel to the green line) in the Cuskinny Member on the eastern side of Bridge 4 looking southwards.

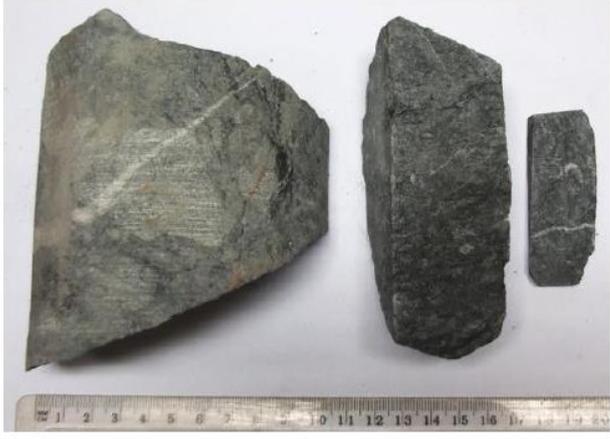
| | <p>BH 04-EC, 30.00m</p> <p>Hand specimen cm scale</p> <p>Medium-grained, grey sandstone and dark grey mudrock wisps</p> <p>Bioturbated texture</p> <p>1-3mm quartz vein visible in core e.g. running top right to centre left on far left sample</p> |

Appearance Mid to dark grey, medium-grained, poorly to moderately-sorted heterolithic rock with mid-grey sandstone (90%) and black mudrock wisps (10%).
 Joints / fractures None visible.
 Veins One quartz vein noted, 1-3mm in width.
 Texture Sedimentary, convolute bedding / lamination.
 Porosity Moderate intergranular porosity, <1.0%.
 Strength Medium-strong to strong.

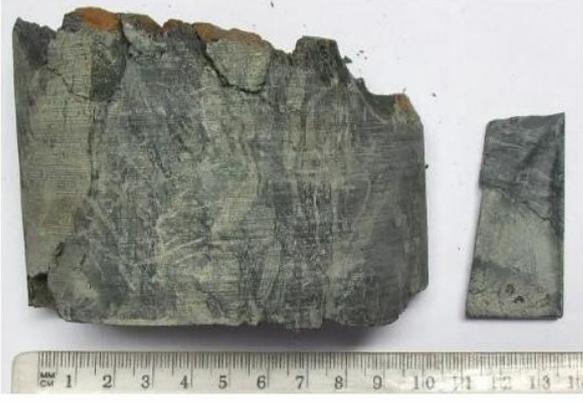
| | <p>BH 05-EC, 22.40m Hand specimen cm scale</p> <p>Flaser-bedded light grey sandstone and dark grey mudrock</p> |

Appearance Cream to dark grey, heterolithic rock with cream, medium-grained, moderately well sorted sandstone (75%) and dark grey, fine-grained mudrock (25%), pyrite flakes are noted in mudrock laminations.
 Joints / fractures Minor fracture, <0.5mm, present along sandstone / mudrock contacts.
 Veins None visible.
 Texture Sedimentary, flaser bedding and lineation visible.
 Porosity Minor intergranular and fracture porosity present.
 Strength Medium-strong to strong.

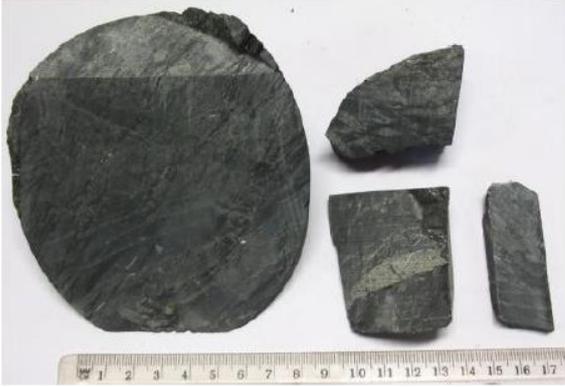
| | <p>BH 05-EC, 44.60m Hand specimen cm scale Grey, heterolithic rock with dark grey mudrock layers and light grey sandstone layers</p> |

Appearance Mid-grey, heterolithic rock sample with laminated intervals of dark grey, well-sorted mudrock (60%) and mid-grey, medium-grained sandstone (40%).
 Joints / fractures Thin fractures present along lineation (crosscuts bedding), <0.5mm in width, occasionally partially-infilled with quartz.
 Veins None visible apart from partially infilled fractures.
 Texture Sedimentary, medium to thick, discontinuous laminations (2-10mm), stain lineation highlighted by thin fractures crosscuts bedding at 40°.
 Porosity Minor porosity along fractures.
 Strength Medium-strong to strong.

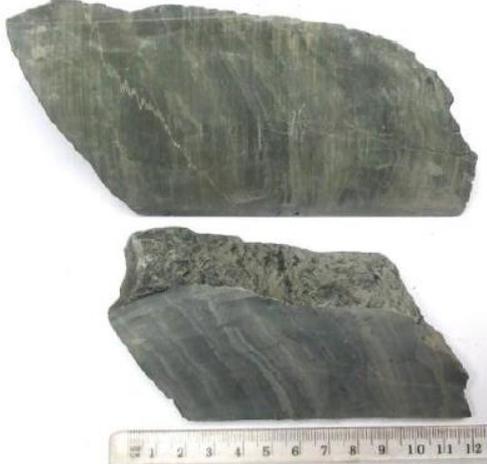
| | <p>BH 08-EC, 25.00m Hand specimen cm scale</p> <p>Mid-grey, fine-grained, thinly laminated mudrock</p> <p>Laminations are visible running top to bottom on core (top) and cut (bottom) surfaces</p> |

Appearance Mid grey / green, fine-grained, moderately to well-sorted, thinly laminated siltstone and mudrock.
 Joints / fractures Thin fractures, <0.5mm present, crosscut laminations at approx. 90°.
 Veins None present.
 Texture Sedimentary, thinly laminated.
 Porosity Minor fracture and intergranular porosity.
 Strength Weak to medium-strong.

Structure This is a fine-grained, well-sorted, thinly laminated mudrock with silty mudrock units. The laminations are 0.2-3mm in width. The matrix of the rock is composed of fine-grained clay mineral and quartz. The components in the rock are clay mineral, quartz, muscovite, and opaques. There are thin stylolites present running perpendicular to the lamination. There is a thin fracture running parallel to the lamination with hæmatite weathering visible on either side of the fracture.

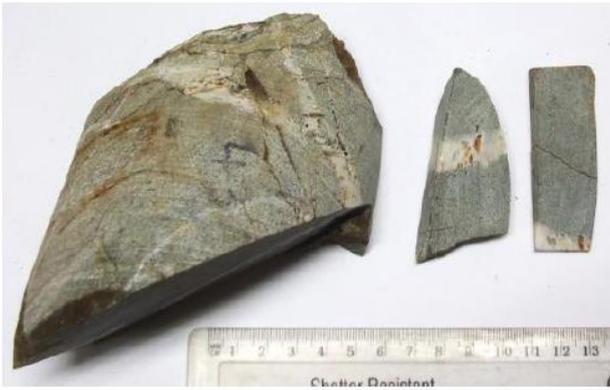
BH 09-EC, 43.00m

Hand specimen
cm scale

Light grey, medium-grained,
sandstone with quartz veins, slightly
vuggy texture

Appearance Light grey, medium-grained, well-sorted, non-calcareous sandstone.
 Joints / fractures Thin fracture <0.5mm in width.
 Veins Quartz veins <1cm in width are present.
 Texture Sedimentary, massive texture, slightly vuggy texture possibly due to some dissolution.
 Porosity Moderate porosity <1.0%.
 Strength Strong to very strong.

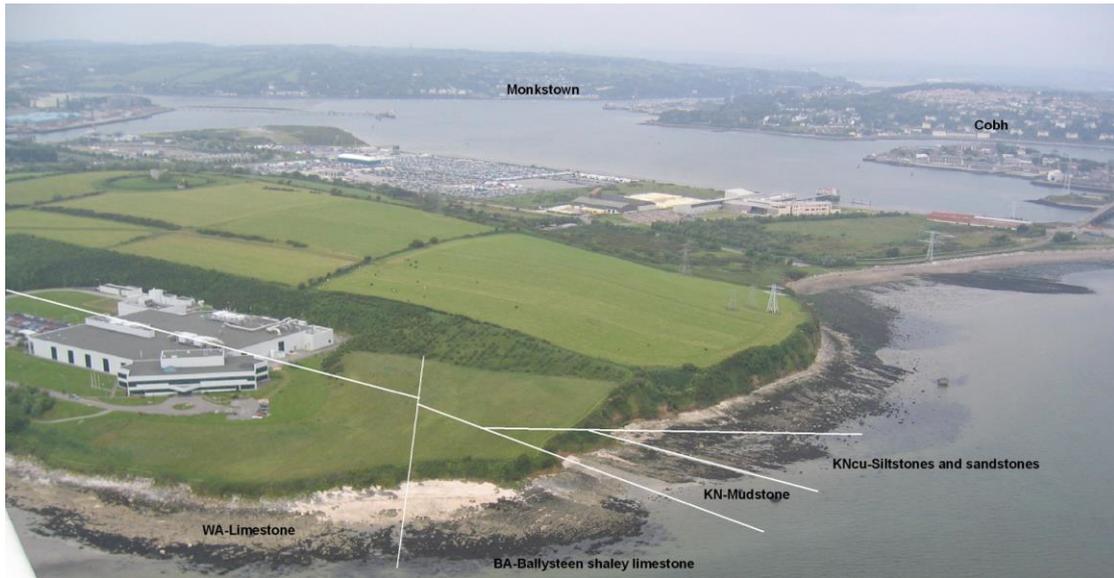
Appendix B2. Aerial view of the Ringaskiddy coastal section showing the bedrock.

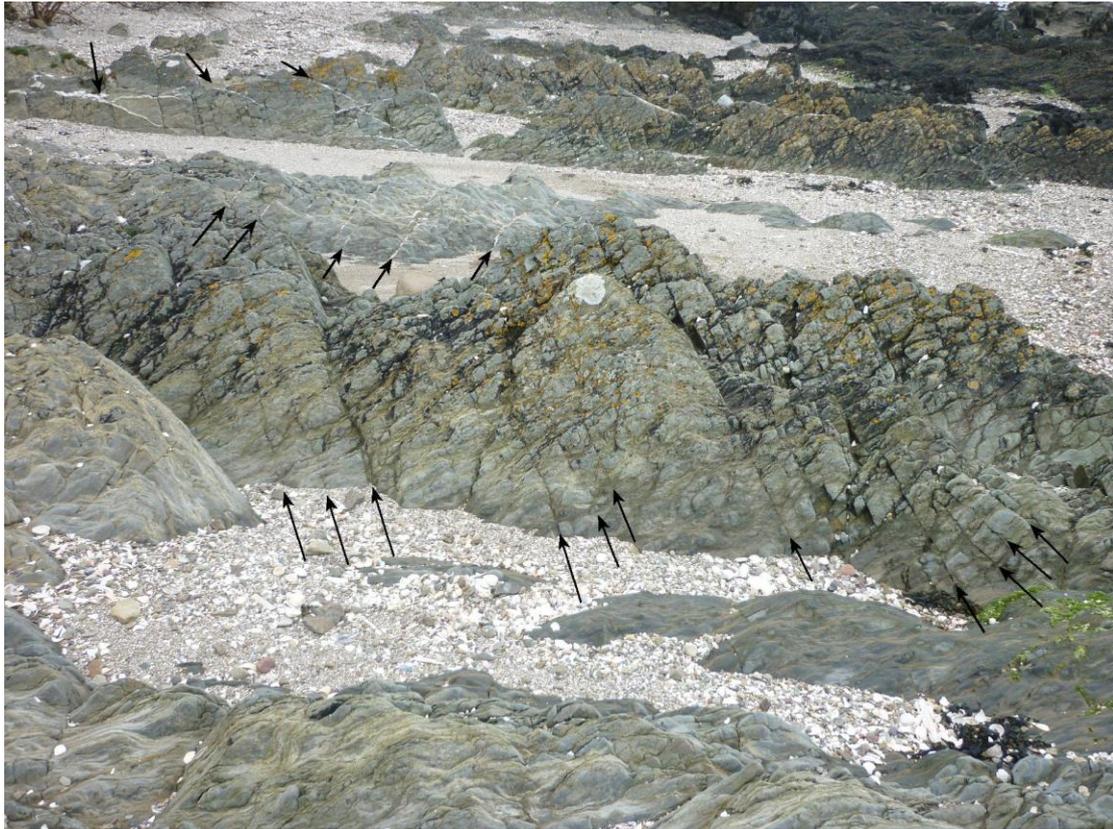
Appendix B3. Jointing pattern (arrows) in the Kinsale Formation Cuskinny Member at Ringaskiddy. The bedrock is almost entirely composed of heterolithic beds. Many of the joints have infills of white vein quartz (arrows). View northwards. Bedding planes dip towards the viewer.

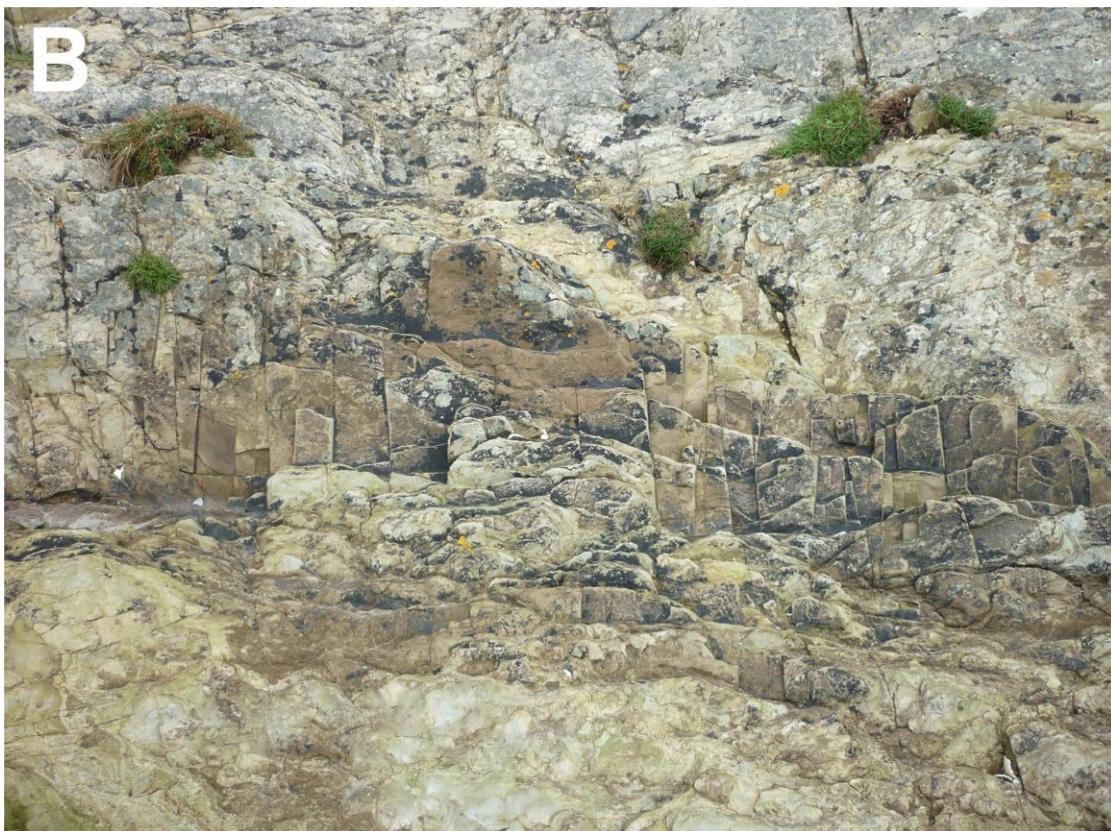
Appendix B4. A-Relationship between cleavage and bedding exposed on a vertical joint plane at Ringaskiddy. B-Vertical joints in weathered siltstones at Ringaskiddy.

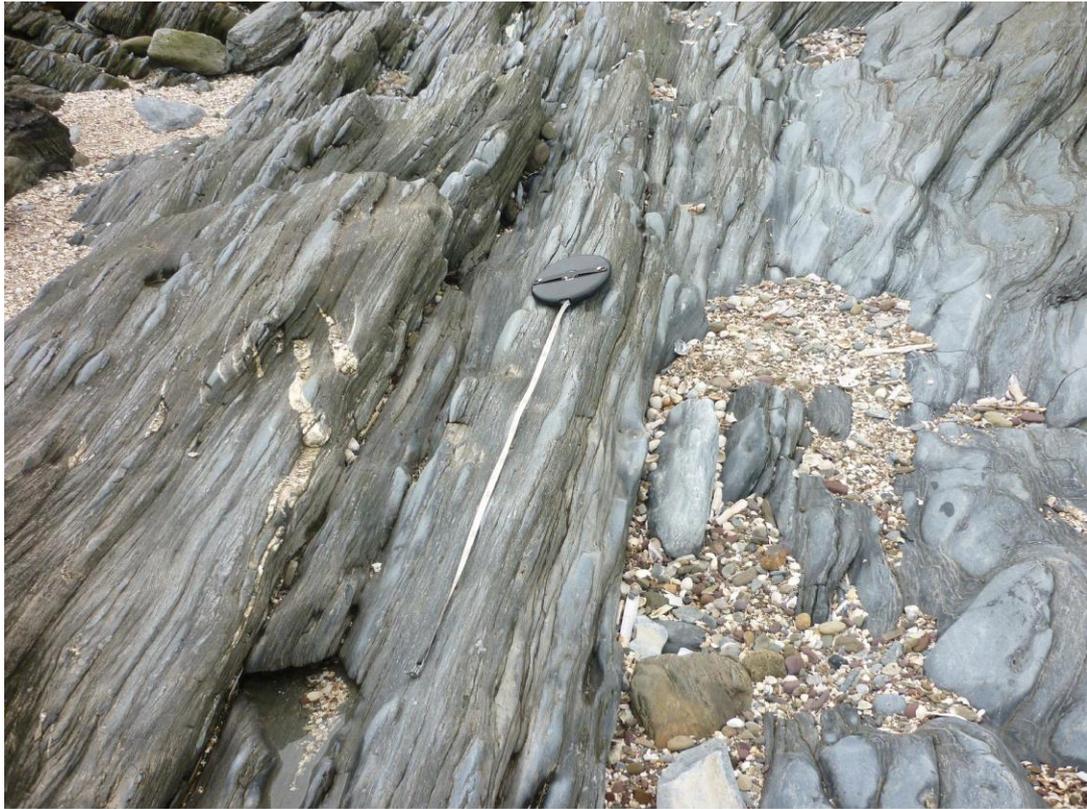
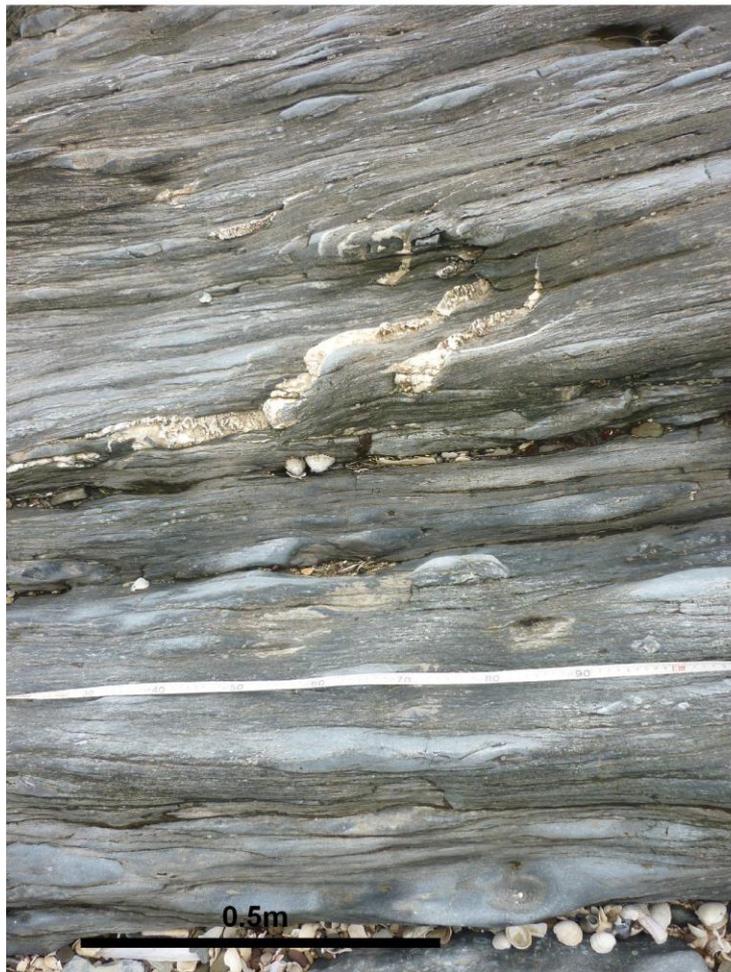
Appendix B6. Ballysteen Formation at Ringaskiddy.

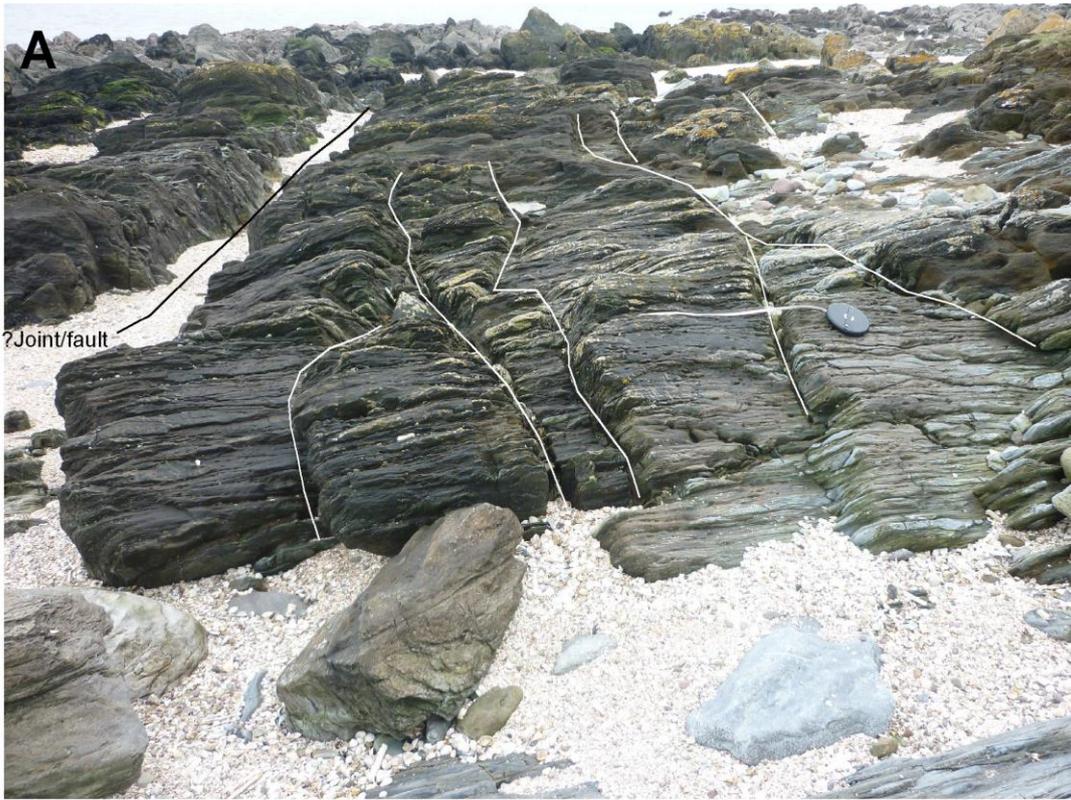
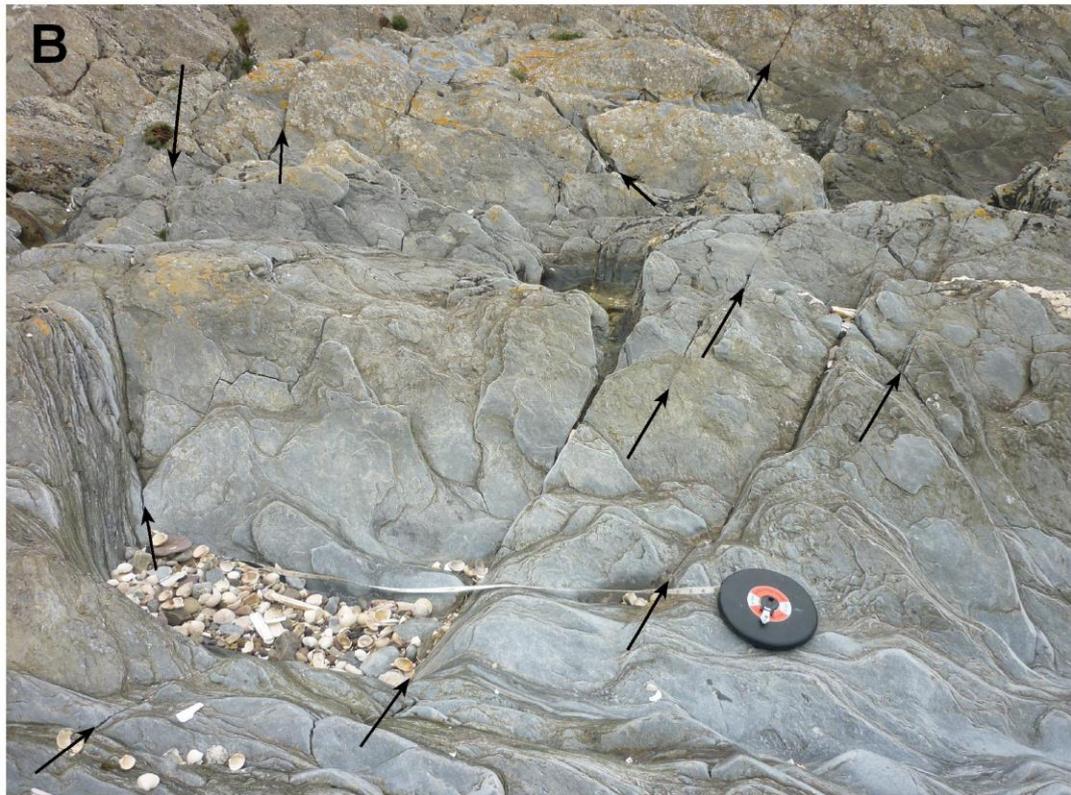
Appendix B7. Jointing in the Ballysteen Formation at Ringaskiddy.
