Cork Lower Harbour Main Drainage Scheme. Estuary Crossing Feasibility Report

Cork Dockyard to Monkstown

**A supplementary Feasibility Study Report in
respect of the installation of pumped sewer mains
by trenchless methods between Cork Dockyard and
Monkstown.**

S3 – 08 July 2016 –FINAL

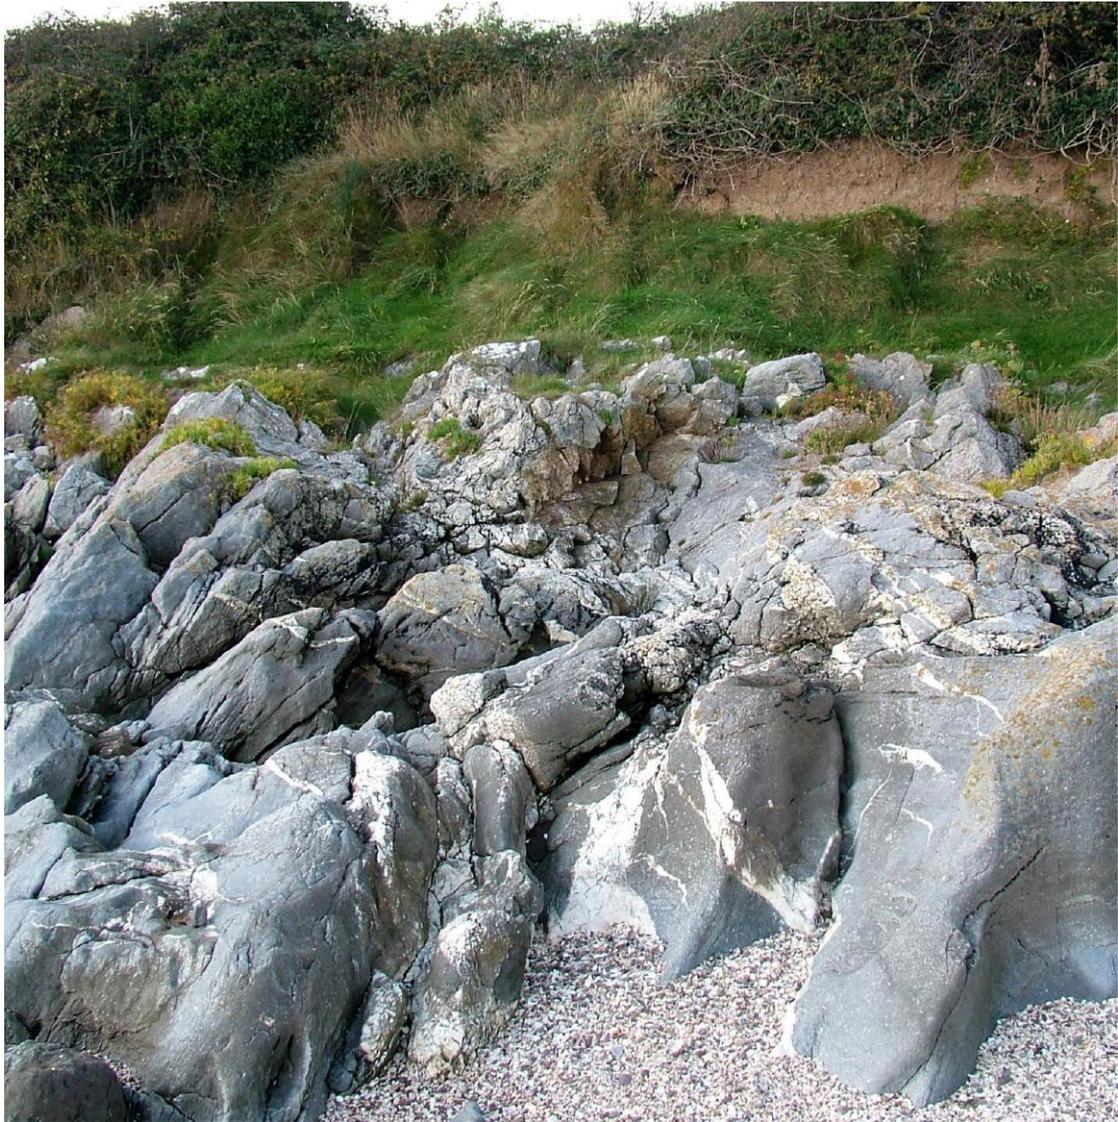
Appendix B8. Calcite veining in the Waulsortian Limestones at Ringaskiddy.

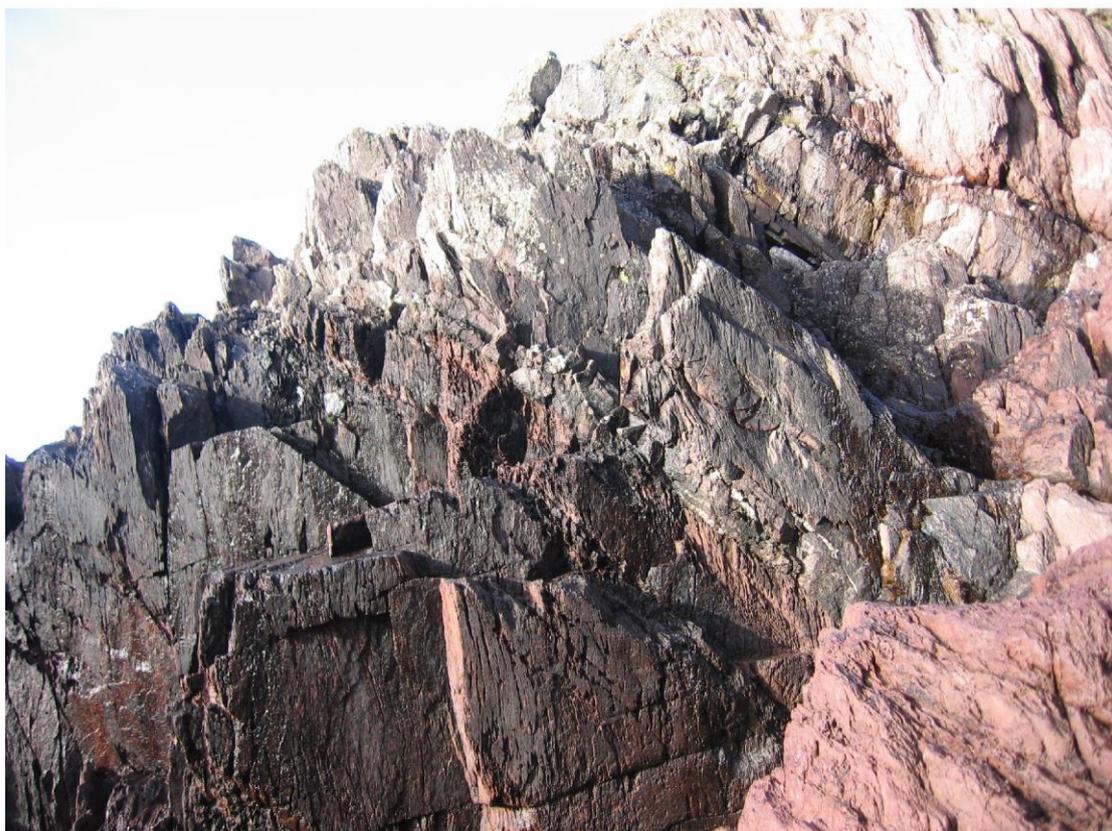
Appendix B11. Examples of structures in the Ballytrasna-Gyleen Formations.
J-Joints, White lines-Bedding, Red lines-Cleavage.

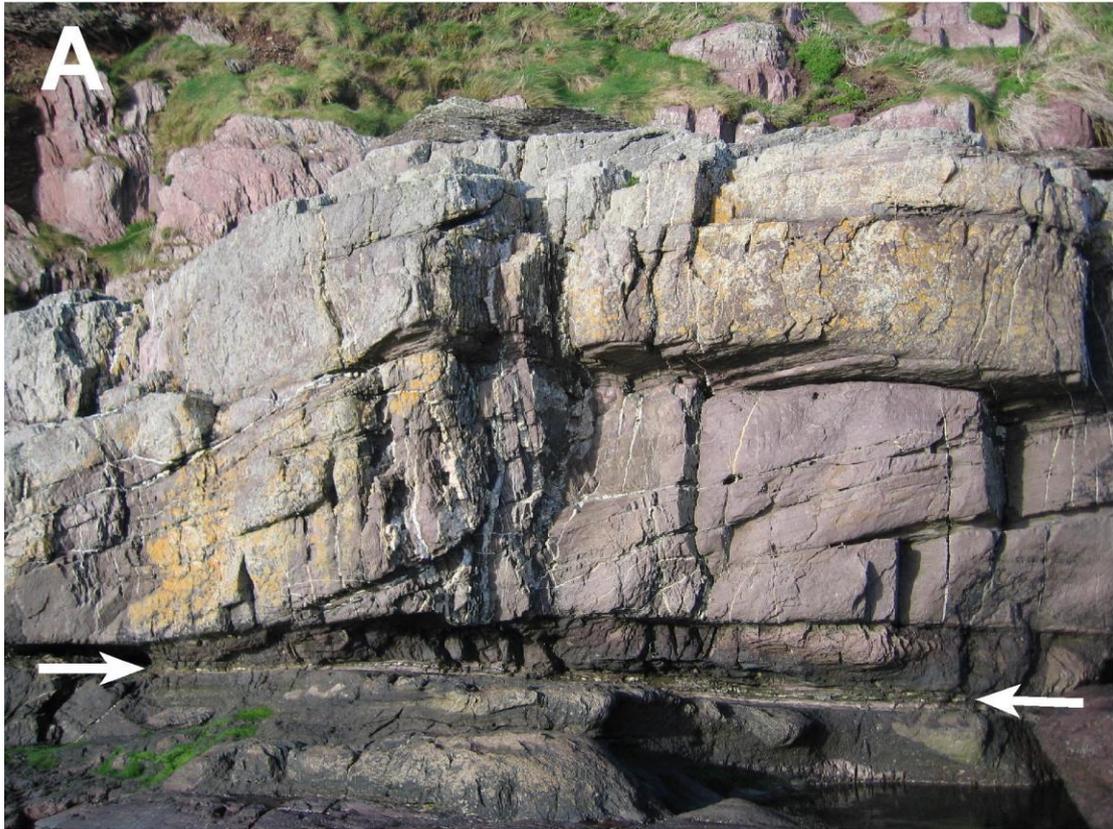
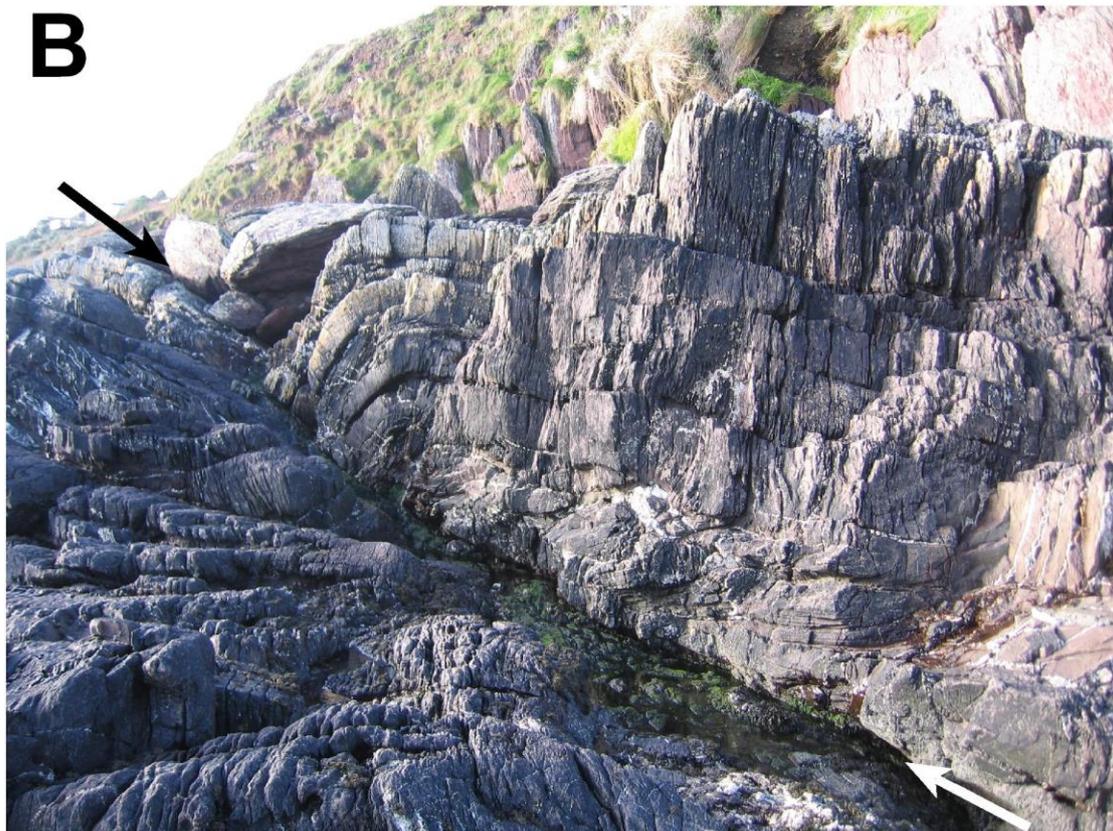
Appendix B12. Examples of faulting (between arrows) at Weavers Point.

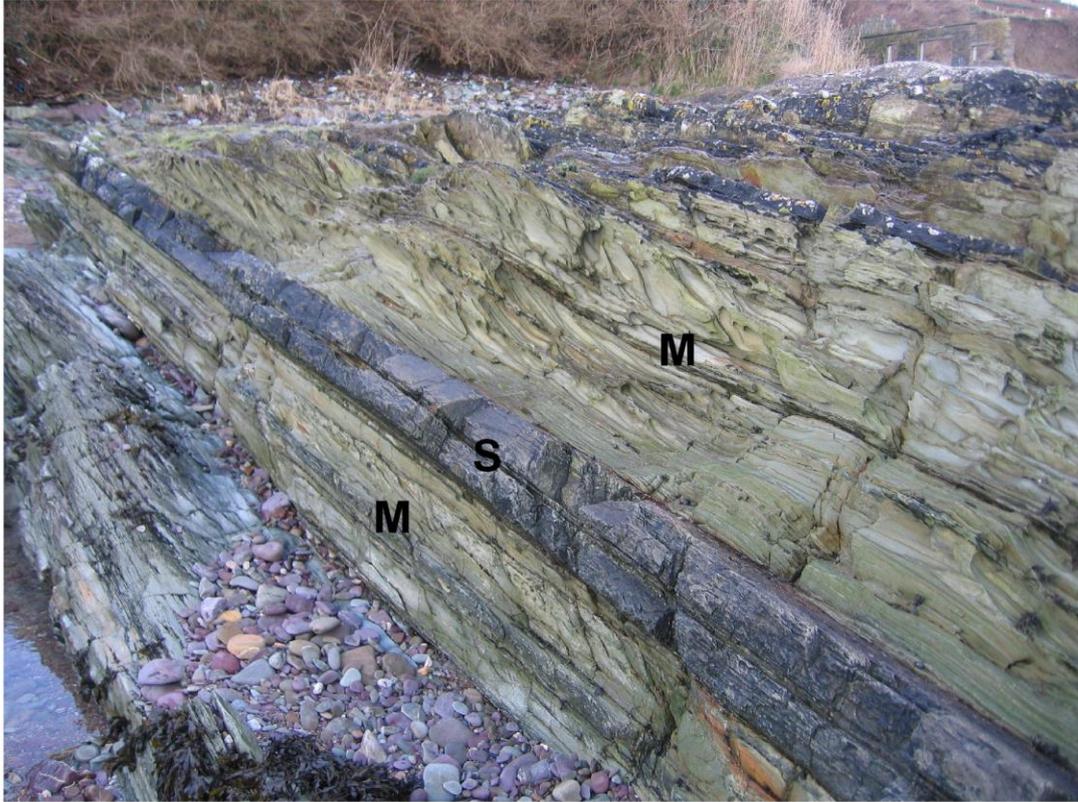
Appendix B14. Representative photo of the Gyleen Formation Ballyknock Mbr.

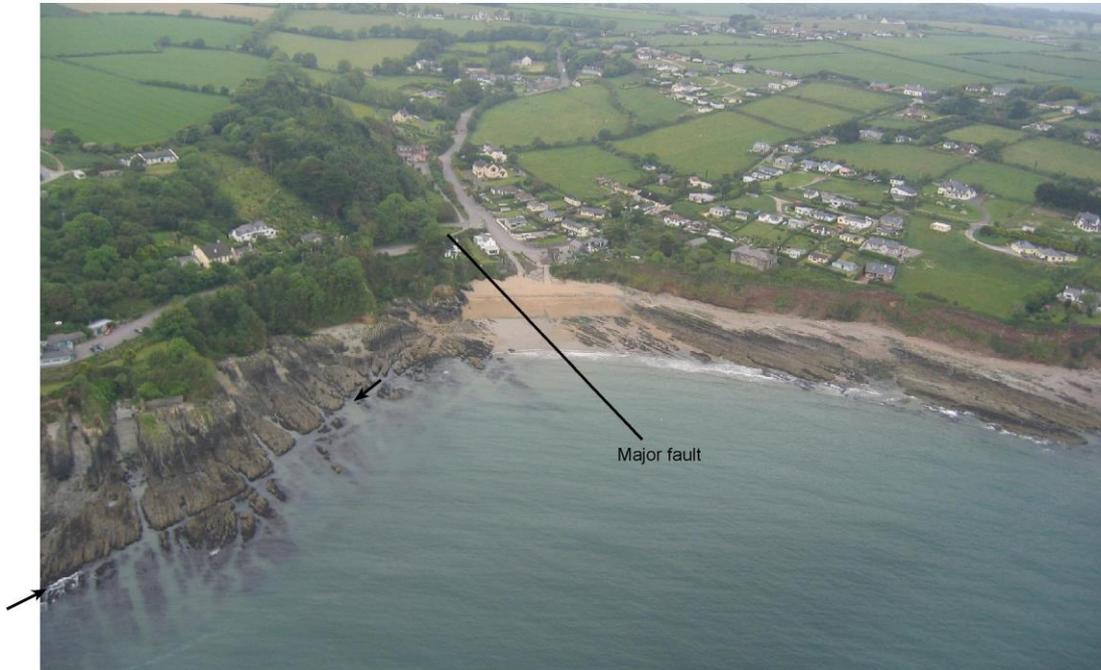
Appendix B16. Faulting at Myrtleville indicated by arrows.

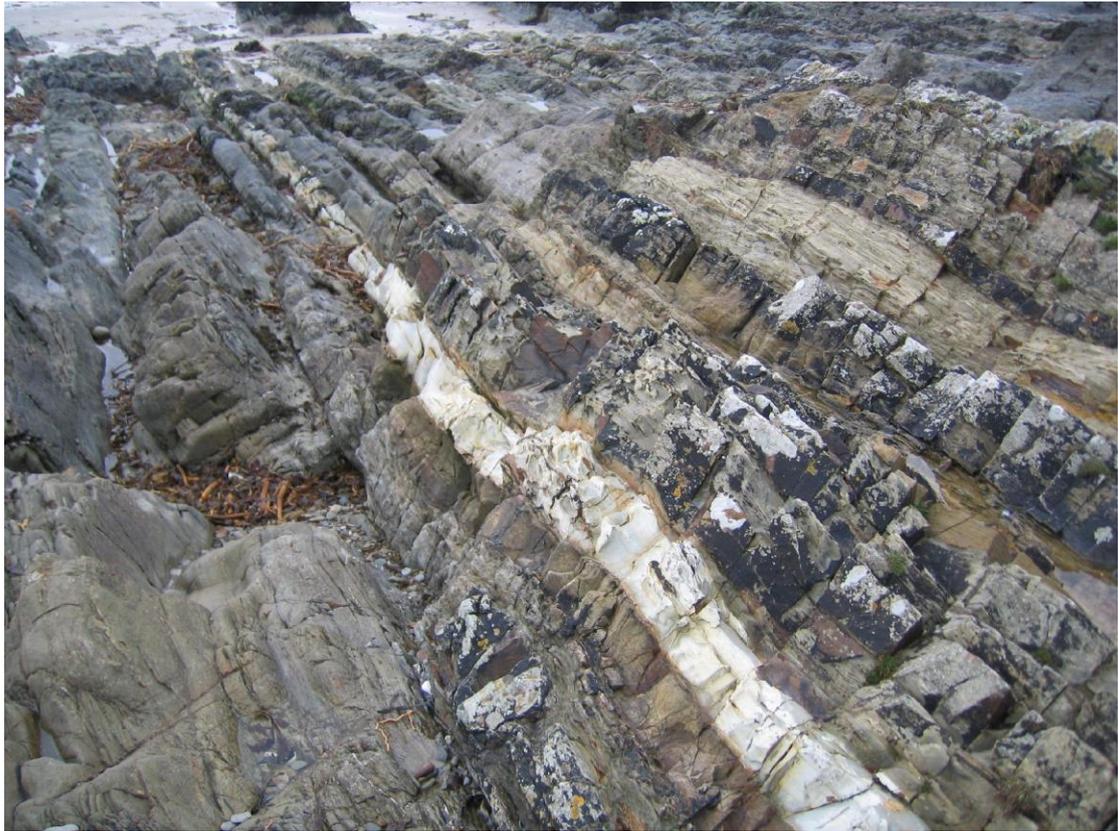
Appendix B20. Sandstones and heterolithic sediments of the Old Head Formation at Whitebay. The pale coloured level is a volcanic tuff.

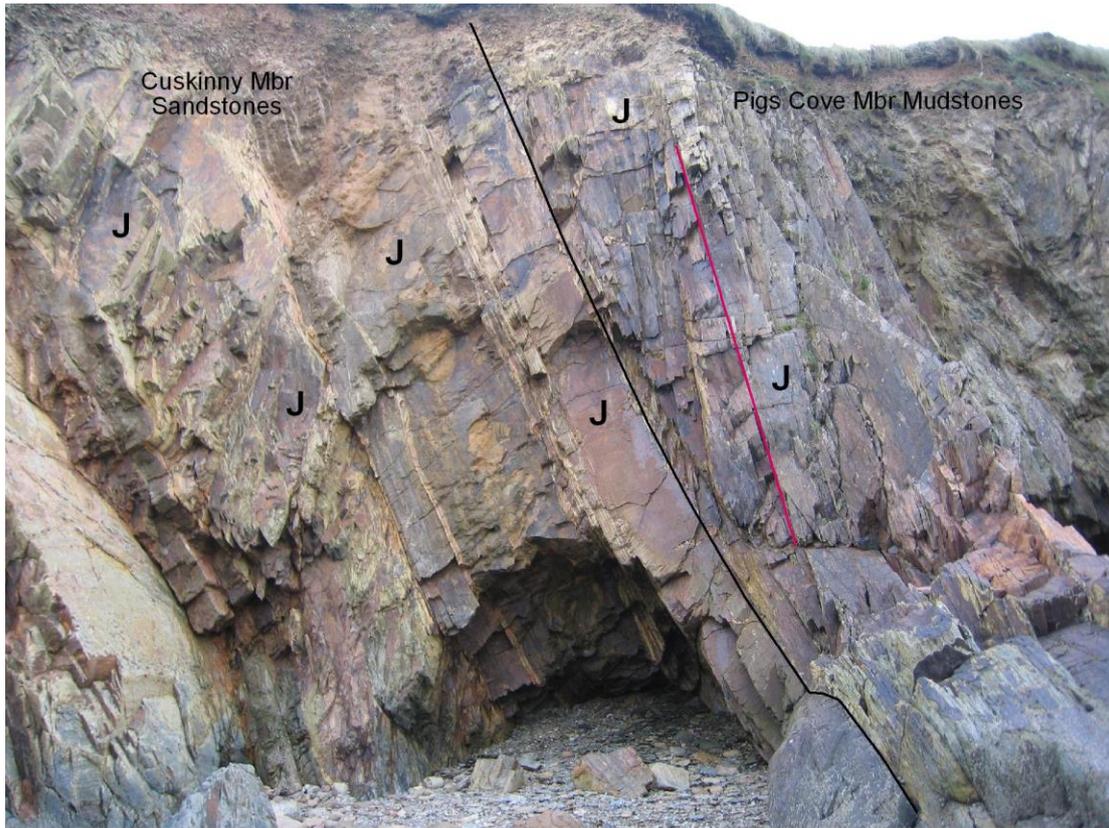
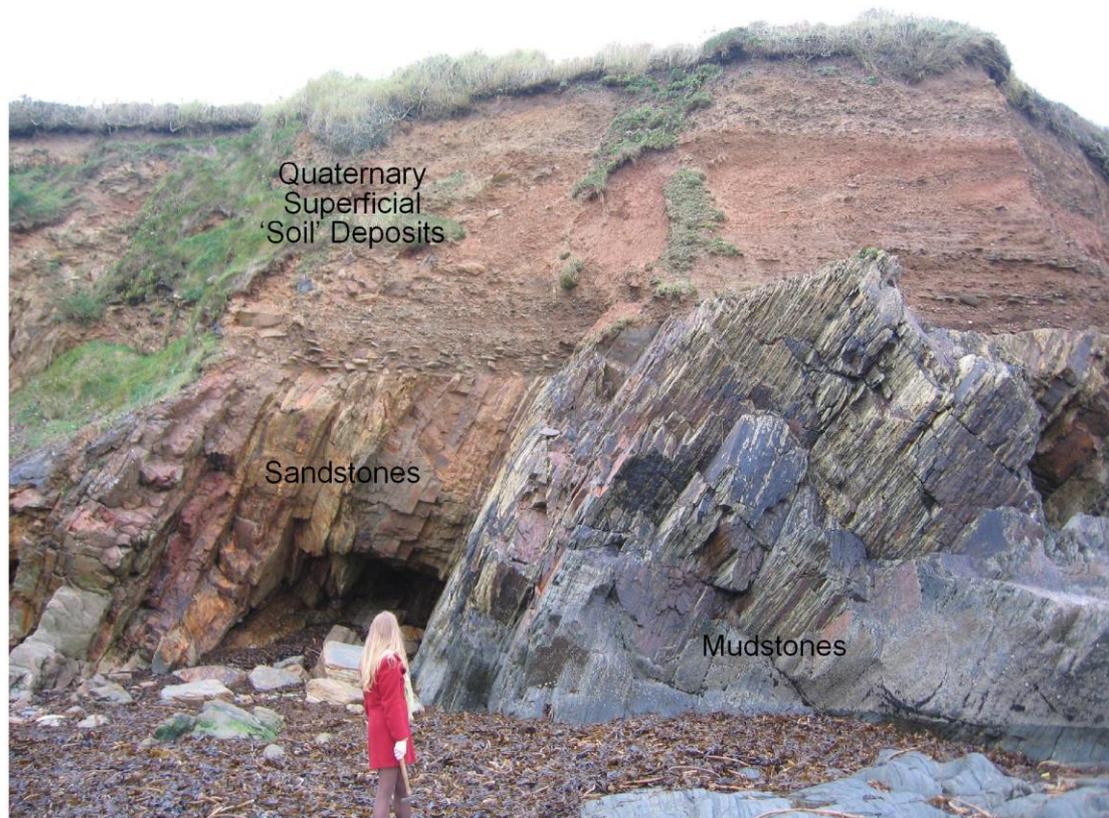
Appendix B21. Examples of the Kinsale Formation Cuskinny and Pig's Cove Members at Whitebay. J-Joint planes.

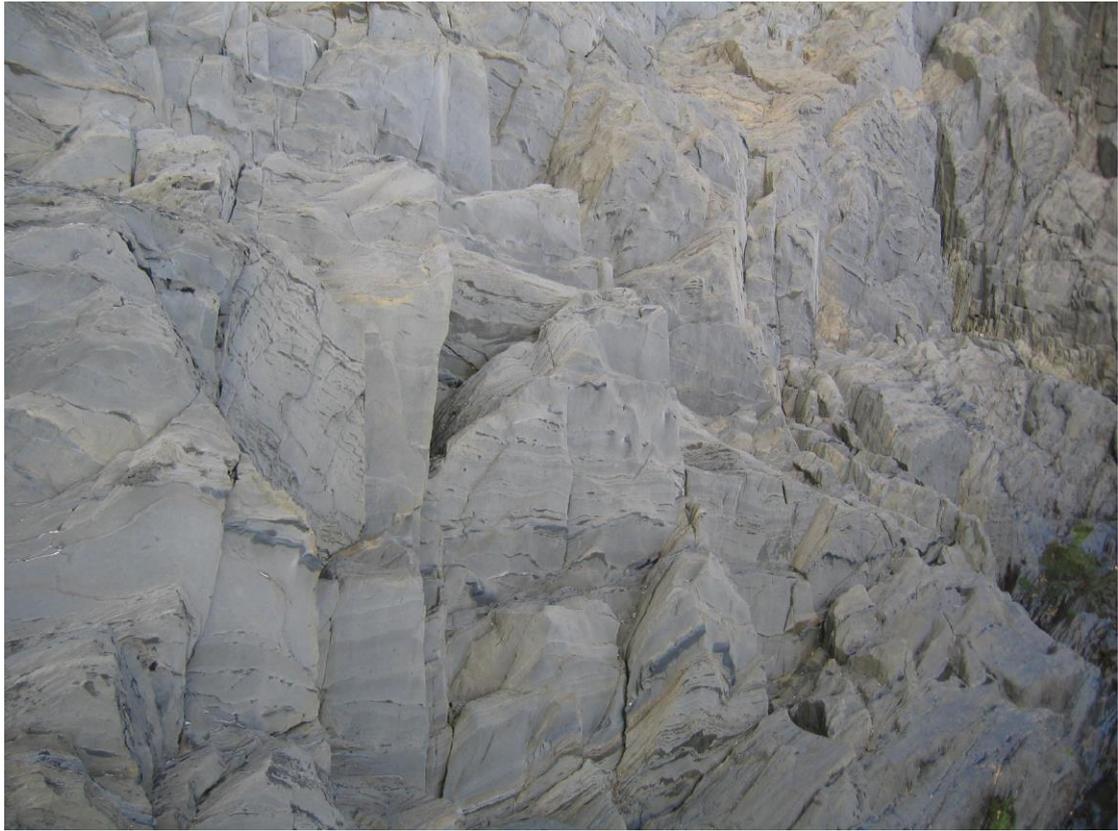
Appendix B22. The Kinsale Formation Castle Slate Member.

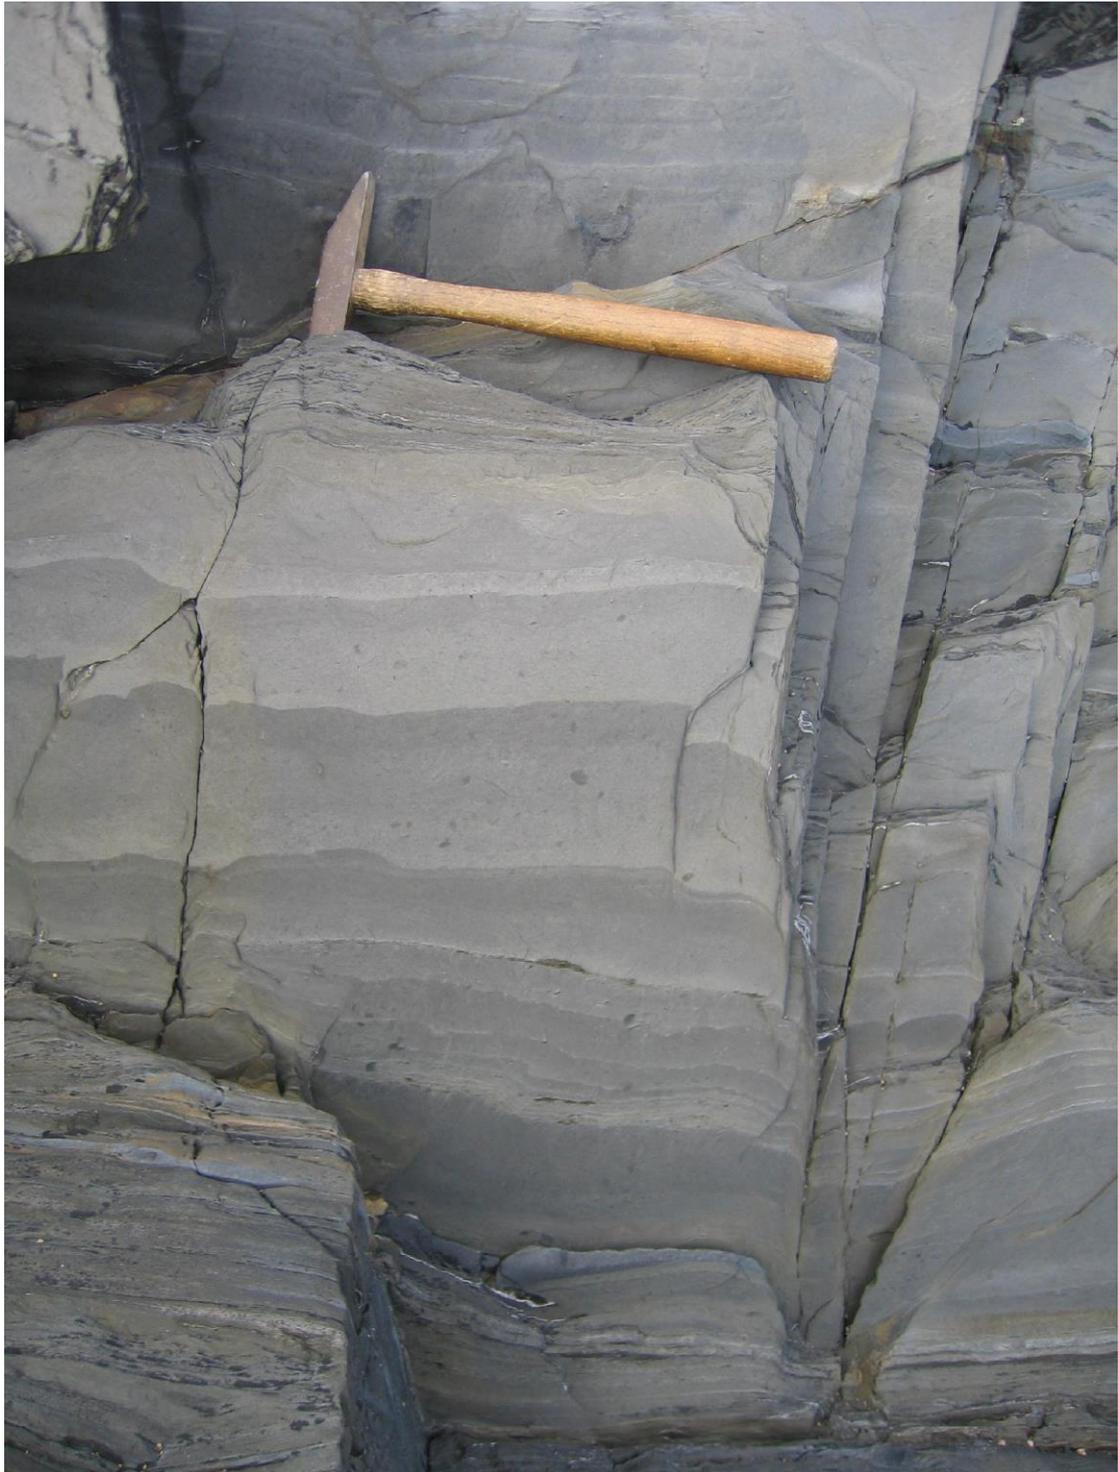
Appendix B23. The Kinsale Formation Castle Slate Member showing jointing, fracturing and lamination.

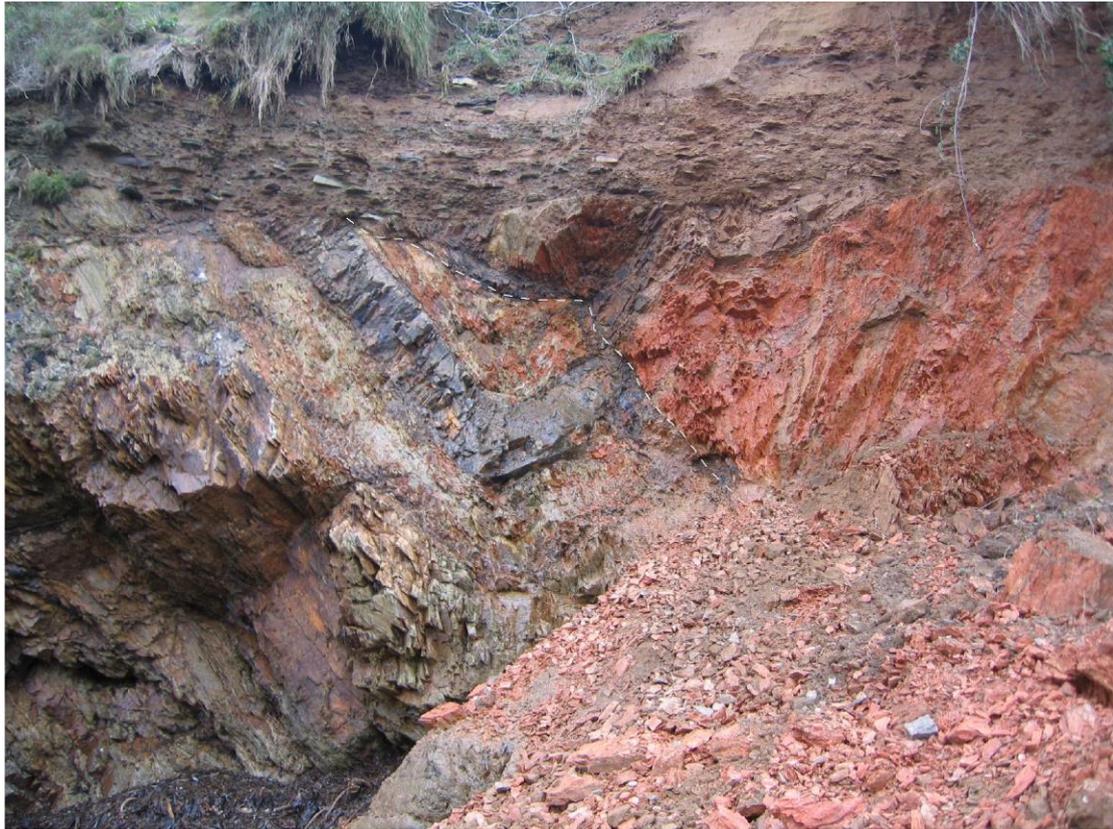
Appendix B24. Faulting at Whitebay indicated by white dash line in upper photo and arrows in lower photo. The red discolouration may be due to post-deformation circulation of hydrothermal fluids. Note associated folding in upper photo and intense fracturing of the bedrock in lower photo.

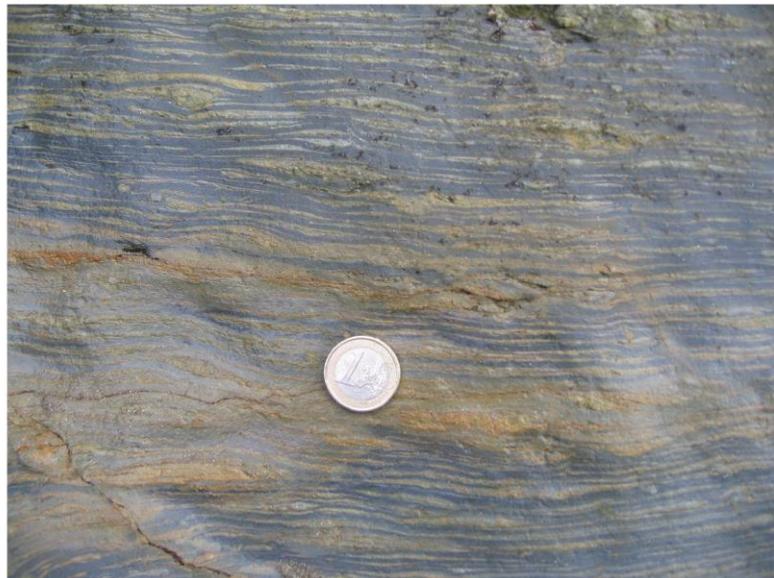
Heterolithic linsen bedding in sedimentary rocks.
