Annual Environmental Report 2021

Milford

D0342-01

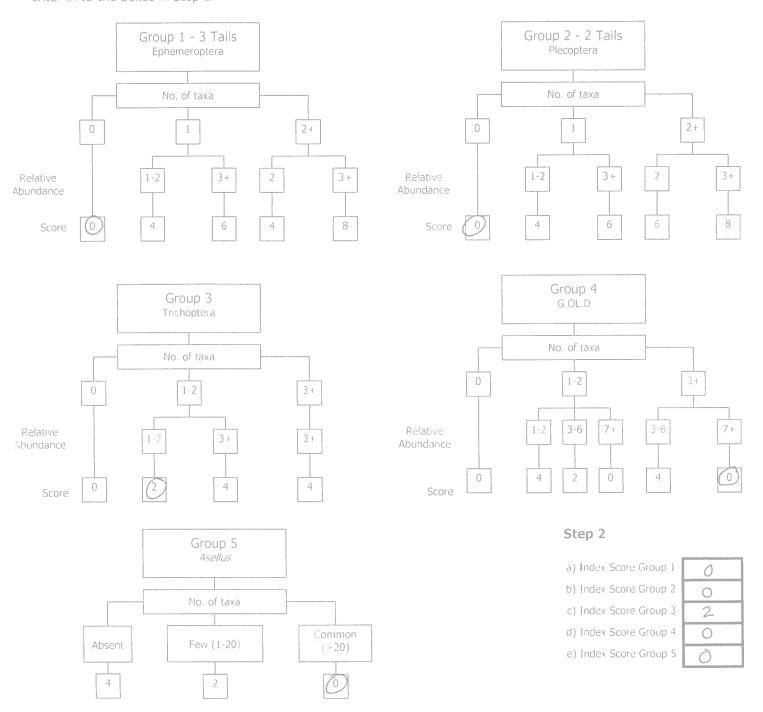
Step 1. Calculate the Index Score by circling the appropriate box representing the total number of taxa and the total abundance calculated from *each macroinvertebrate group* calculated from page 1 of the recording sheet and enter in to the boxes in Step 2.

Step 3. Calculate the Total Index Score, the Average Index Score and the SSR Score using the boxes below

rotal Index Score (115 sum (a+b+c+d+e	e) 2 Averag	S/5 (5 for 5 groups)	0.4	(AIS x 2)	0,8
Step 4. Assess the stream b	by comparing the final S	SR score with the	categories below an	d tick the appropri	ate box
> 7.25 Probably not at risk	> 6.5 - 7.25 Indeterminate Stream may be at risk	< 6. Stream at ris	5 5 6

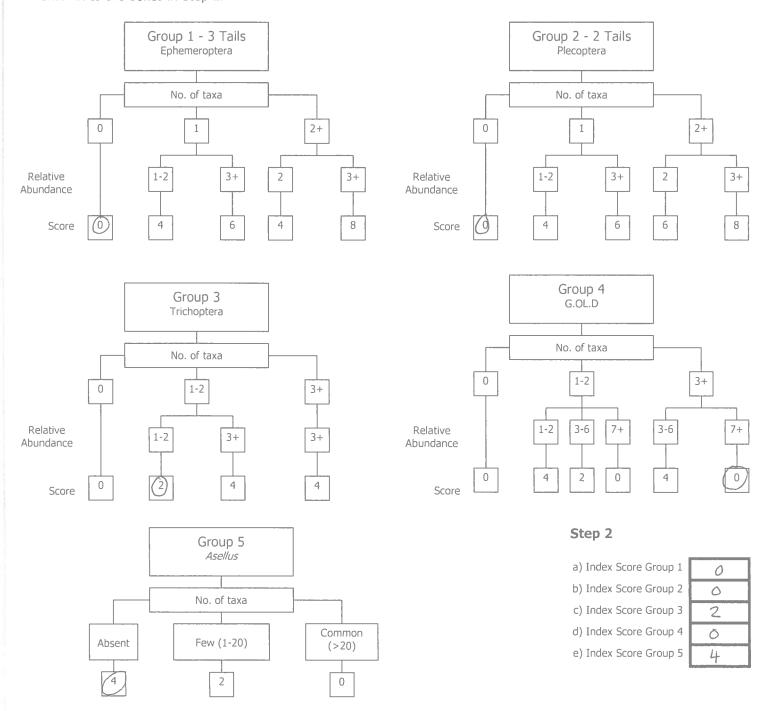
Step 1. Calculate the Index Score by circling the appropriate box representing the total number of taxa and the total abundance calculated from *each macroinvertebrate group* calculated from page 1 of the recording sheet and enter in to the boxes in Step 2.

Step 3. Calculate the Total Index Score, the Average Index Score and the SSR Score using the boxes below

Total Index Score (TIS) 6 Average Index Score (AIS) 1.2 SSR Score (AIS × 2)
