# Annual Environmental Report

2020

Derrinturn

D0244-01

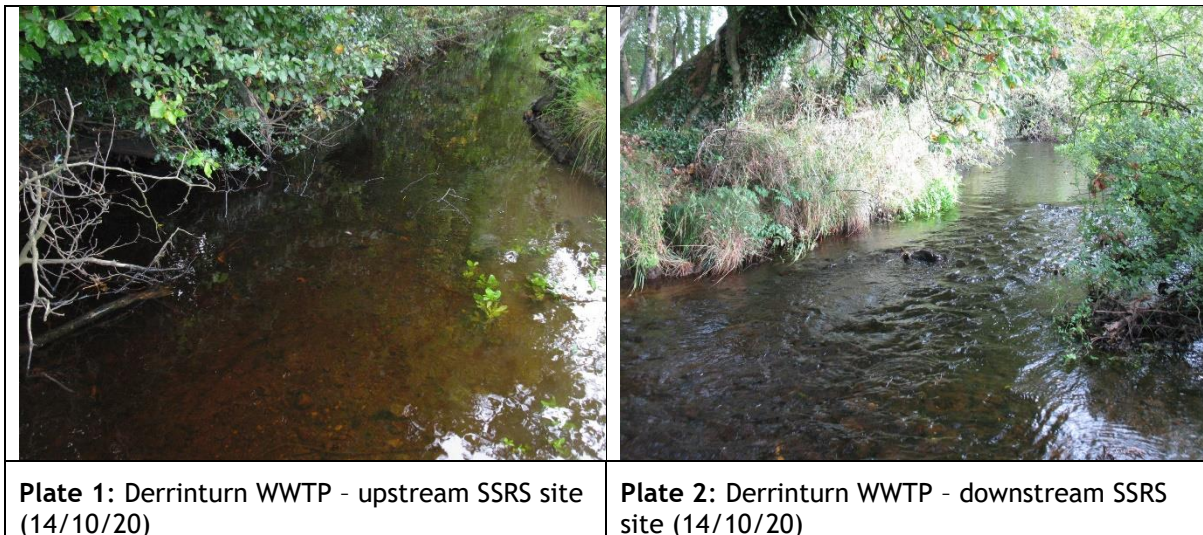
#### 3.3 Site Photographs

SSRS placed both upstream and downstream sites “At Risk” in 2020. Downstream was slightly better quality compared to upstream in 2020. Faunal diversity was low at both sites and no sensitive fauna (mayflies and stoneflies) were recorded at either site. The downstream site was dominated by tubificid worms, a sign of organic enrichment.

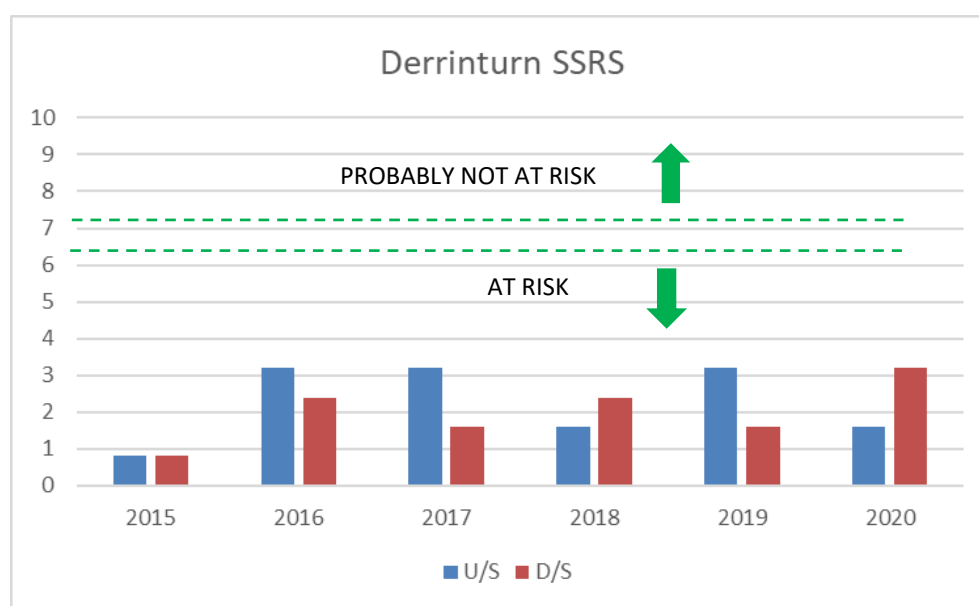
*Figure 1 – SSRS Comparison 2015 -2020 Derrinturn WWTP*

**Table 2** compares SSRS results 2015 to 2020. **Figure 1** illustrates trends at sites across sampling years. Both sites are consistently “At Risk”, indicating poor water quality. Even though the upstream site is not ideal habitat for SSRS sampling (i.e., slow run/glide), there is clearly a water quality problem in this stream, affecting upstream and downstream of the WWTP discharge.
